OTTAWA ROAD 174 AT JEANNE D'ARC
PIPE COLLAPSE

ROOT CAUSE ANALYSIS REPORT

December 7, 2012

B. M. ROSS AND ASSOCIATES LIMITED
Engineers and Planners
62 North Street
Goderich, ON N7A 2T4
Phone: 519-524-2641
Fax: 519-524-4403
www.bmross.net

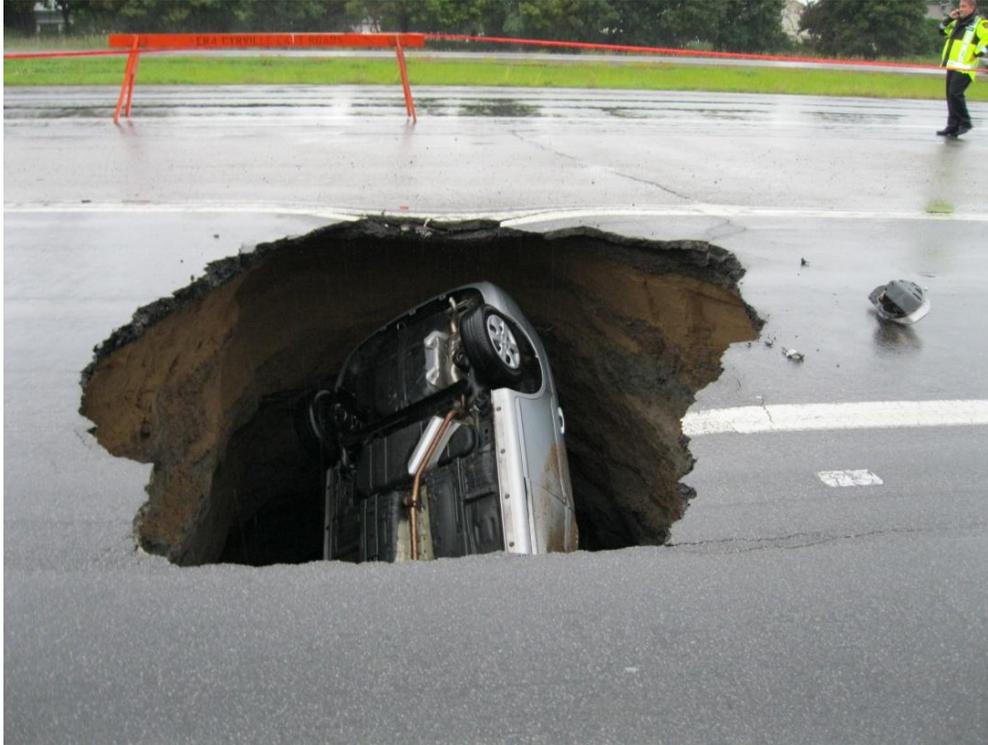
Figure 2.1
Sinkhole in Ottawa Road 174 September 4, 2012

1. At approximately 5:00 p.m. on Tuesday, September 4, 2012, a sinkhole developed in the east driving lane of the Jeanne D'Arc Boulevard off-ramp. The centre of the sinkhole has been estimated to be approximately 41 m north of the pipe entrance. The sinkhole was a consequence of a complete loss of structural integrity and the collapse of part of the liner plate section of the pipe beneath the road.
2. On August 31 and September 4, 2012 the Contractor had been inside the pipe installing lights and removing rocks and debris. He was using a CAT 301.8 mini-excavator and a skid-steer loader. Both pieces of equipment were on rubber tracks and fit easily into the 3.6 m diameter space.

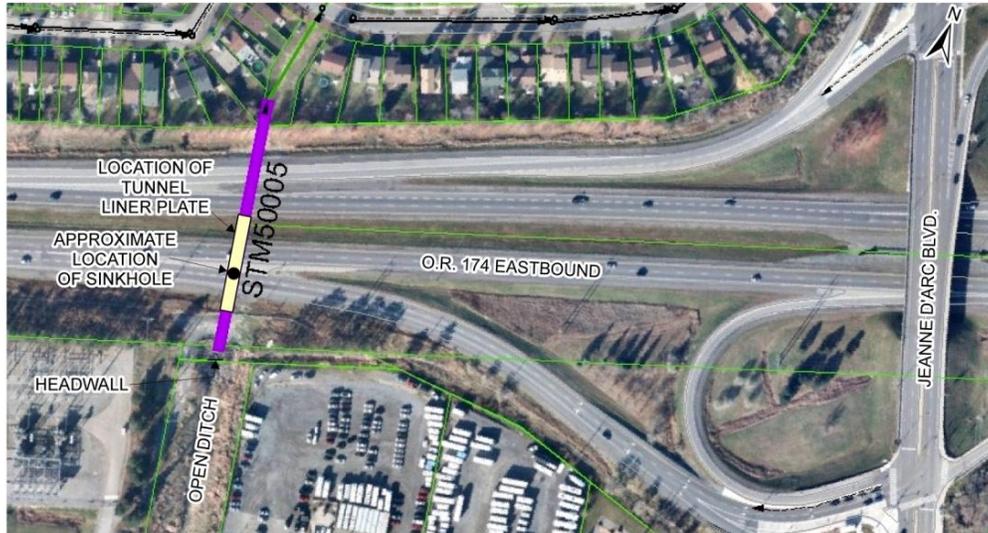
Figure 3.1
Location of STM50005

STM 50005, as shown in figure 3.1, could be considered to be somewhat unique in that it was partially constructed of un-galvanized tunnel liner plate in a corrosive environment with conventional galvanized CSP on both ends.

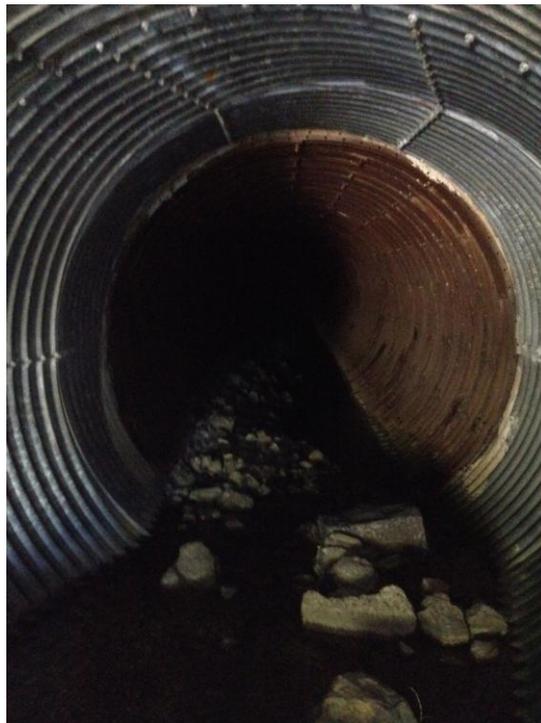
Figure 3.2
Transition from CSP to Liner Plate – July 2012

Figure 3.2 is a photograph taken in July 2012, showing the transition from CSP to liner plate. The photo was taken during the tendering period for the re-lining project by a representative of a pipe supplier for the proposed liner whose interest was the nature of the bend in the pipe.

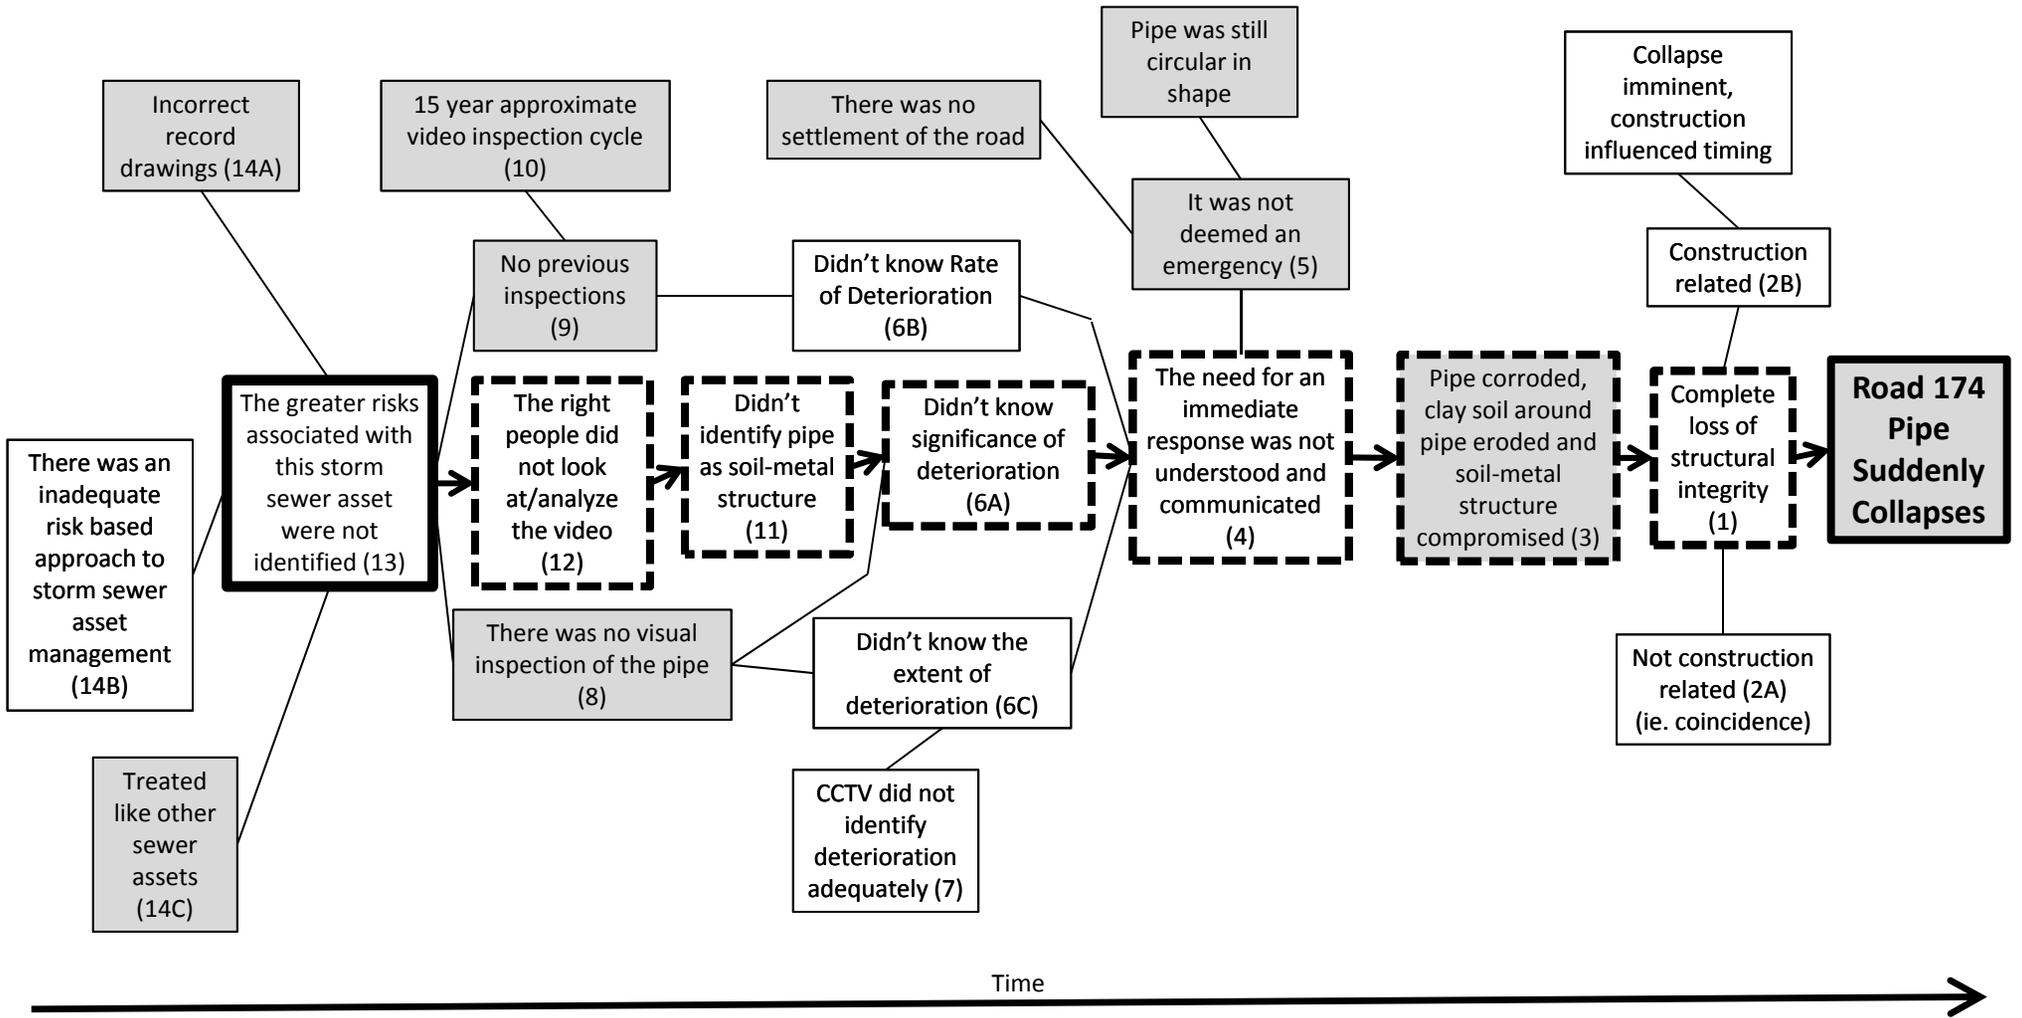
Figure 5.1
Root Cause Analysis
Diagram

Figure 5.1 provides a visual summary of the findings of the RCA. The event (the collapse of the pipe) is presented on the extreme right and causes for the event are presented right to left, moving backwards towards the root cause(s). Facts established through the investigation are presented in a shaded box. Where a cause is our “opinion”, based on the investigation, it is presented in an unshaded box.

In conclusion, it is our opinion that the root cause of failure of the pipe beneath Ottawa Road 174 was that the structure's inherently greater risks were not identified and acted on before the pipe's structural integrity was lost.
