FIELD ASSESSMENT OF TWO COATINGS FOR CORRUGATED STEEL PIPES: GALVANIZED AND ALUMINIZED TYPE 2

January, 2020

301013357: BI-METAL CULVERT ASSESSMENT
TECHNICAL REPORT NO. 2 (2020)

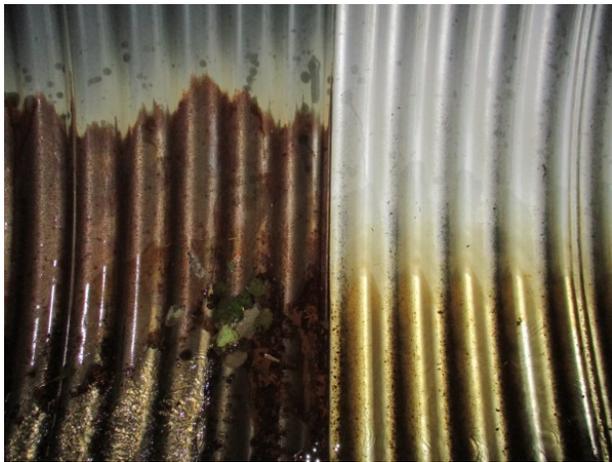
Site 1 is located near the community of Powell River in mainland B.C. The galvanized section is located at the outlet of the culvert (Figures 5 and 6).

Figure 5. Galvanized coating (left) and aluminized coating (right) joined at a lock seam.

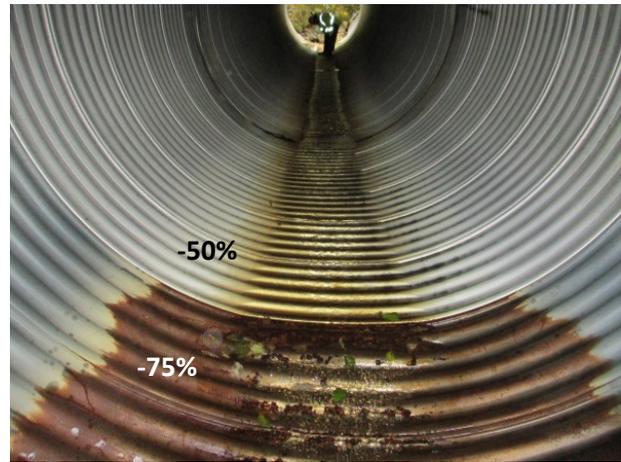
Figure 6. View toward the culvert inlet. This image shows minimal flow during the field visit, obvious corrosion of the galvanized section, and the average percentage of coating lost (locations 5 and 7) compared to that on the sides (locations 3 and 9) of the culvert.

Comparing the average readings from the sides of the culvert (locations 3 and 9) to the seasonal high flow points (4 and 8), there was no significant change in coating thickness for the galvanized or the aluminized sections. Comparing the sides of the culvert (3 and 9) to the points near the flowing water (5 and 7), the change on the galvanized section was greater than on the aluminized; the galvanized was reduced by 75%, and the aluminized was reduced by 50%. This site had the highest percentage of coating reduction for both galvanized and aluminized type 2 coatings. It also had the lowest flow, which may be attributed to measurements being taken lower (toward the invert) at locations 5 and 7, where even minimal bedload movement could contribute to abrasion. Coupon thickness from top to bottom samples showed some reduction on the galvanized coating, and the aluminized type 2 remained unchanged. Some corrosion build-up on the coupon samples resulted in thicker measurements than

steel and coating alone. It was observed that on the galvanized coupons at the bottom of the culvert, the coating had worn away on the water side and the soil side.

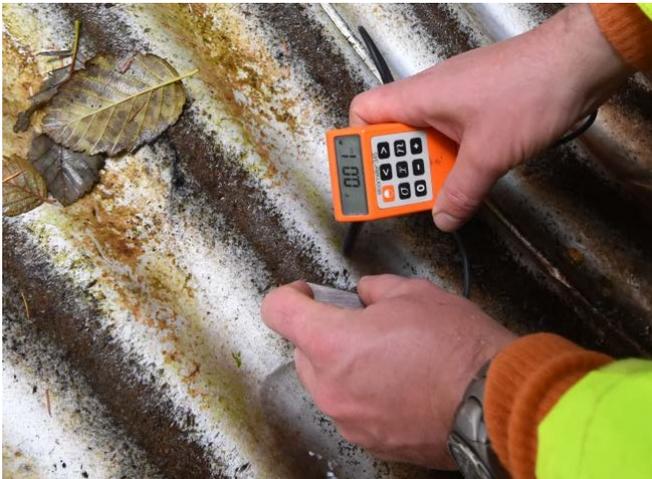
Abrasion within the culvert was more pronounced on the upstream side of the corrugations than the downstream side, and especially near the flowing water at the invert/bottom of the culvert. Figures 7 and 8 show the differences in measurement from the upstream (0.01 mm) to the downstream (0.04 mm) of a corrugation within the area of the invert visually affected by bedload movement and abrasion. The galvanized section and the aluminized type 2 section had abrasion on the upstream side of the corrugations, which removed the coating and exposed the steel beneath; the downstream side of the corrugations along the invert retained the coating, with only minor pitting. The range in coating measurements near the flowing water (5 and 7) for the galvanized section extended to zero, correlating to a measurement of bare steel. This site showed the greatest wear for any aluminized or galvanized section which may be due to the very low flow at time of field visit allowing measurements to be taken along the true invert where even minor bedload abrasion would be more constant.

Figure 7. Upstream side of an aluminized corrugation, showing a coating measurement of 0.01 mm.

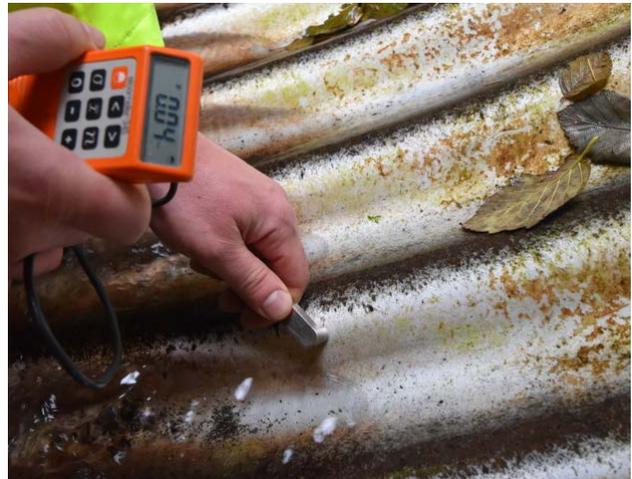
Figure 8. Downstream side of an aluminized corrugation, showing a coating measurement of 0.04 mm.

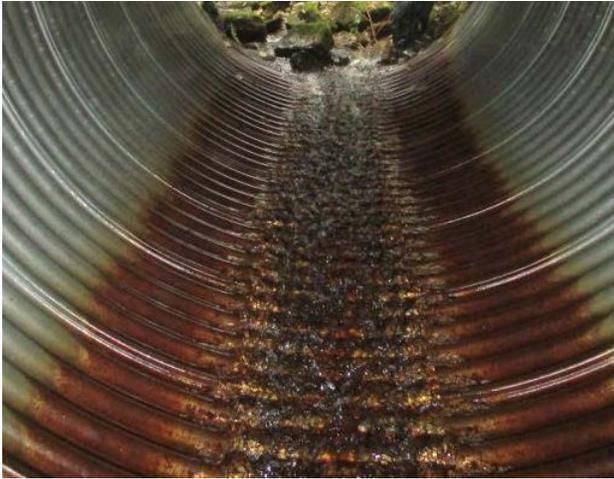
Figure 9. View of the galvanized section. Areas below the water were observed and felt to be slightly pitted, likely due to bedload movement causing abrasion.

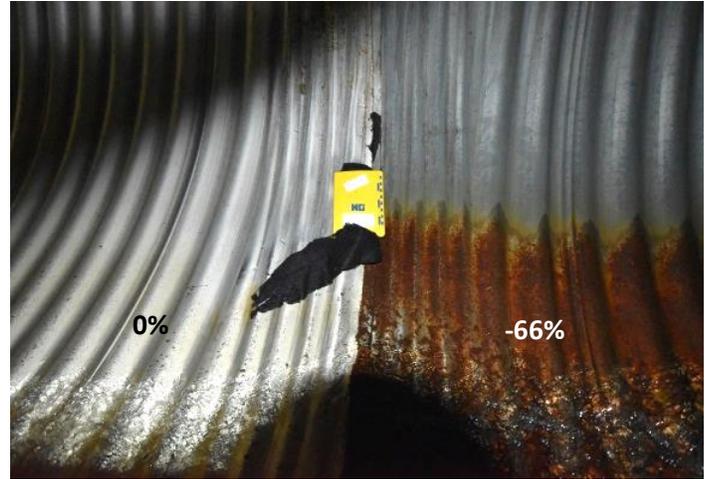
Figure 10. View of an aluminized (left) and galvanized (right) section joined at a coupler. The notebook was included for scale and was resting on a piece of geotextile fabric, which would have been placed next to the coupler on the outside of the culvert during installation. The numbers indicate the average percentage of coating lost near flowing water (locations 5 and 7) compared to the sides (locations 3 and 9) of the culvert.

Comparing the average readings from the sides of the culvert (locations 3 and 9) to the seasonal high flow points (4 and 8), there was no significant change in coating thickness for the galvanized or the aluminized sections. Comparing the sides of the culvert (3 and 9) to the points near the flowing water (5 and 7), the change on the galvanized section was greater than on the aluminized; the galvanized was reduced by 66%, and the aluminized was reduced by 0%. Coupon thickness from top to bottom samples showed some reduction on the galvanized coating, and the aluminized type 2 gained thickness. Some corrosion build-up on the samples resulted in thicker measurements than steel and coating alone.

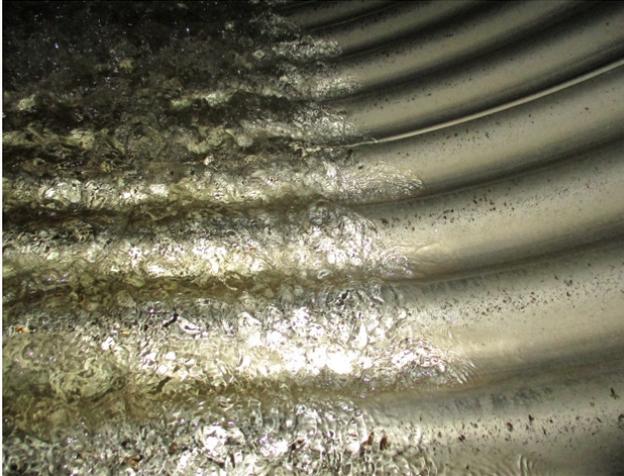
Abrasion at this site was more pronounced visually on the galvanized section, and the site appeared to have a low to medium movement of bedload. On the aluminized section, the upstream side of the corrugations had minor “pock” marks, and an estimated 90% of coating remained intact; the downstream side had no abrasion (Figure 11). The galvanized section showed overall greater wear (Figure 12). Although the culvert at this site was installed the longest (1997), the higher stream flows during the site visit kept the near flowing water measurements (5 and 7) to be further from the true invert which could have removed some of the effect of bedload abrasion, resulting in the measurements showing more coating remaining.

Figure 11. View of aluminized coating, showing only minor abrasion along the upstream side of the corrugations along the invert.

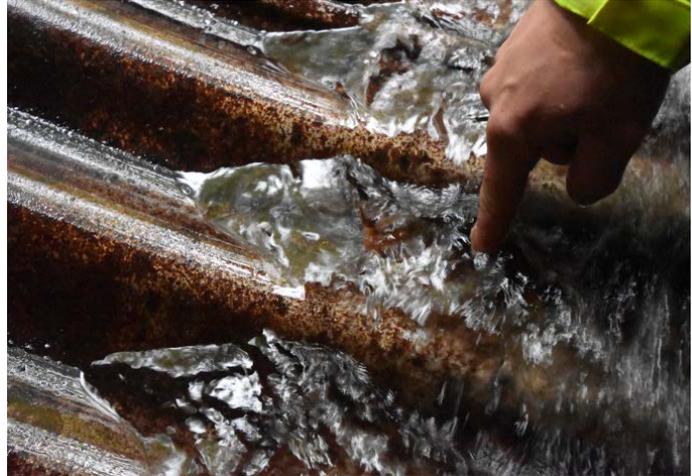
Figure 12. View of galvanized zinc coating, showing a greater amount of surface corrosion; the upstream portion of corrugation had minor pitting, and the galvanized zinc coating had worn off.

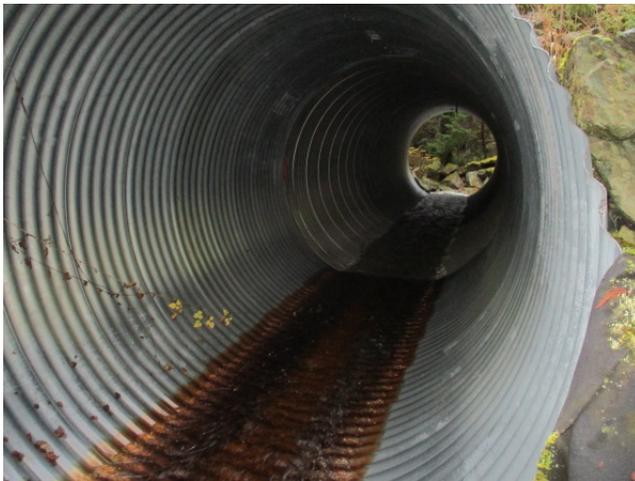
Figure 13. View of a galvanized section in the foreground and the aluminized type 2 section in the middle of the culvert.

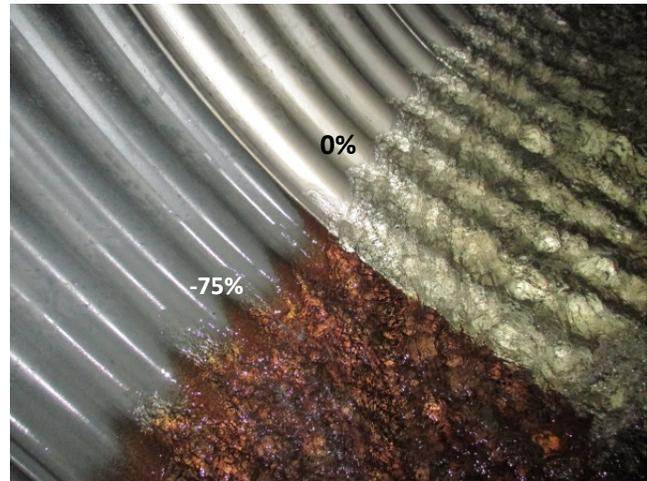
Figure 14. Junction of the galvanized and aluminized type 2 materials. The numbers indicate the average percentage of coating lost near flowing water (locations 5 and 7) compared to the sides (locations 3 and 9) of the culvert.

Comparing the average readings from the sides of the culvert (locations 3 and 9) to the seasonal high flow points (4 and 8), there was a slight reduction (25%) in coating thickness for the galvanized section. There was no significant change on the aluminized section. Comparing the average readings from the sides of the culvert (3 and 9) to the points near the flowing water (5 and 7), the galvanized section was reduced by 75%. Again, there was no

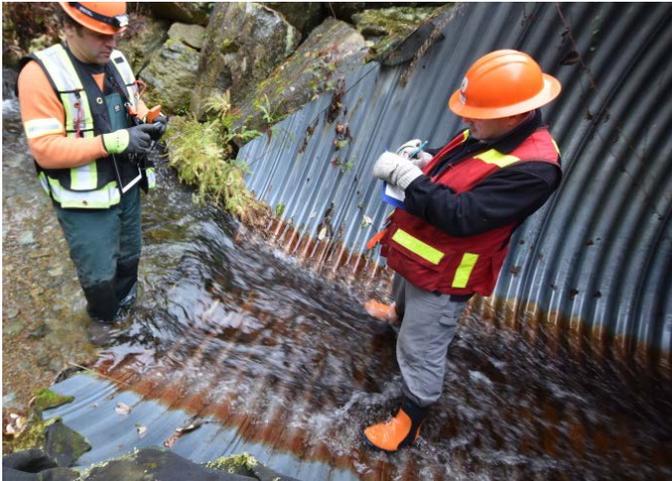
The flow at site 3 was high during the site visit. Abrasion at the site showed corrosion and pitting below the water line on the galvanized section (Figure 15), with some signs of steel showing (no coating remaining). The range in readings of the coating thickness also provides insight into coating wear, and in this case, the galvanized coating had a range extending to zero near the flowing water location (5 and 7). This correlates with the visual abrasion assessment, which noted bare steel visible in some areas. On the aluminized section, there was minimal corrosion and pitting, with much of the coating intact (Figure 16).

Figure 15. View of step-bevelled inlet made of galvanized steel.

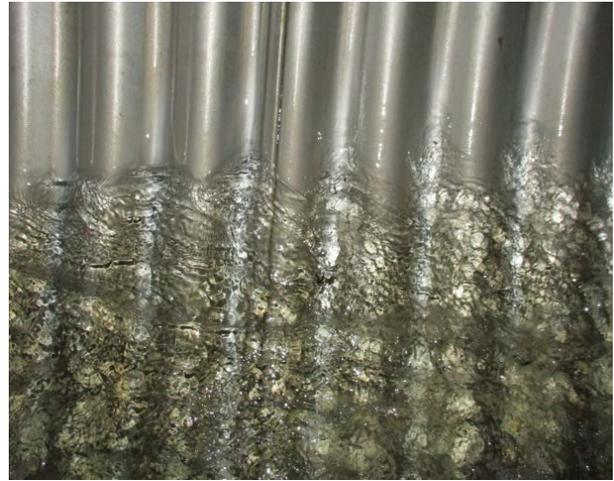
Figure 16. View of the aluminized type 2 section at a helical lock seam joint.
