February 3, 2009

Subject: Aluminized Type 2, The First 50 Years
RI No. 090017, Report No. 1 - Final

During 1952-3 Armco collaborated with state departments of transportation which installed of Type 2 Aluminized corrugated steel pipes (T2 CSP) in various locations. Two reports were published documenting T2 CSP durability in 1983 and 1996 summarizing the 30 and 43 year status. This Research Investigation represents the third report summarizing the status of the remaining 22 sites following more than 50 years in service. Ten of the sites assessed in 1996 were removed from service due to changes in land use. The site in Sangamon Co. Illinois was completely submerged due to locally heavy rains prior to the time of the assessment, while a site in Marshall Co. IA had to be relined and grouted due to damage on the galvanized half of this tandem site.

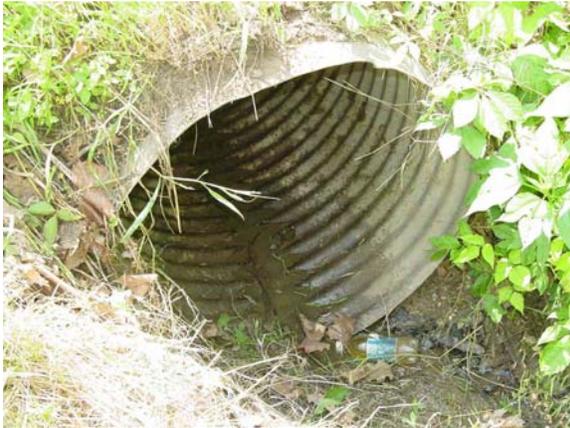
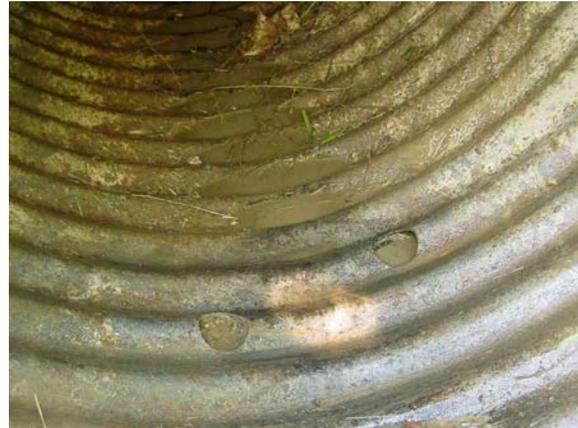
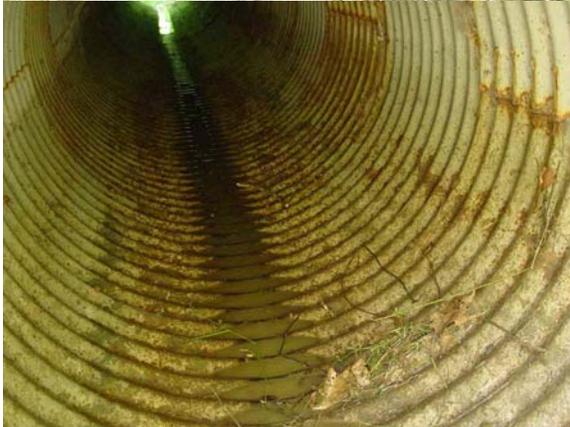
Images from Greene County Site:

Description: 36” dia. ALT2 in good condition, visually round – no apparent ovality or buckling. Estimate 5 days since previous rainfall.

Observations: Good condition, no buckling, still round. Almost no red rust at the 6’o’clock position. Approximately 5 days since last rainfall per J. DuBoise.

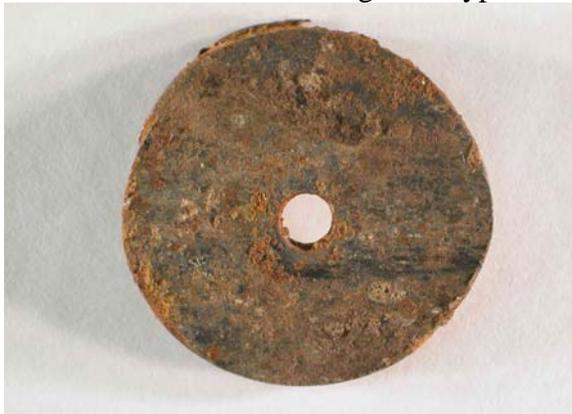
Trepan Evaluation: The top images represent the coupon ‘as received’. The coupon was then bead blasted to remove loose oxides and an images were recorded of the remaining surface. Micrometer readings were taken after bead blasting using a ball micrometer (general thickness) and a point micrometer (deepest pit depth). Starting thickness: 0.114”.
Micrometer results: Ball: 0.113”, 0.114”, 0.113” Point: 0.096” (0.018” deep)
Based on conservative pit penetration extrapolations, the projected service life of 16 gage T2 CSP will exceed 100 years in this environment.

ALT2 water side

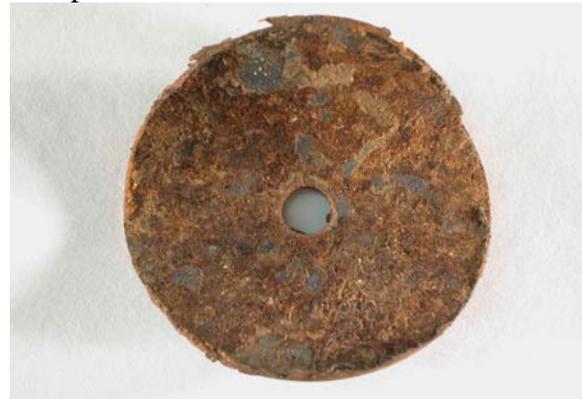
ALT2 soil side

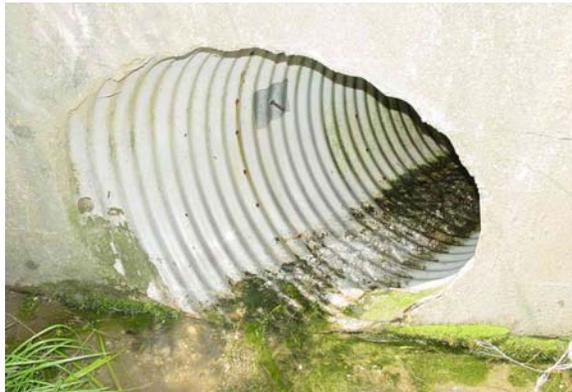
Aluminized end

Description: 36” dia. ALT2 in very good condition on south end of pipe. Galvanized on north end of pipe corroded completely through at bottom.

Observations: Free aluminum coating is visible around the complete circumference. Previous trepan holes not corroded further. Sample taken at 6:30 position. Galvanized end is corroded completely through at bottom of pipe. The exposed crown on the galvanized end is rusted with no remaining zinc. Estimate 5 days since previous rainfall per J. DuBoise.

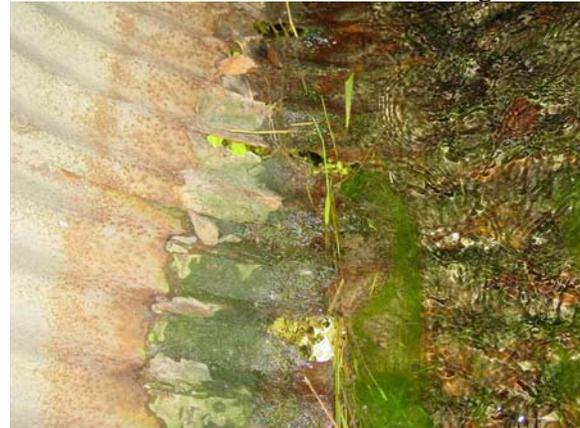
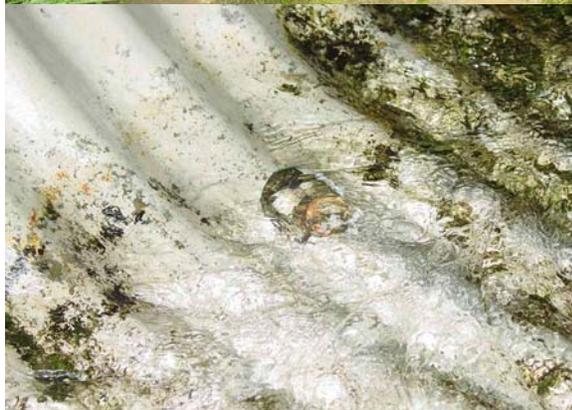
Galvanized end corroded through

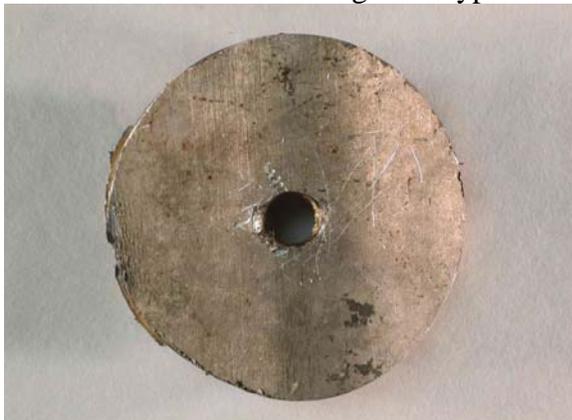
Trepan Evaluation: The top images represent the coupon ‘as received’. The coupons were then bead blasted to remove loose oxides and images were recorded of the remaining surface. Micrometer readings were taken after bead blasting using a ball micrometer (general thickness) and a point micrometer (deepest pit depth). Starting thickness: 0.113”.
Results Ball: 0.112”, 0.112”, 0.113” Point: 0.111” (0.002” deep – very few small pits)
Based on conservative pit penetration extrapolations, the estimated service life of 16 gage T2 CSP will exceed 100 years in this environment.

ALT2 water side

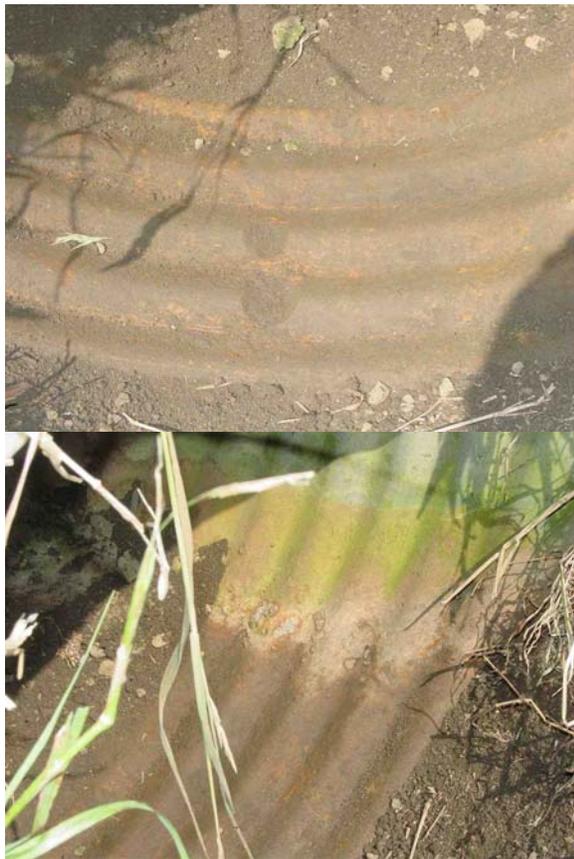
Observations: Good condition, no buckling, still round on both ends. ALT2 in very good condition. Sampled at the 6’o’clock position. Galvanized end rusted and discolored with a heavy oxide layer @ 18” of pipe bottom, not perforated just heavily pitted. Surroundings are very densely vegetated with tall thick grass covering the entire slope from the road to the crops.

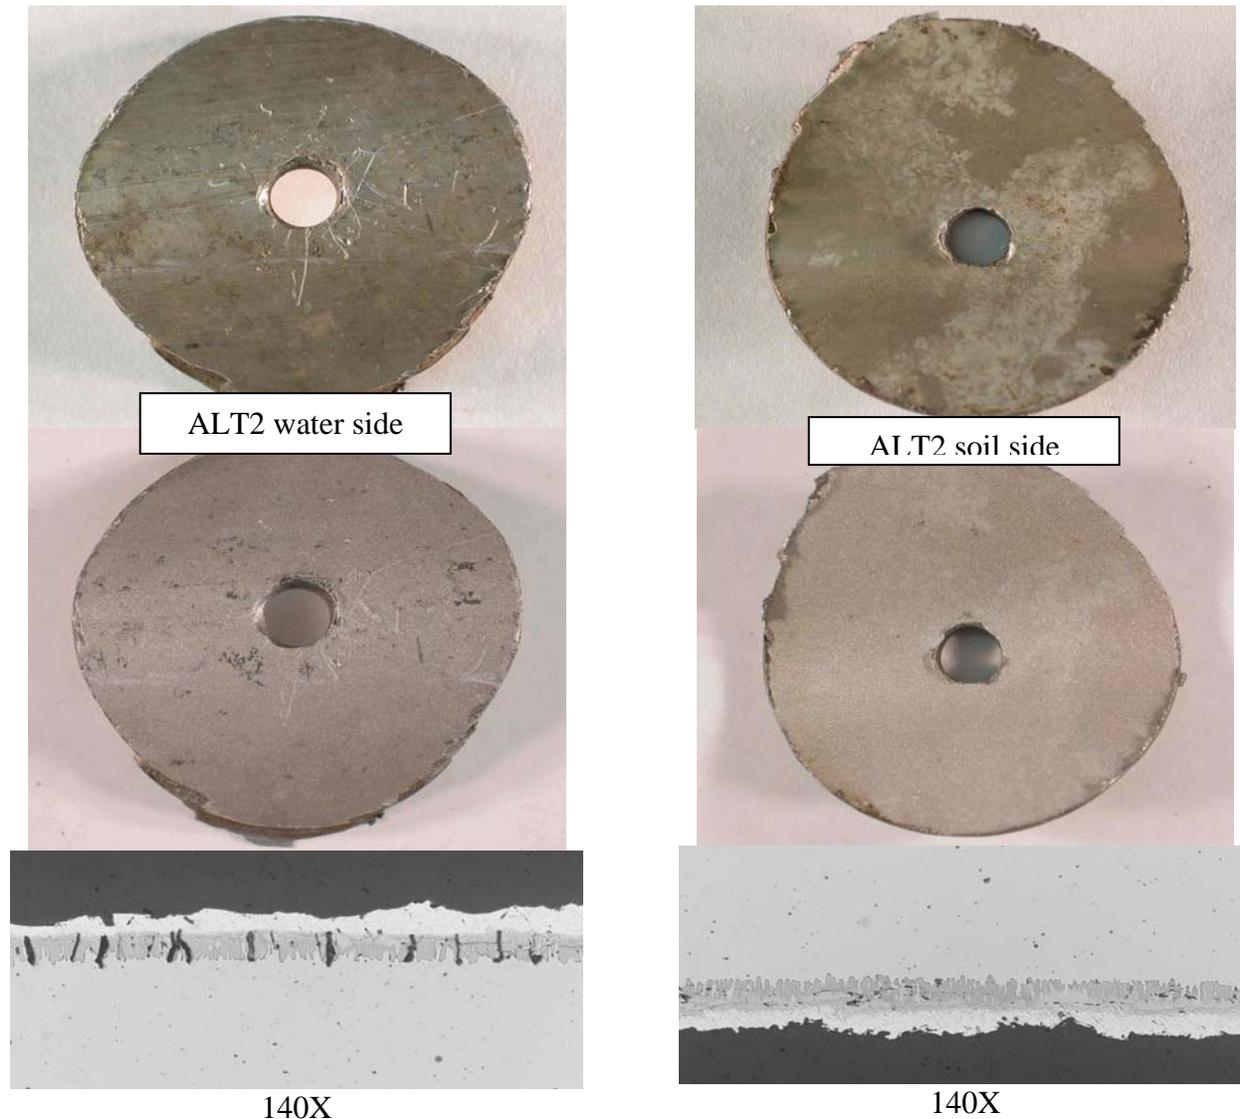
Images of ALT2 trepans from Site 3: all 6 o'clock pipe positions

Site 3 Trepan Evaluation ALT2: The top images are of the coupon as removed after rinsing off loose dirt and debris. The coupon was then bead blasted to remove loose oxides and the lower images were recorded. No pitting evident.

Based on conservative pit penetration extrapolations, the service life of 16 gage T2 CSP will exceed 100 years.

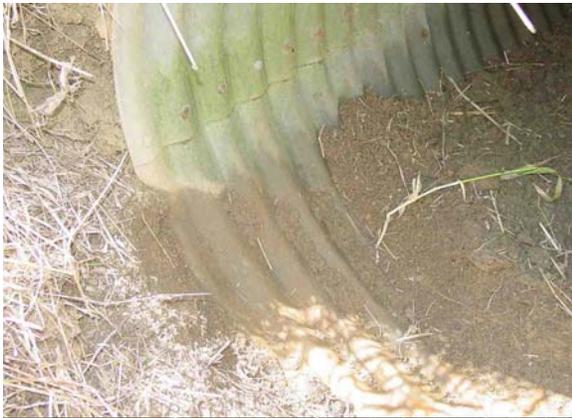
Observations: Good condition, no buckling, still round on both ends. ALT2 (outlet) in very good condition although it was beneath 12” of soil. Some free aluminum was still visible. Sampled at the 6’o’clock position. Galvanized end (high side) was beneath 6” of dirt. It was rusted and discolored with a heavy oxide layer @ 20” of pipe bottom, not perforated just heavily pitted. Surroundings are very densely vegetated with tall thick grasses covering the entire slope from the road to the crops, similar to all Marshall Co. Sites in Iowa.

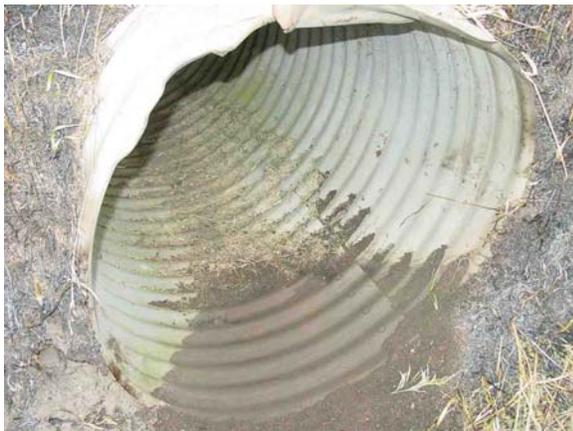
Observations: Good condition, no buckling, still round on both ends. ALT2 (outlet) in very good condition although it was beneath 2” of soil. Some free aluminum was still visible. Sampled at the 6’o’clock position. Galvanized end (inlet) was engulfed in heavy brush and undergrowth. It was rusty and discolored @ 12” of pipe bottom, not perforated, pretty good condition for galvanized. Surroundings on both ends were very densely vegetated with tall thick grasses covering the entire slope from the road to the crops, similar to all the Marshall Co. sites.

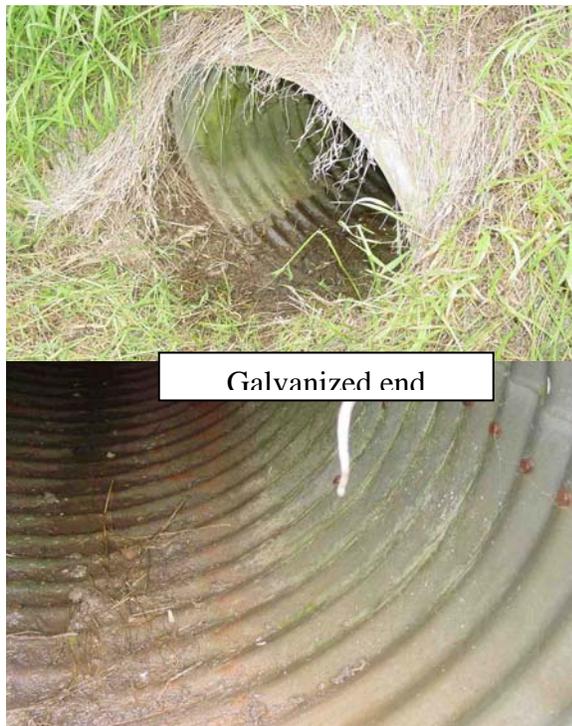
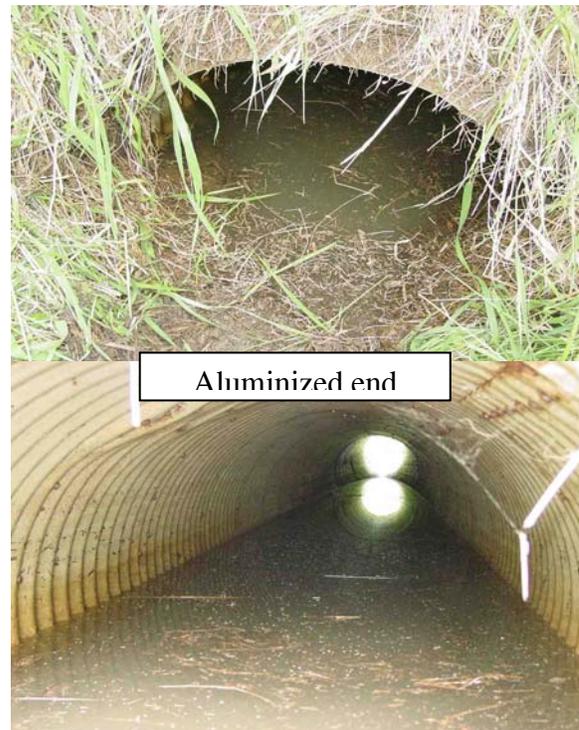
Images from Marshall County Site 6:

Aluminized end (outlet) is too deeply buried/submerged to trench and sample. Galvanized end (inlet) is rusted and pitted but not perforated, no apparent ovality or buckling.

Observations: Good condition, no buckling apparent. ALT2 (outlet) is mostly buried and submerged under mud and standing water, too much to drain and trench. Galvanized end (inlet) was rusty @ 14” of pipe bottom, not perforated, pretty good condition for galvanized.

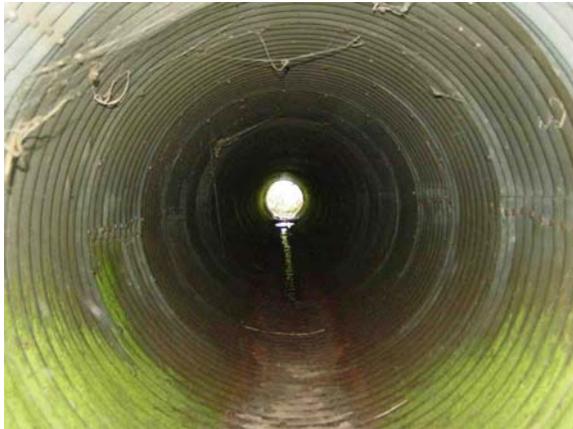
Galvanized end

Observations: Good condition, no buckling apparent.

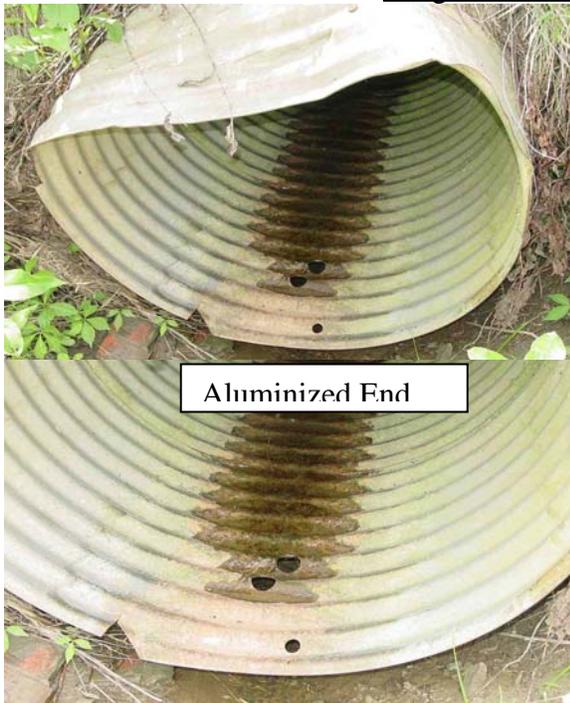
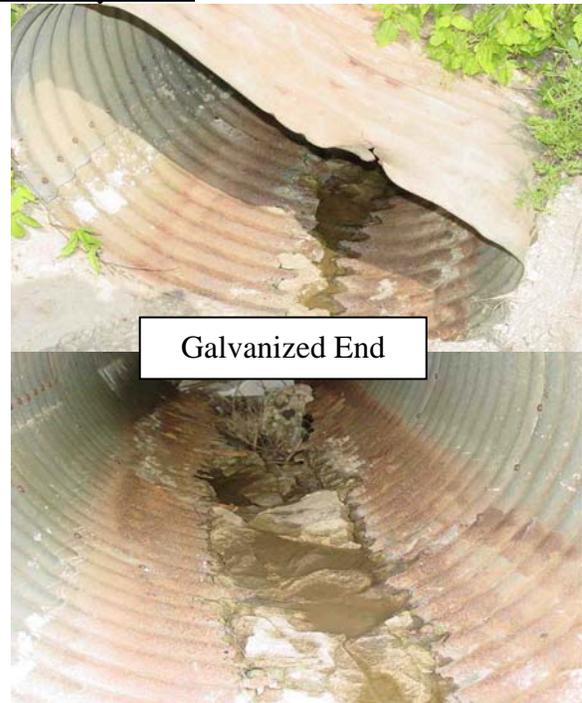
Images from Lafayette County Site 8:

Observations: ALT2 is in good condition, no buckling, still round. Previous hole saw cuts are intact with no appreciable ‘creep’. Narrow path between 5:30 and 6:30 position appears to be without coating. Alloy appears exposed from 4:30 to 7:30 position. Galvanized end is completely perforated from 5 to 7 o’clock position. Fairly rocky soil on both ends of the pipe.

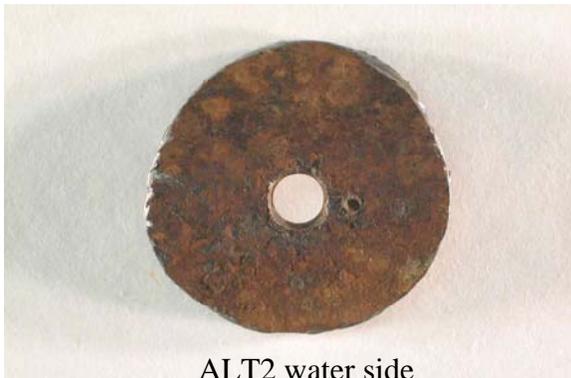
Site 8 ALT2 Trepan Evaluation: The top images are the coupon as removed after rinsing off loose dirt and debris. The coupon was then bead blasted to remove loose oxides and the lower images were recorded. Lite to moderate pitting is present on the top surface. Micrometer readings were taken after bead blasting using a ball micrometer (general thickness) and a point micrometer (deepest pit depth). Starting thickness: 0.107", Micrometer results: Ball: 0.099", 0.103", 0.101" Point: 0.090" (0.017" deep) Based on conservative pit penetration extrapolations, the service life of 16 gage T2 CSP would remain 75 years in this environment. The main detractor appears to be pitting due to abrasion.

Images of ALT2 trepan from Lafayette Co. Site 8: ALT2 soil side

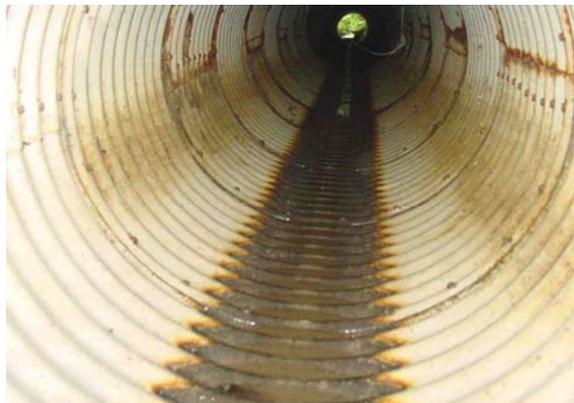
Aluminized end

Observations: Free aluminum coating is visible around most of circumference. ALT2 pipe was in good condition with some red rust at the 6 o'clock position approximately 9" wide at bottom. Previous saw cuts from the 30 year and the 42 year durability studies are intact with no creep evident. Galvanized end of pipe corroded completely through from 5 to 7 o'clock position exposing a washed out rocky surface beneath. No soil sample was procured.

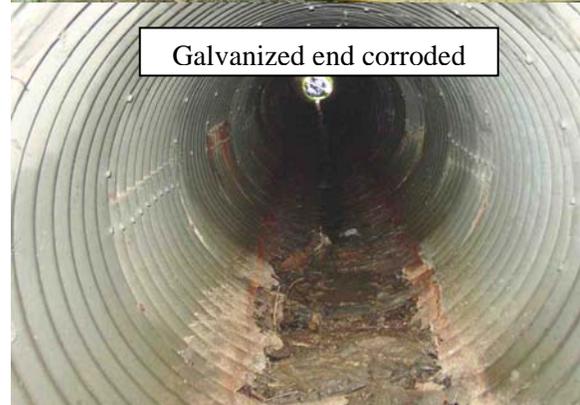
Galvanized end corroded

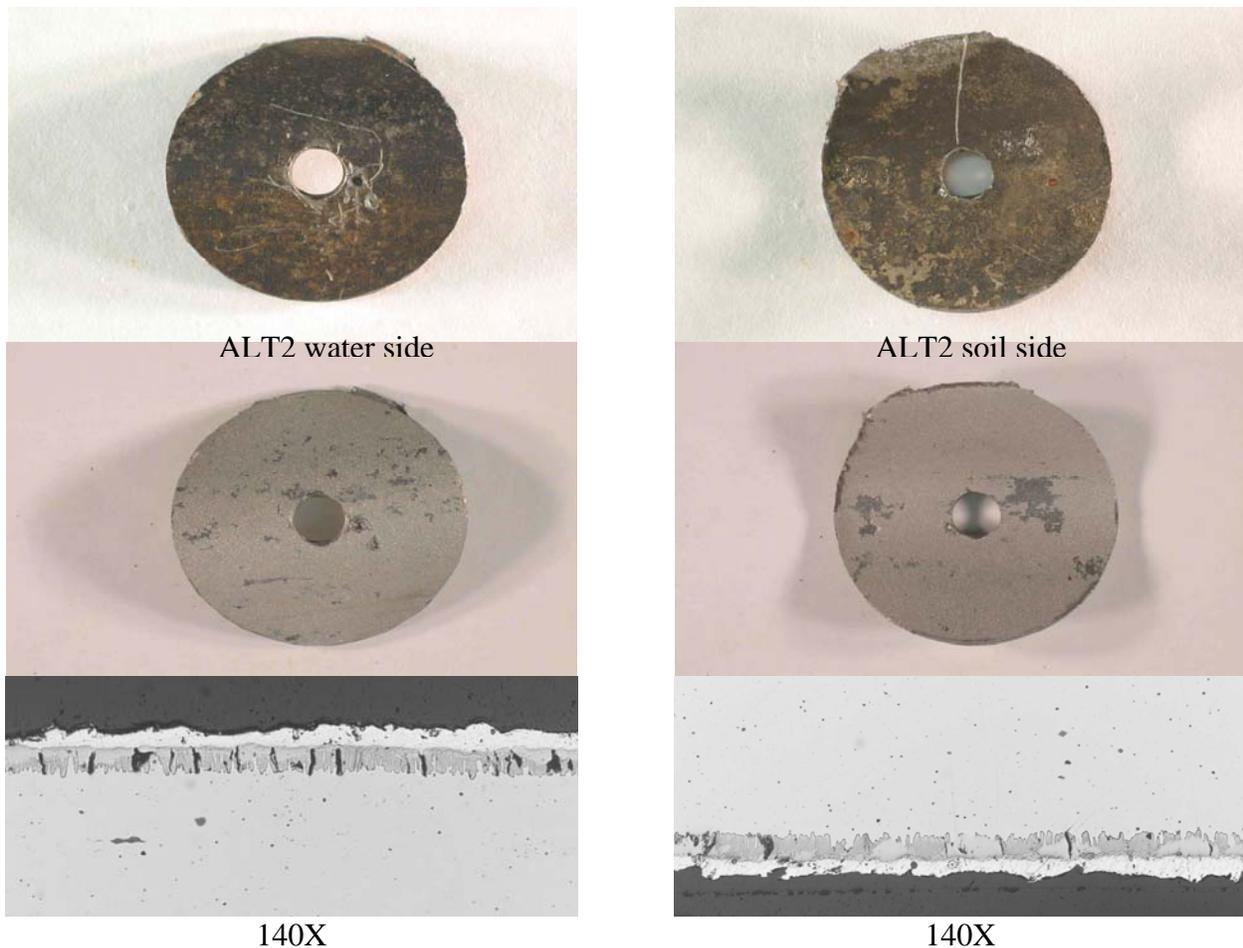
Images of ALT2 trepan from Lafayette Co. Site 9:

Site 9 ALT2 Trepan Evaluation: The top images are of the coupon removed from the lowest point on the pipe after rinsing off loose dirt and debris. The coupon was then bead blasted to remove loose oxides and the lower images were recorded. Almost no pitting is present on the top or bottom surfaces. Removal of the red rust revealed that Type 2 coating was still intact and the red rust appears to be ‘leached on’ from the remnants of the rusty upstream galvanized pipe. Micrometer readings were taken after bead blasting using a ball micrometer (general thickness) and a point micrometer (deepest pit depth). Starting thickness: 0.083”.

Based on conservative pit penetration extrapolations, the service life of 16 gage ALT2 material would be in excess of 100 years.

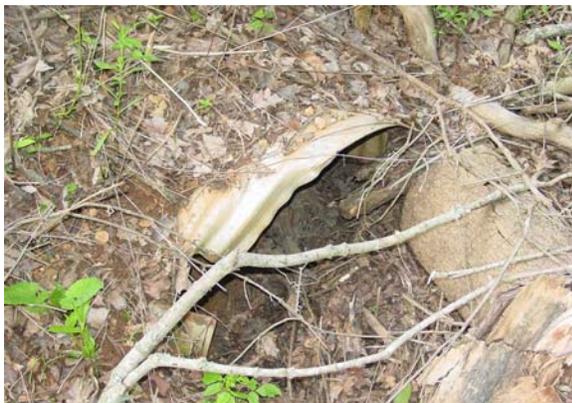
Aluminized end

Observations: Qualitatively, the aluminized end showed slightly less evidence of red rust. Upon looking into the half filled culvert (lower left image) the visible upper arch on the aluminized end was intact with some red rust at the joints. This culvert is overdue for maintenance, it was not possible to determine the pipe condition below grade on either end.

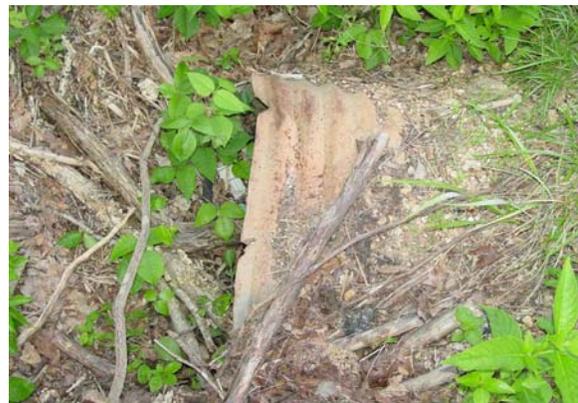
Galvanized end

The galvanized end was closer to the shoulder of the road which would explain the higher chloride levels likely from road salt. Water sample: none, site dry

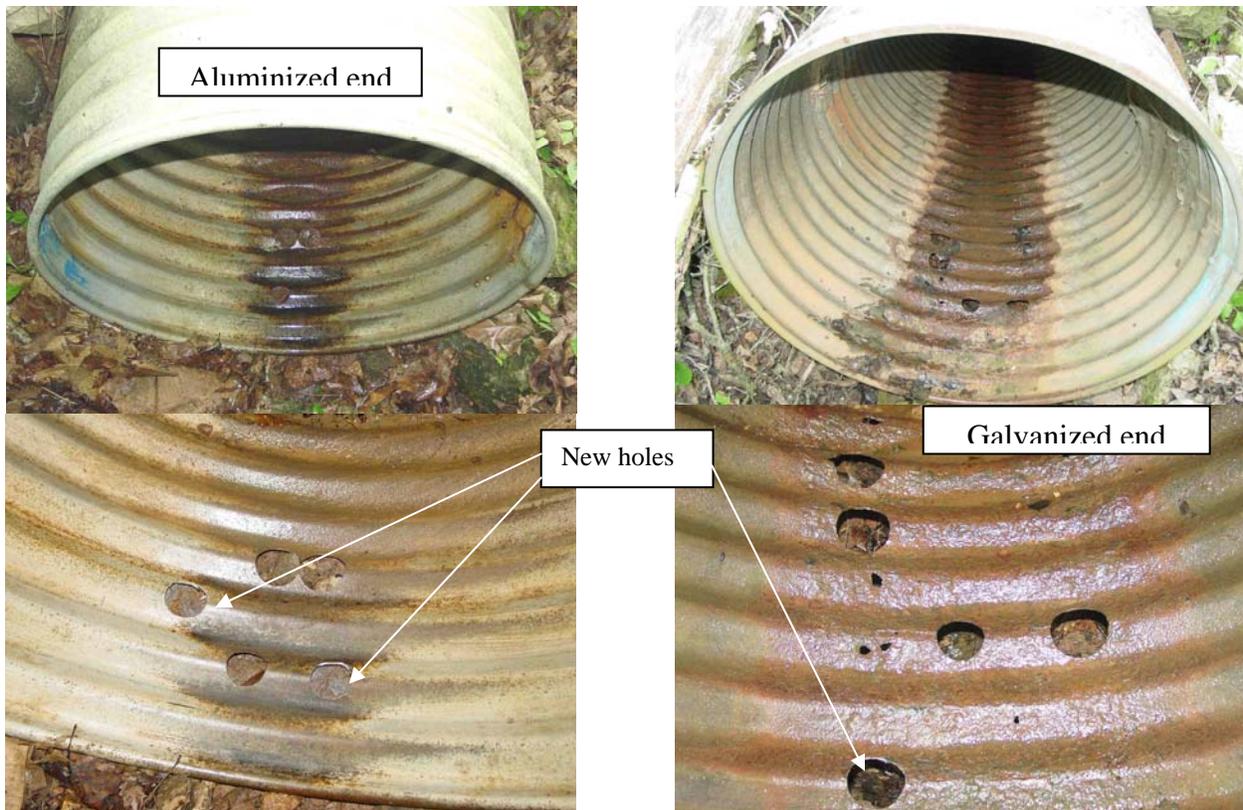
Images from Carter County Site 11:

Observations: Free aluminum coating is visible around most of circumference. ALT2 pipe was in good condition with some red rust at the 6 o’clock position approximately 6” wide at bottom. Previous saw cuts from the 30 year and the 42 year durability studies are intact with no creep evident on both ends. Galvanized end of pipe has some scattered perforations and red rust at the 6 o’clock position approximately 14” wide. Fairly dense vegetation and leafy ground cover was evident around both ends of the pipe, especially the upstream end, likely reducing abrasion.

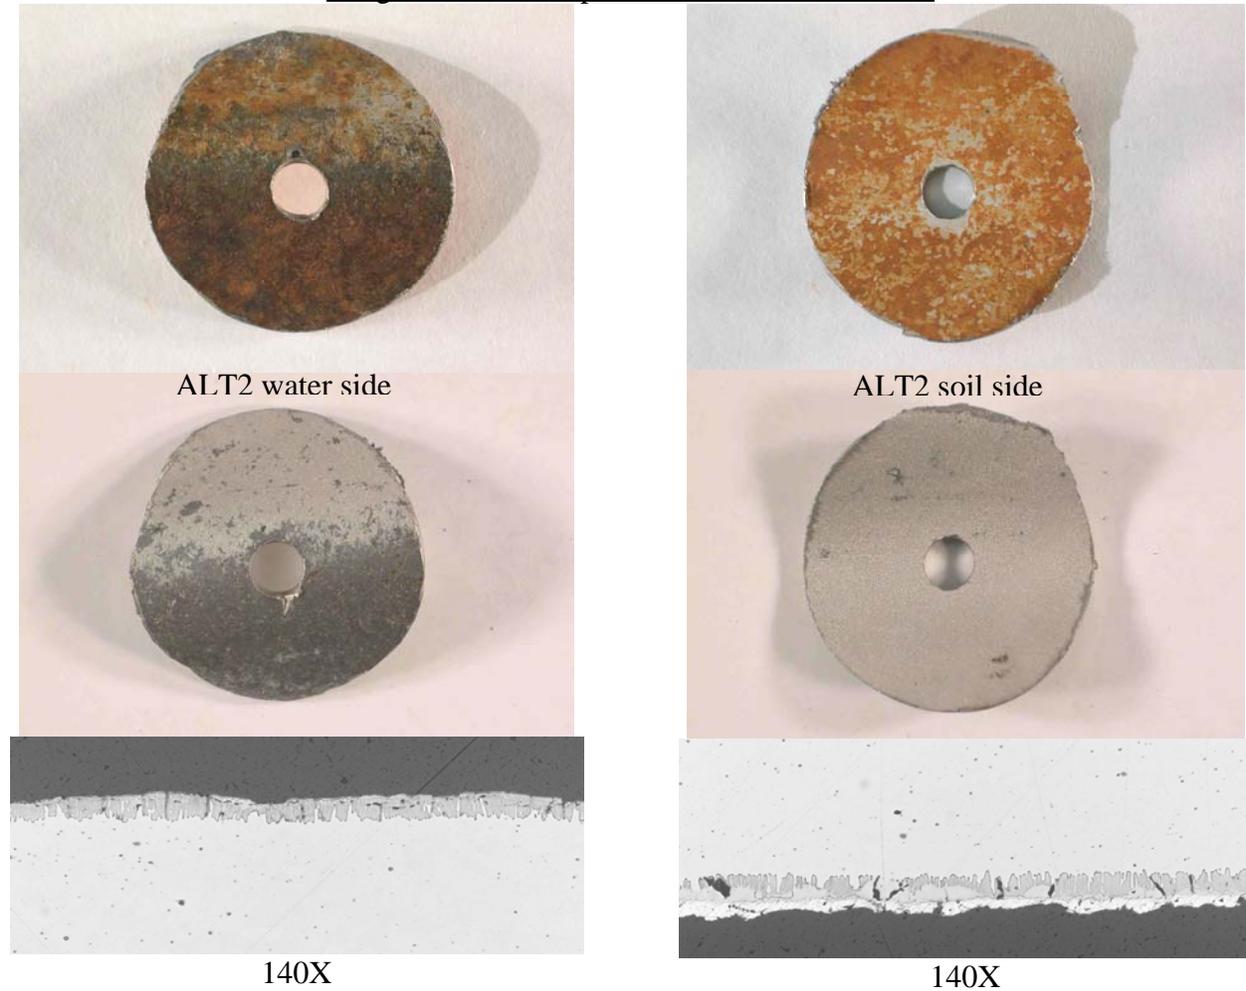
Images of ALT2 trepan from Carter Co. Site 11

Site 11 ALT2 Trepan Evaluation: The top images are of the coupon removed from the lowest point on the pipe after rinsing off loose dirt and debris. The coupon was then bead blasted to remove loose oxides and the lower images were recorded. Almost no pitting is present on the top or bottom surfaces. Removal of the red rust revealed that Type 2 coating was still intact on the downstream side of the corrugation's water side and completely intact on the soil side. Micrometer readings were taken after bead blasting using a ball micrometer (general thickness) and a point micrometer (deepest pit depth). Starting thickness: 0.083"

Based on conservative pit penetration extrapolations, the service life of 16 gage ALT2 material would be in excess of 100 years.

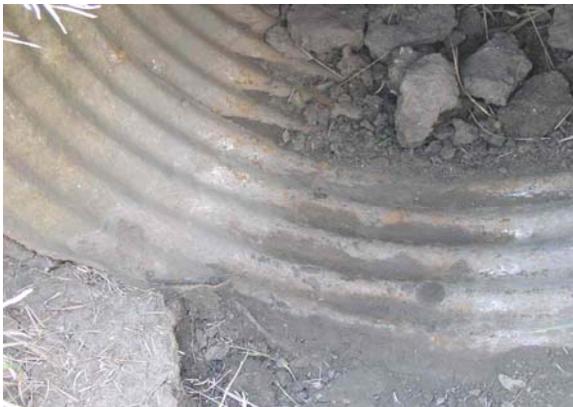
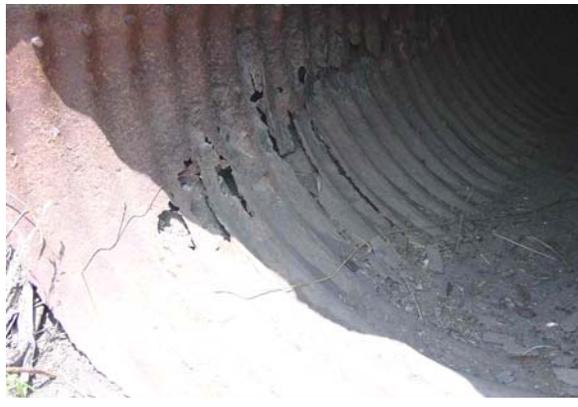
Observations: ALT2 is in good condition, no buckling, still round, some scaling on the bottom where pipe was beneath the soil. The only red rust is where pipe was damaged by DOT mowers. Galvanized end is completely rusted from 8 o'clock to 4 o'clock position and perforated.

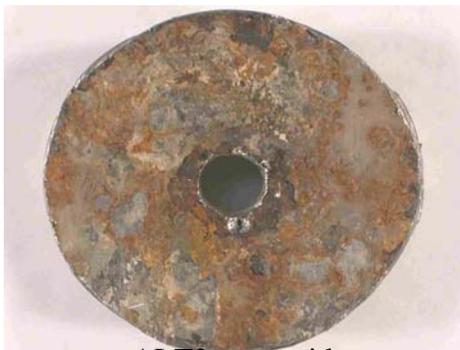
Site 12 ALT2 Trepan Evaluation: The top images are the coupon as removed after rinsing off loose dirt and debris. The coupon was then bead blasted to remove loose oxides and the lower images were recorded. Lite to moderate pitting is present on the top surface near the peak. Micrometer readings were taken after bead blasting using a ball micrometer (general thickness) and a point micrometer (deepest pit depth). Starting thickness: 0.112". Micrometer results: Ball: 0.111", 0.093", 0.098"; Point: 0.088" (0.024" deep) Based on conservative pit penetration extrapolations, the service life of 16 gage T2 CSP will exceed 100 years.

ALT2 water side

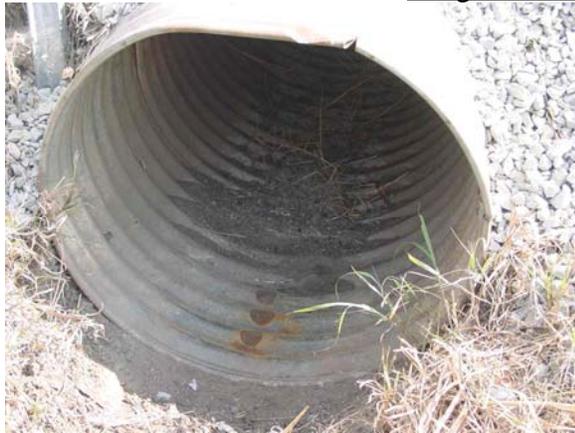
Aluminized end

Observations: Both ends looked good. Previous trepan holes not corroded further on either end. Sample taken at 6:30 position. Galvanized end has some red rust from the 5 to 7 o'clock position.

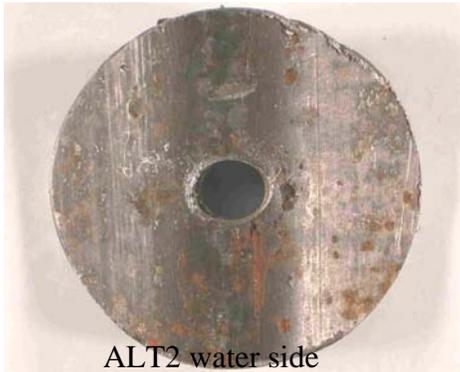
Site 13 ALT2 Trepan Evaluation: The top images are the coupon as removed after rinsing off loose dirt and debris. The coupon was then bead blasted to remove loose oxides and the lower images were recorded. Lite to moderate pitting is present on the top surface near the peak. Micrometer readings were taken after bead blasting using a ball micrometer (general thickness) and a point micrometer (deepest pit depth). Starting thickness: 0.082”
Results Ball: 0.081”, 0.081”, 0.082” Point: 0.066” (0.016”deep)
Based on conservative pit penetration extrapolations, the service life of 16 gage T2 CSP will exceed 100 years.

ALT2 water side

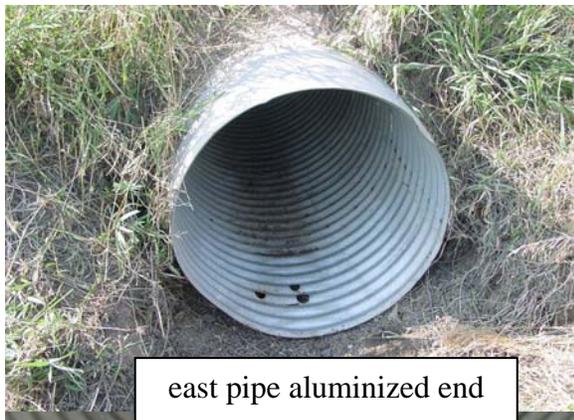
east pipe aluminized end

Observations: Both ends looked pretty good. Aluminized end still has good free aluminum coating intact. Previous trepan holes had not corroded further on either end. Samples were taken at 6:00 position. Galvanized end has red rust from the 4 to 8 o'clock position. Not perforated.

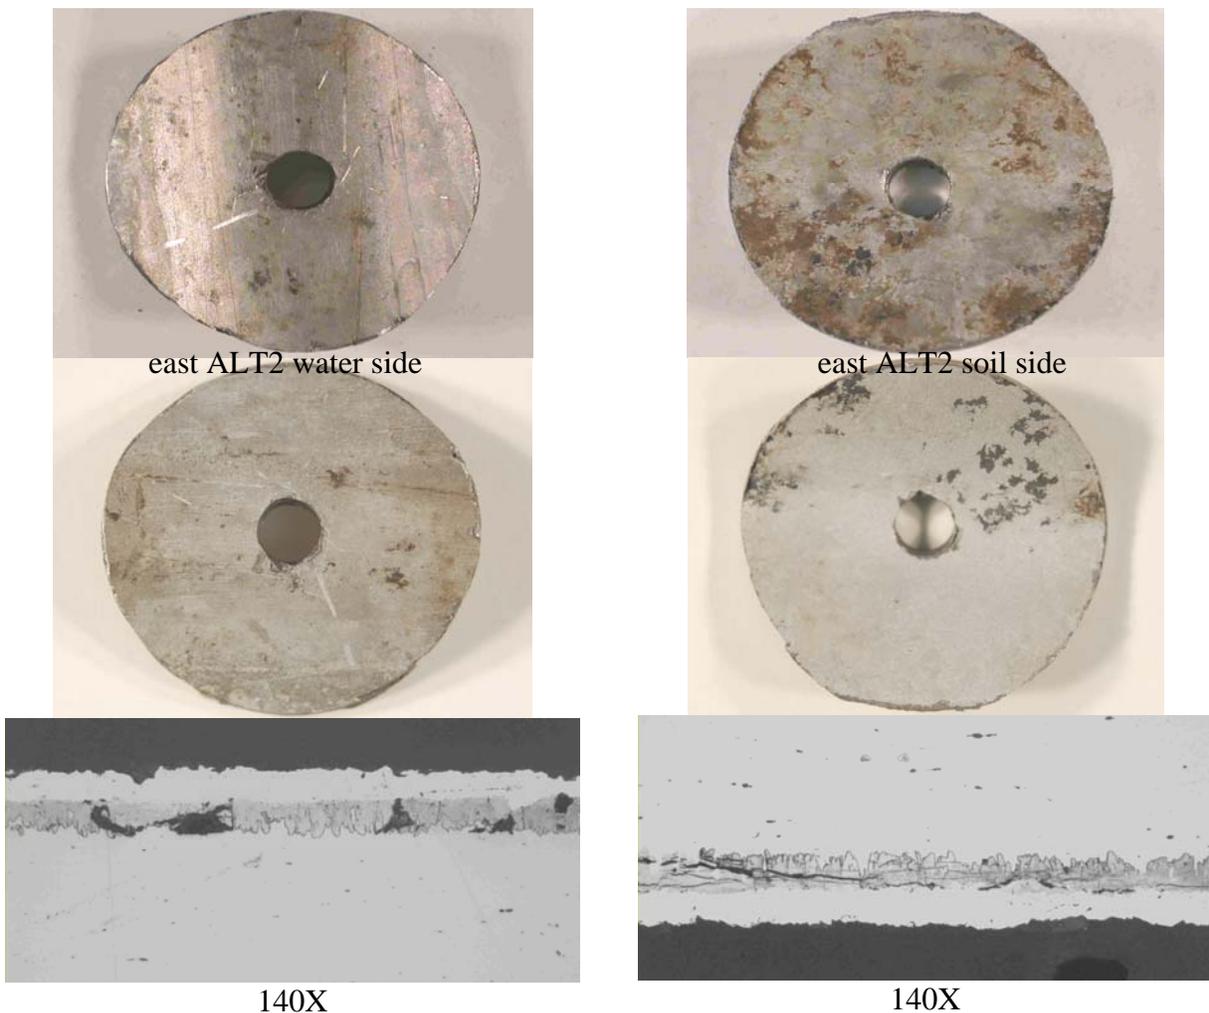
Images of East ALT2 trepan from Decatur Co. Site 14:

Site 14 East ALT2 Trepan Evaluation: The top images are the coupon as removed after rinsing off loose dirt and debris. The coupon was then bead blasted to remove loose oxides and the lower images were recorded. Lite pitting is present on the bottom surface and on the top very near the peak.

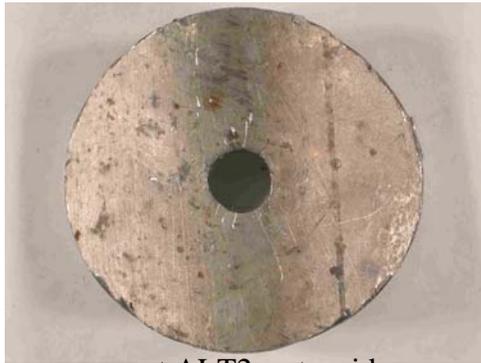
Site 14 West ALT2 Trepan Evaluation: The top images are the coupon as removed after rinsing off loose dirt and debris. The coupon was then bead blasted to remove loose oxides and the lower images were recorded. Lite pitting is present scattered on the top and bottom surfaces. Micrometer readings were taken after bead blasting using a ball micrometer (general thickness) and a point micrometer (deepest pit depth). Starting thickness: 0.110".
Micrometer results: Ball: 0.107", 0.108", 0.108", 0.109" Point: 0.105" (0.005")
Based on conservative pit penetration extrapolations, the service life of 16 gage T2 CSP will exceed 100 years.

west ALT2 water side

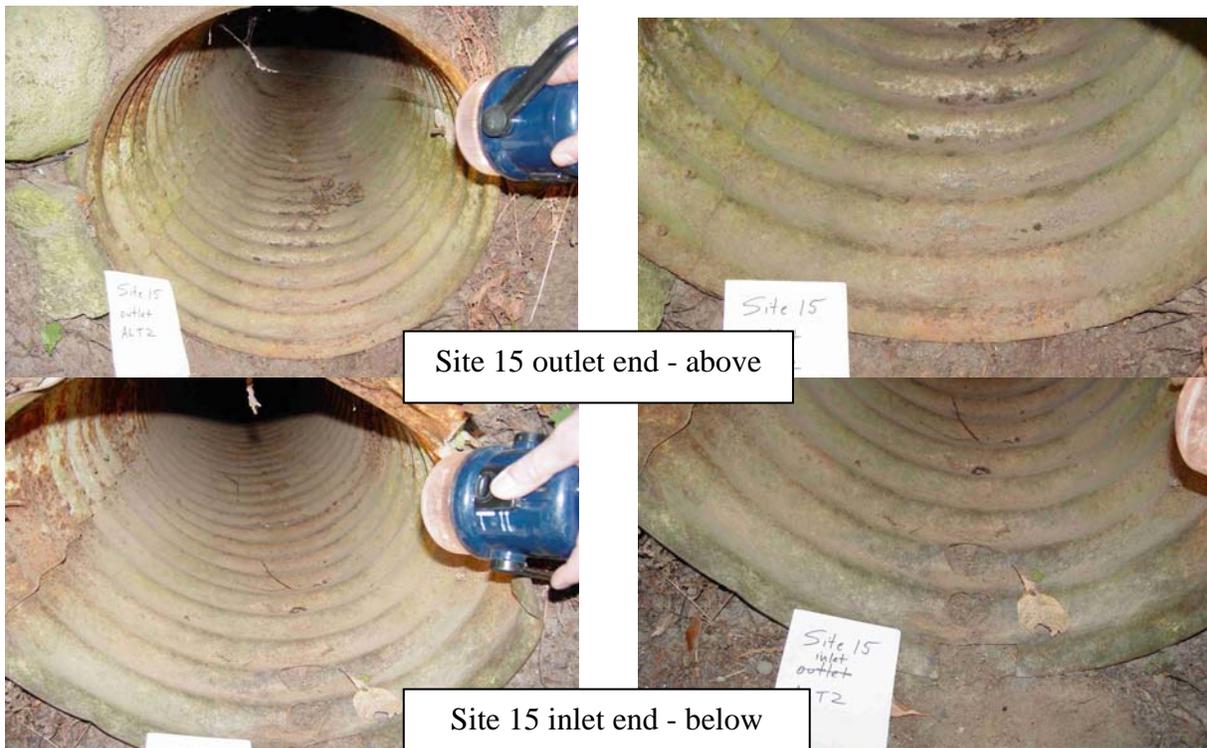
Images from San Juan County Site 15:

Description: 18” dia. ALT2. Currently dry, remains dry most of the summer months. Has water continuously from November to March. Loamy soil with thick vegetation all around. Overall good condition. Rust was visible on upper corrugations inside the pipe, but no appearance of ovality.

Observations: ALT2 is in good condition. Previous hole saw cuts are intact with no appreciable ‘creep’. Portions of a narrow path between 5:30 and 6:30 position appear to be without coating. Moss appears to be growing over the oxide on the lower half of the pipe.

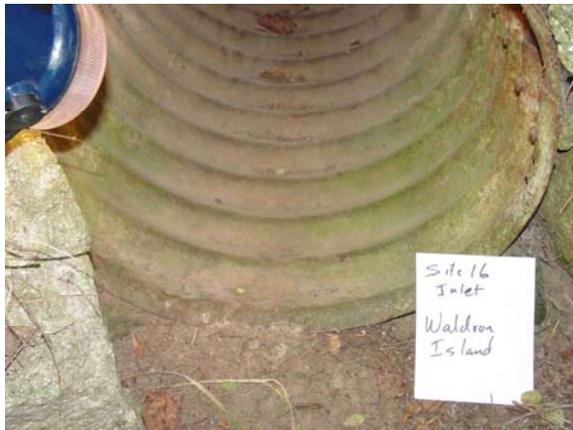
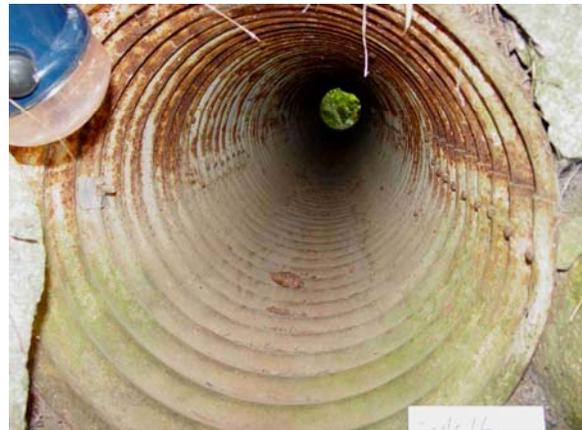
Image from San Juan County Site 16:

Description: 18” dia. 16 gage ALT2. Currently dry, remains dry most of the summer months. Has water continuously from November to April per county observers. Loamy soil with thick vegetation all around. Overall good condition.

Observations: The remnant of aluminized coating was obscured by moss and oxide similar to other Waldron Island sites. No ovality was noted.
