National
Corrugated Steel Pipe
Association

Condition Survey of Corrugated Steel Pipe Detention Systems

An Interim Report
March, 1999

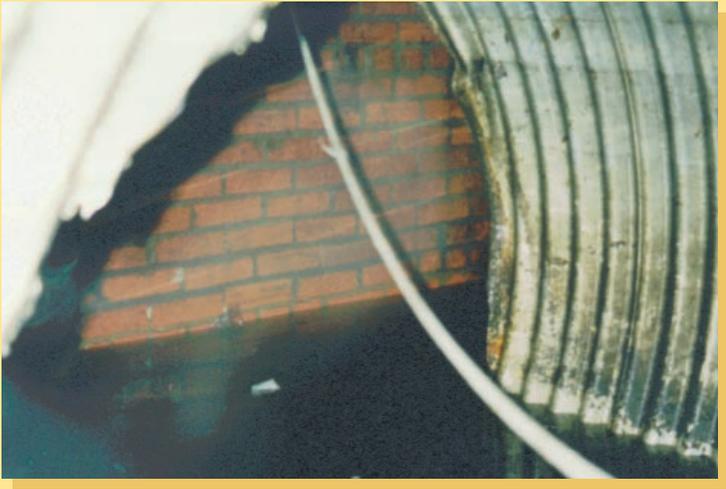
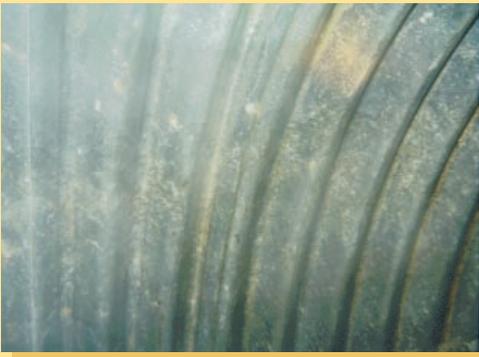
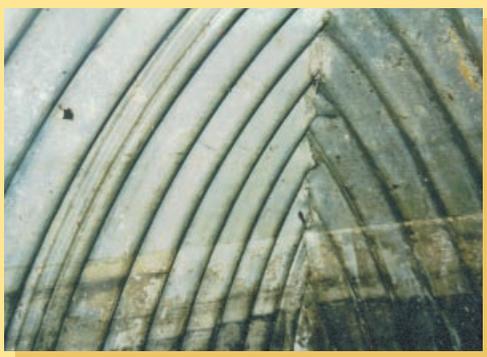
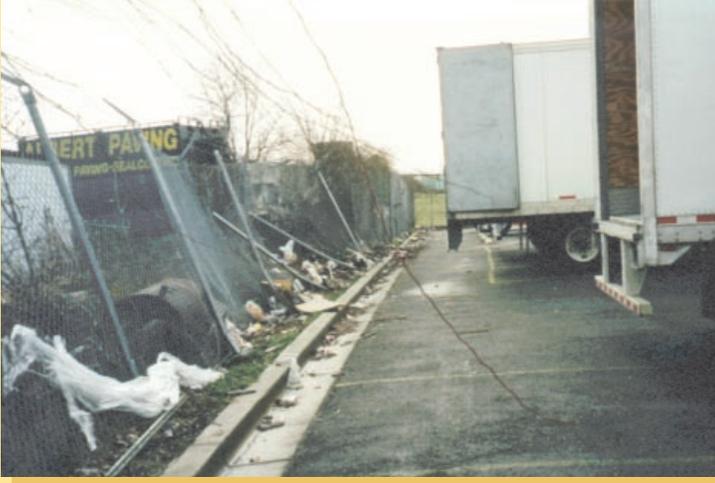
<p>Condition Rating</p> <p>Top95/100</p> <p>Sides95/100</p> <p>Invert.....75/90*</p> <p>Avg. Rating.....92.5</p>	<p>Age: 25 years</p> <p>Coating Type: Galvanized</p> <p>Diameter: 60"</p> <p>Corrugation: 1x3" Helical</p> <p>Land Use: Industrial</p> <p>Location: Montgomery County, Maryland</p>	<p>Comments:</p> <p>*18" standing water;</p> <p>could not see invert;</p> <p>rating based on probing.</p> <hr/> <hr/> <hr/>
--	---	--

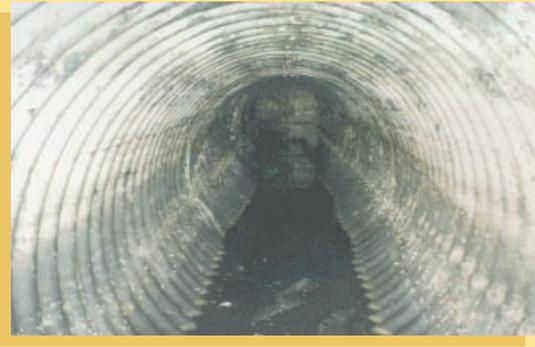
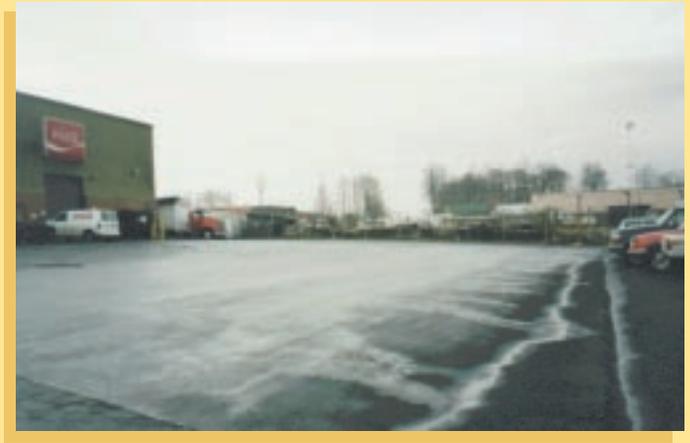
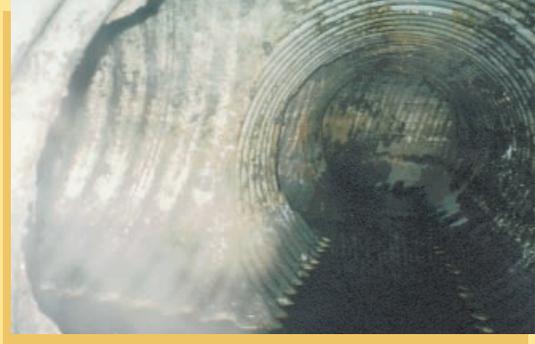
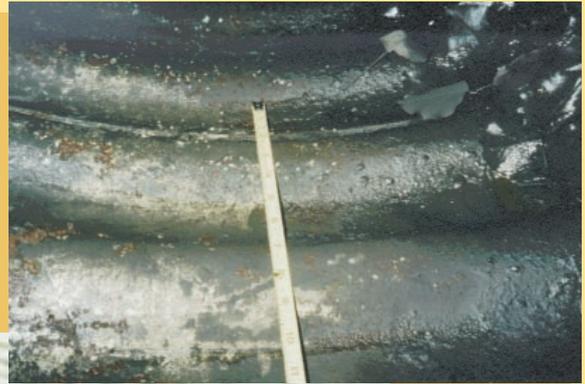
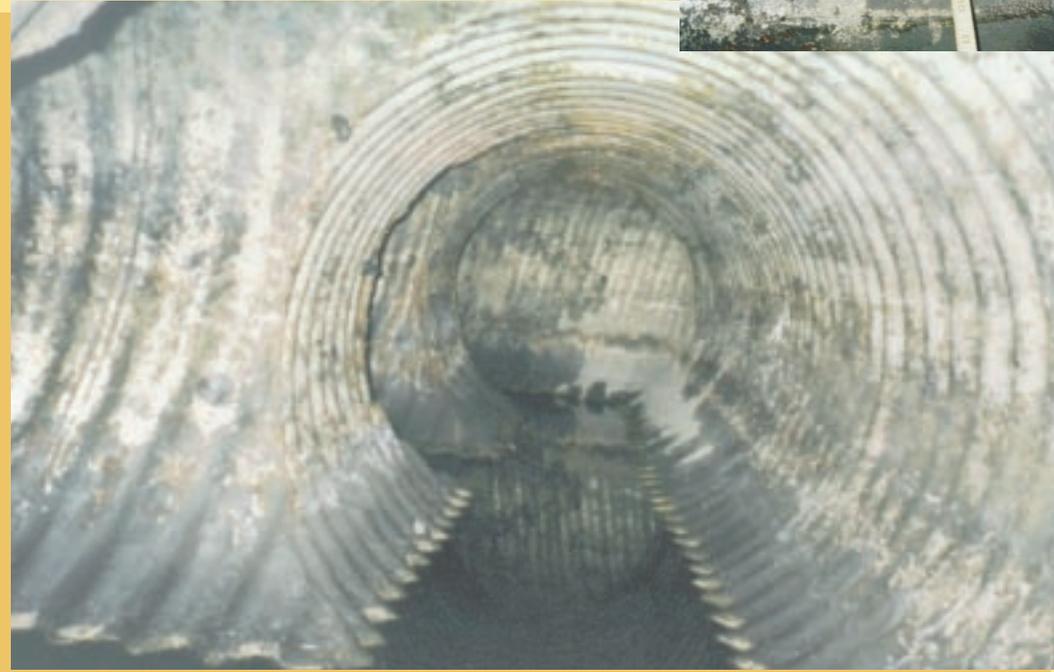
. SITE . 2 .

Top90/95
 Sides90/95
 Invert.....70*
Avg. Rating85

*Isolated pitting invert.

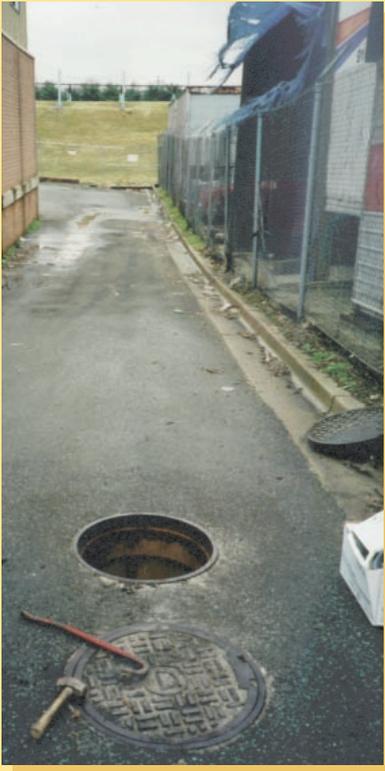
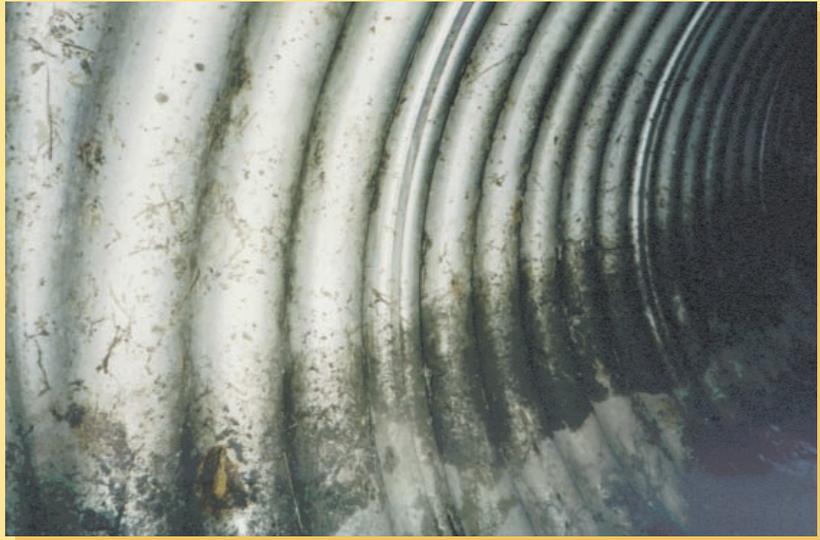
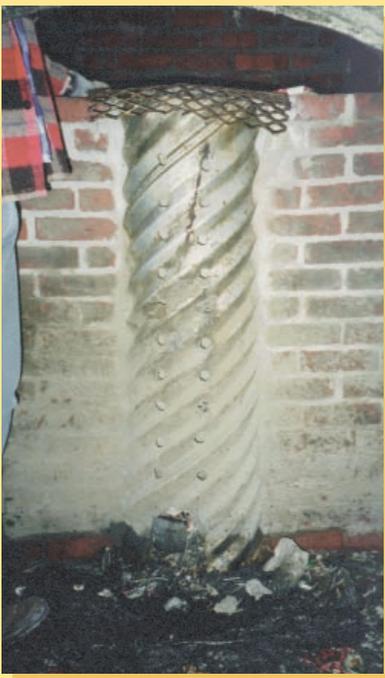
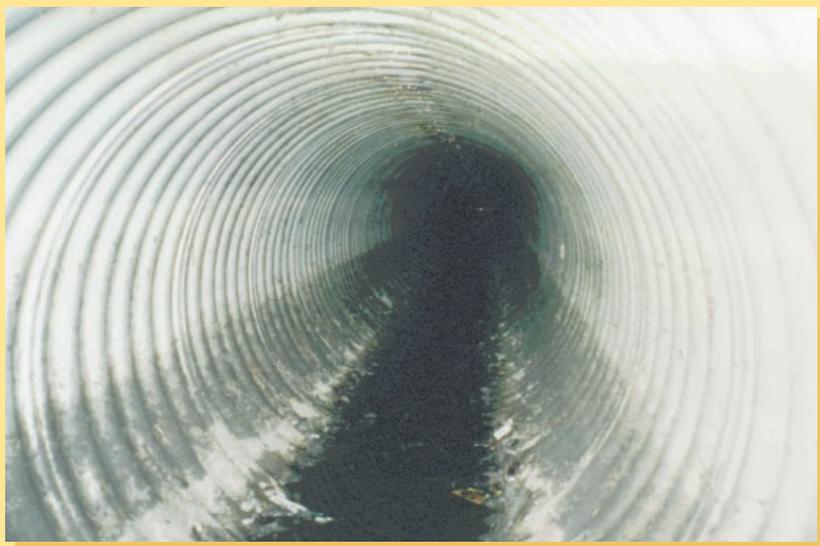
Top90/95
 Sides90/95
 Invert75
Avg. Rating.....86.7

Comments:
 36" saw-cuts in every
 corrugation to promote
 infiltration;
 stone backfill.

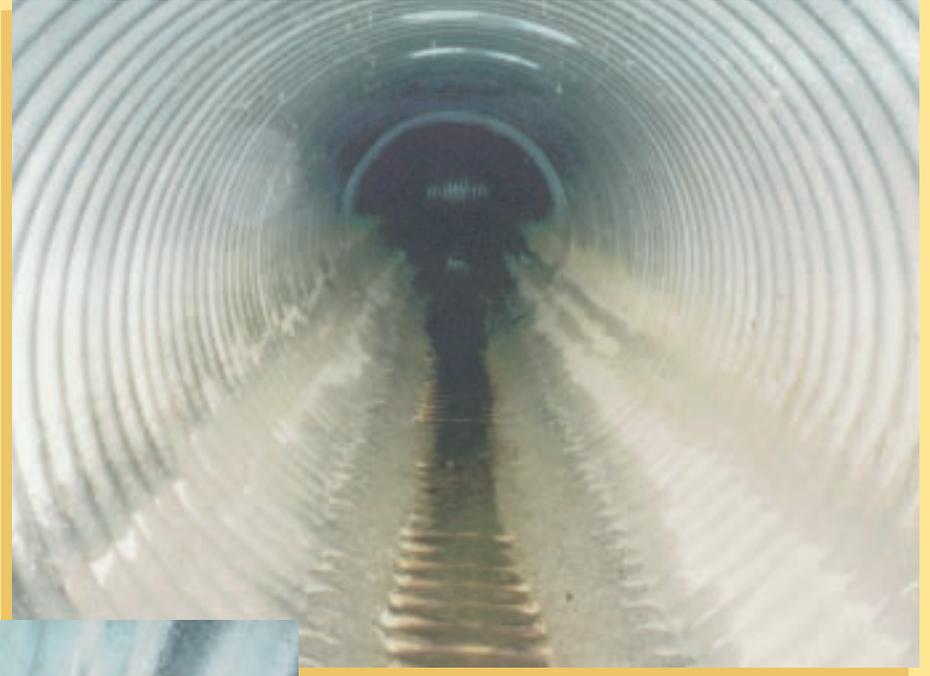
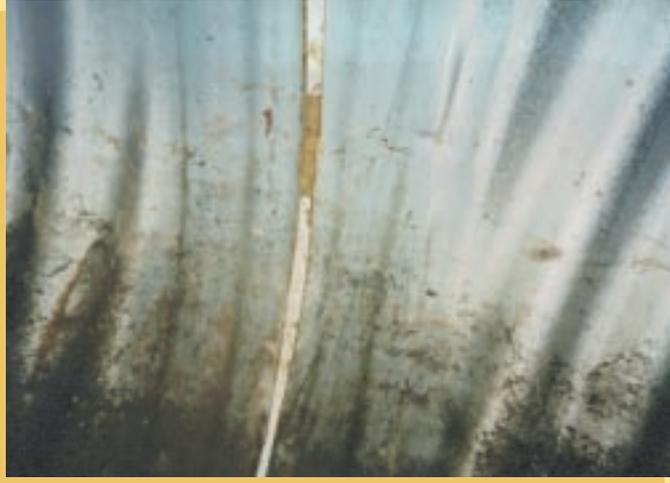
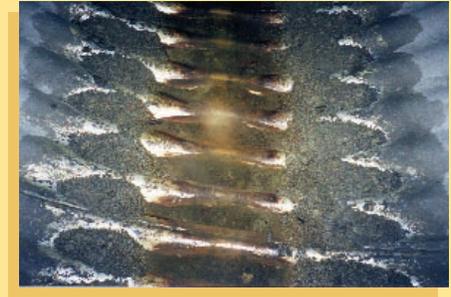
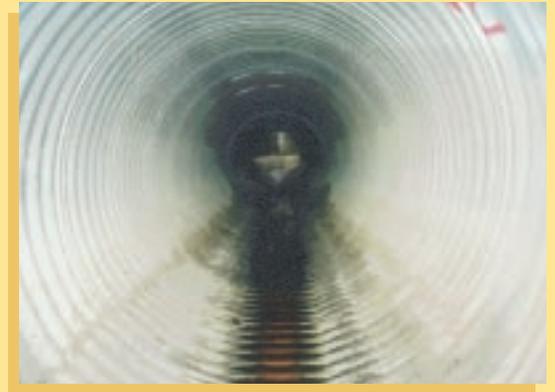
Top100
 Sides100
 Invert90
Avg. Rating.....96.7

Oil grit separator at entrance.

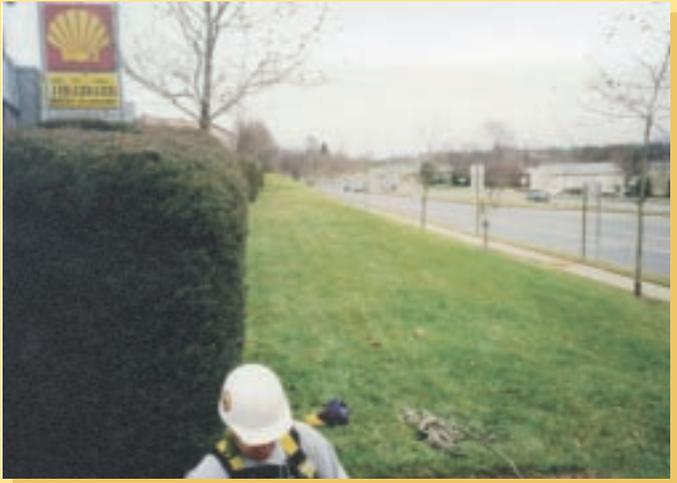
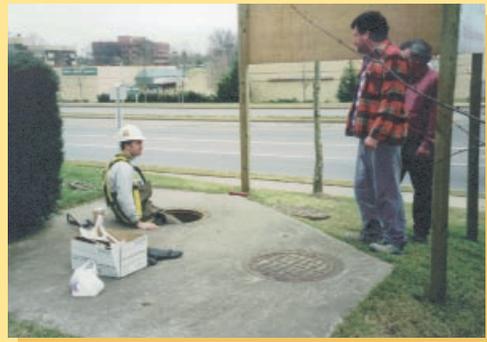
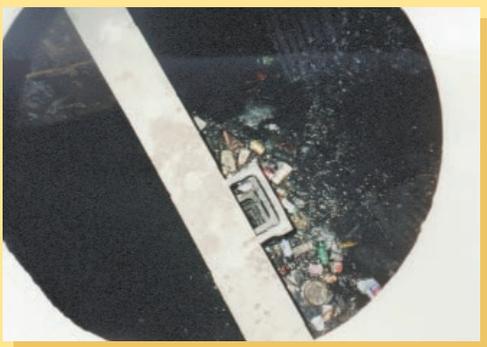
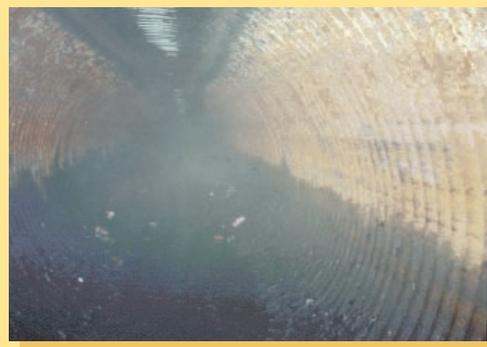
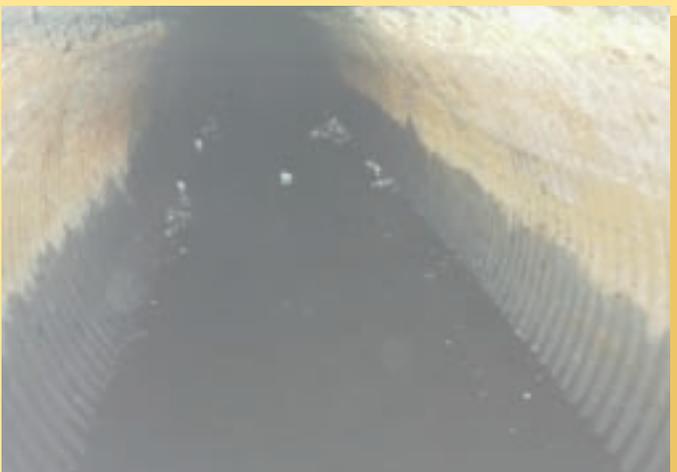
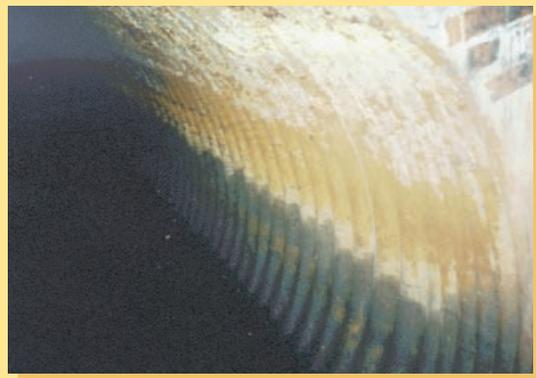
Top	90
Sides	70
Invert	60
Avg. Rating.....	73.3

Comments:
 6" low orifice clogged;
 24" standing water.
 Red rust on sides with
 coating loss.

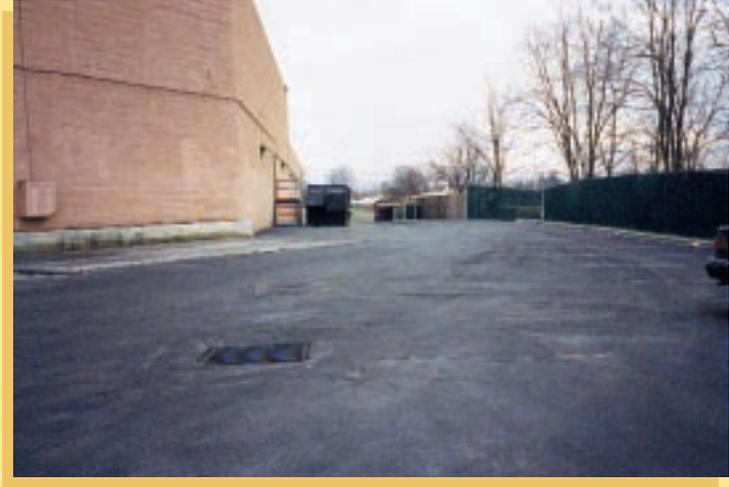
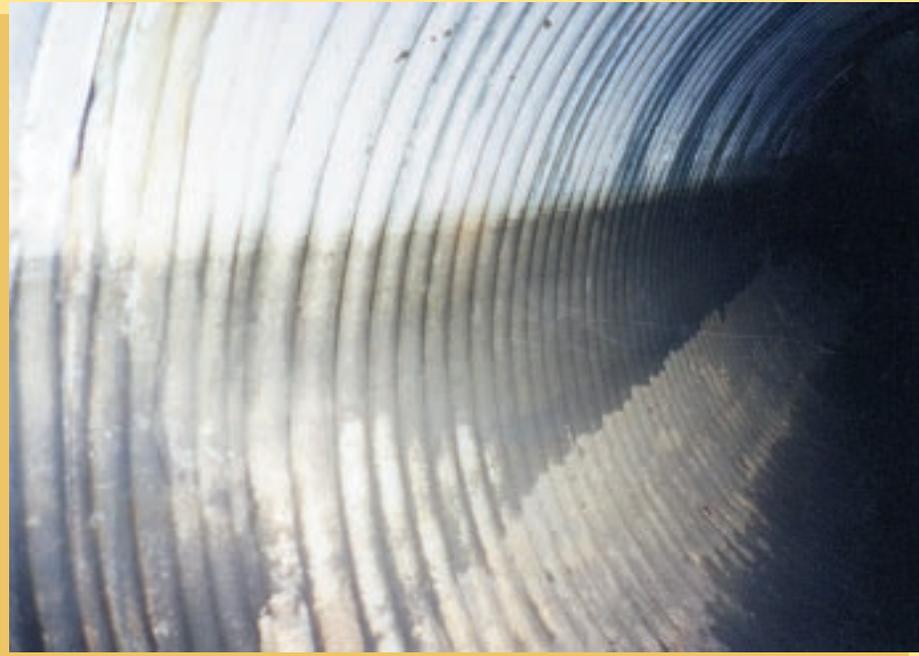
<p>Condition Rating</p> <p>Top100</p> <p>Sides90/95</p> <p>Invert80/85</p> <p>Avg. Rating.....91.7</p>	<p>Age: 20 years</p> <p>Coating Type: Galvanized</p> <p>Diameter: 96"</p> <p>Corrugation: 1x5" Helical</p> <p>Land Use: Commercial</p> <p>Location: Montgomery County, Maryland</p>	<p>Comments:</p> <p><u>Limited staining in</u></p> <p><u>invert.</u></p> <p>_____</p> <p>_____</p> <p>_____</p>
--	---	--

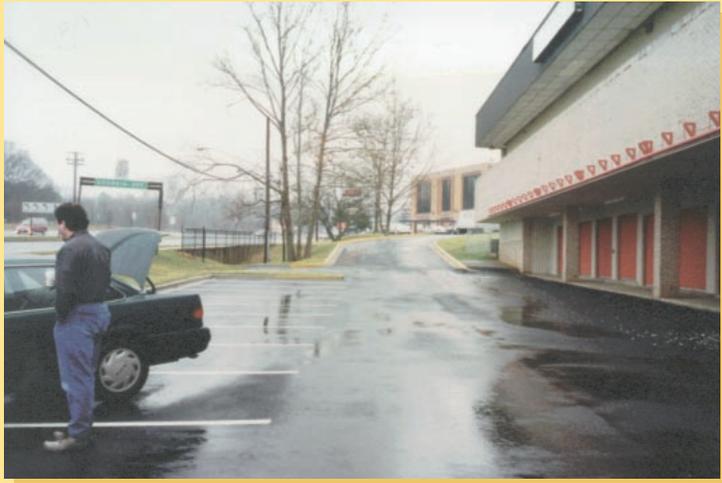
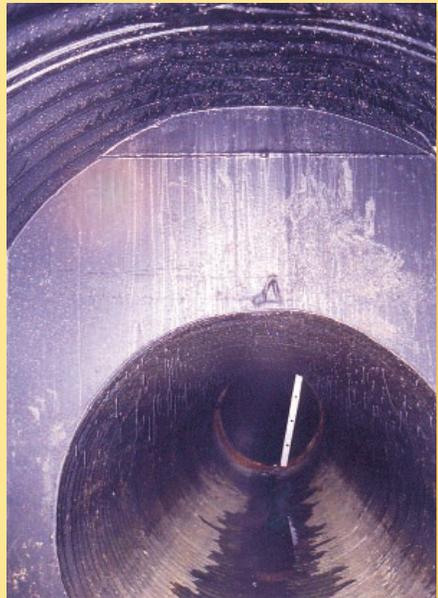
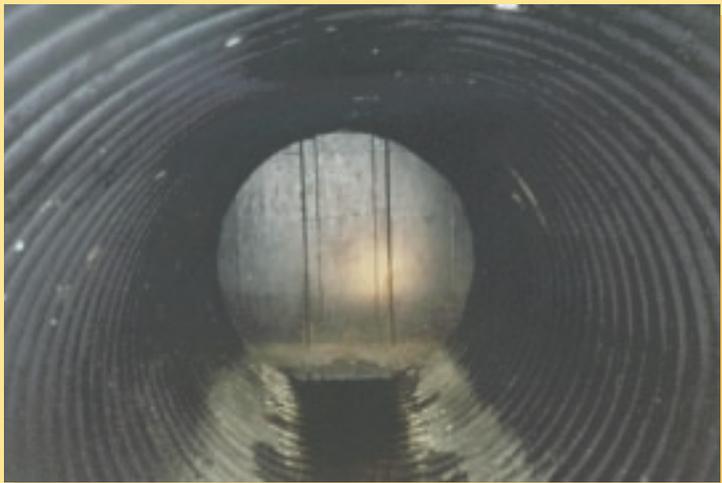
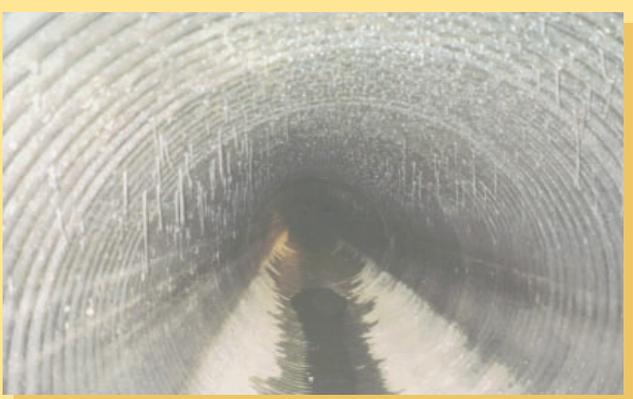
<p>Condition Rating</p> <p>Top100</p> <p>Sides100</p> <p>Invert100</p> <p>Avg. Rating.....100</p>	<p>Age: 20 years</p> <p>Coating Type: Fully Bituminous Coated</p> <p>Diameter: 72"</p> <p>Corrugation: 1x5" Helical</p> <p>Land Use: Commercial</p> <p>Location: Montgomery County, Maryland</p>	<p>Comments:</p> <p><u>Bituminous coating</u></p> <p><u>intact; no rust on exposed</u></p> <p><u>galvanized surface.</u></p> <p>_____</p> <p>_____</p>
---	--	---

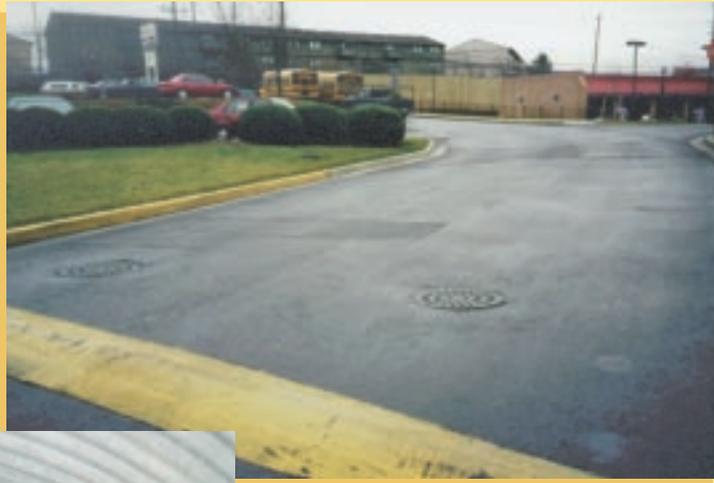
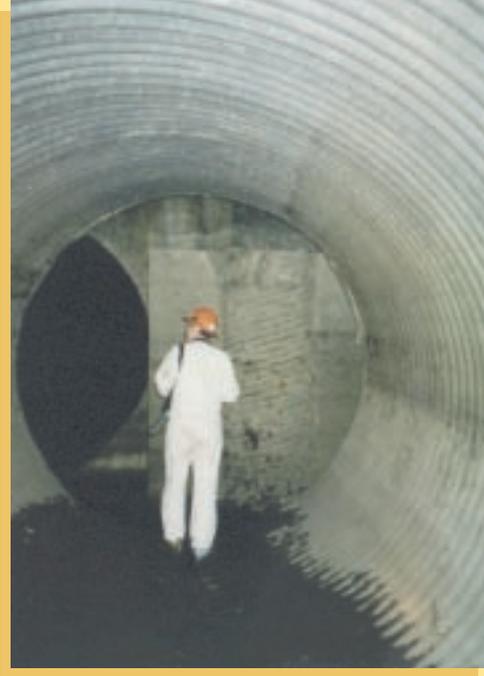
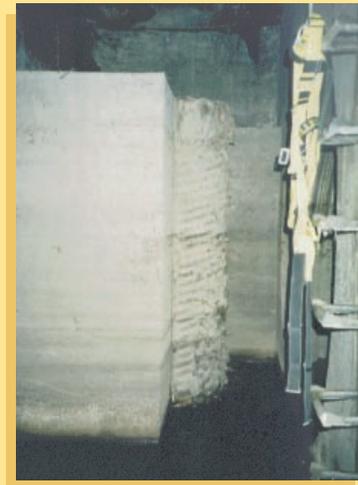
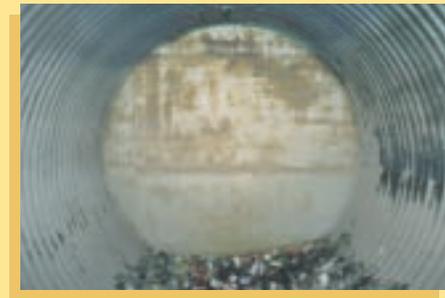
Top	95
Sides	95
Invert	85
Avg. Rating.....	91.2

Oil grit separator at
entrance;
minor soil trough joints;
no sign of gaskets with
joints.

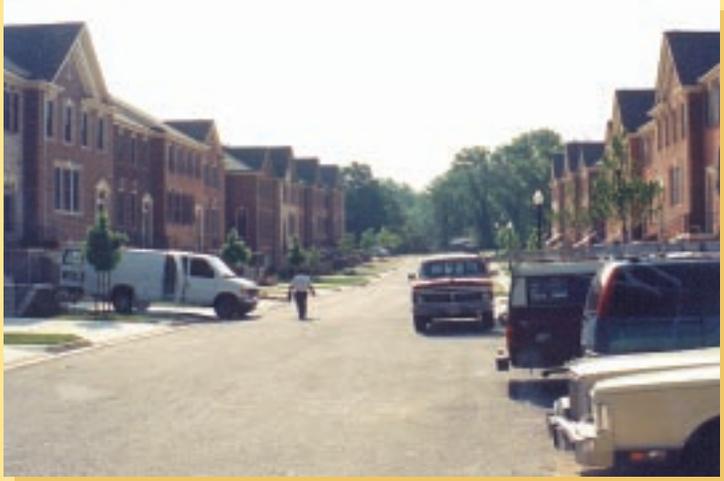
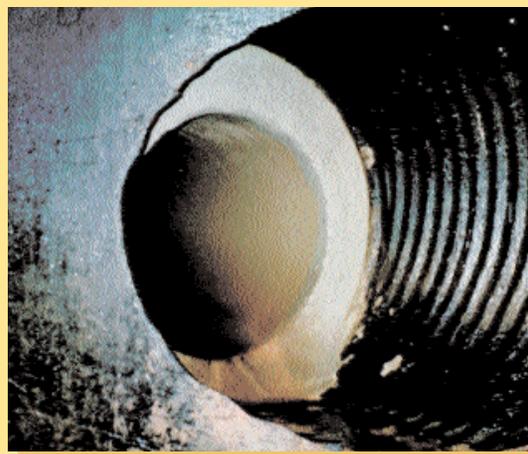
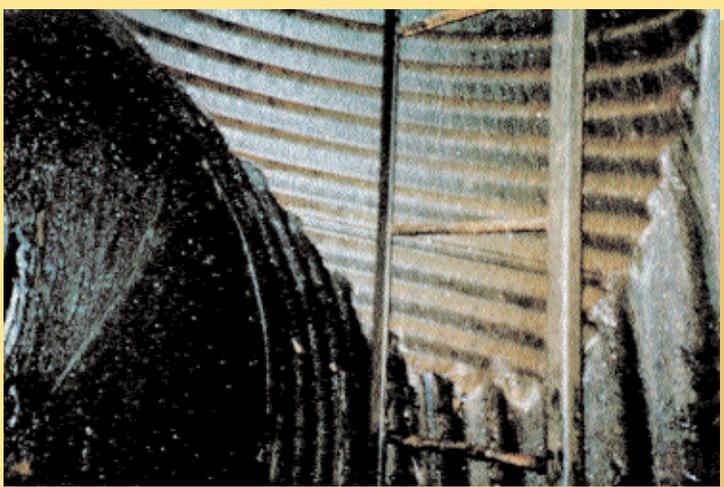
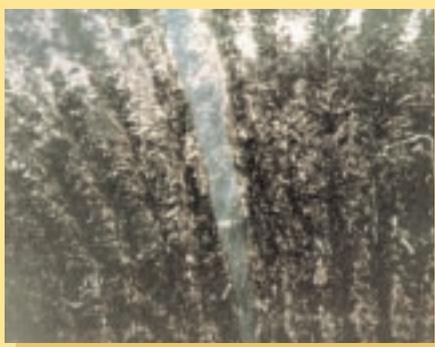
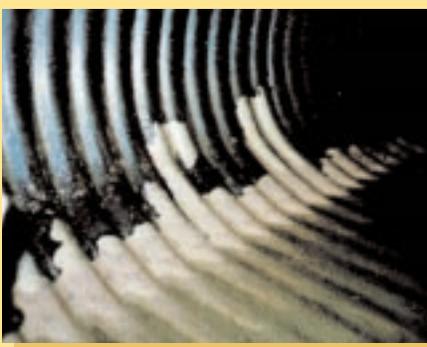
Top100
 Sides100
 Invert95/100
Avg. Rating.....99.2

Comments:
Asphalt coating removed
in sections of invert.
No signs of rust on
exposed galvanizing.

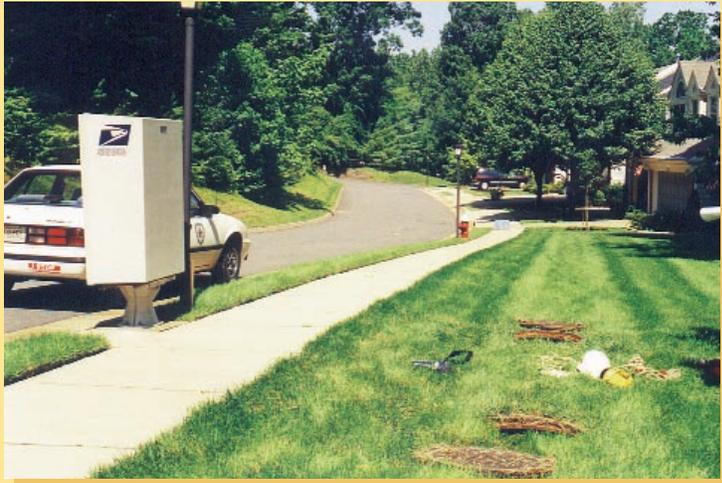
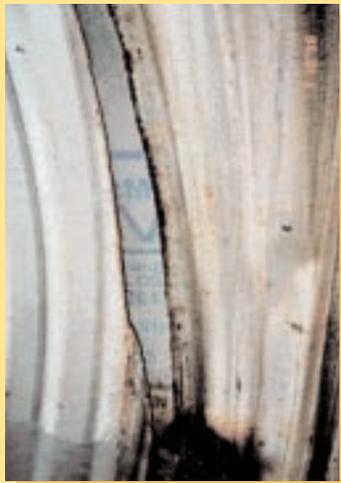
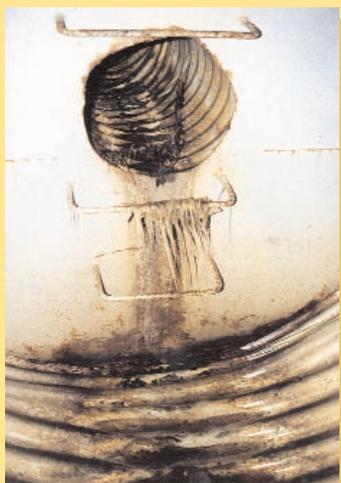
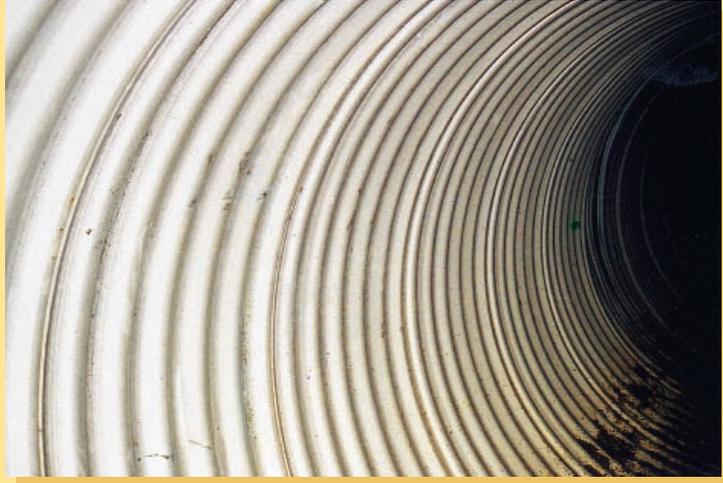
Top	100
Sides	100
Invert	95/100
Avg. Rating.....	99.2

Comments:
Light staining in invert.

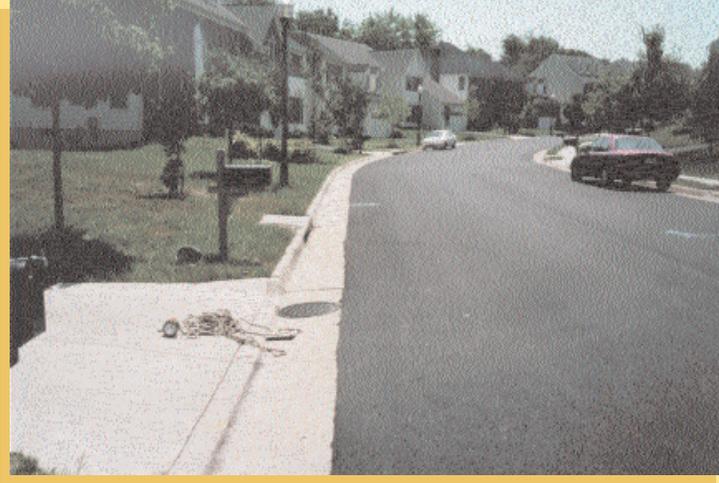
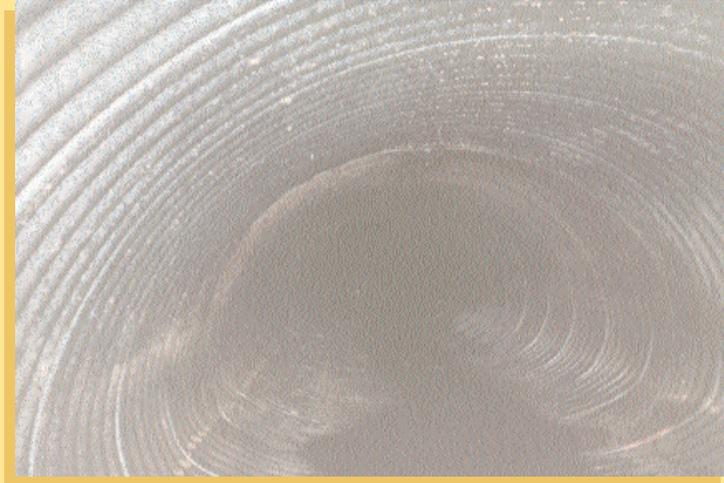
Top	100
Sides	100
Invert	95/100
Avg. Rating	99.2

Asphalt removed in
some areas; no rust on
exposed galvanized
surface.

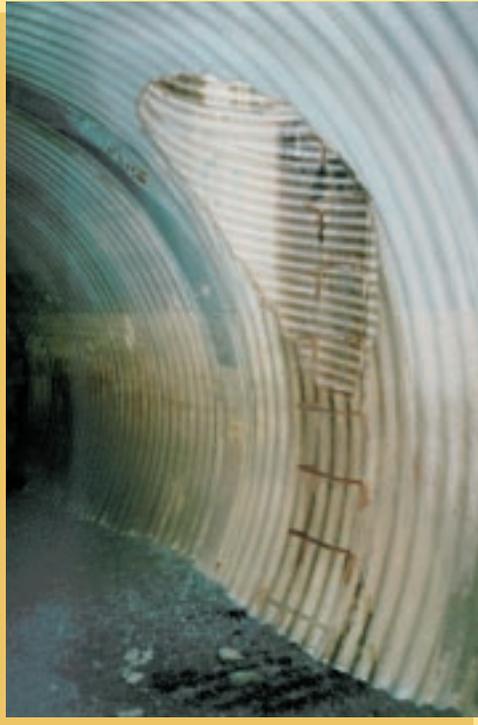
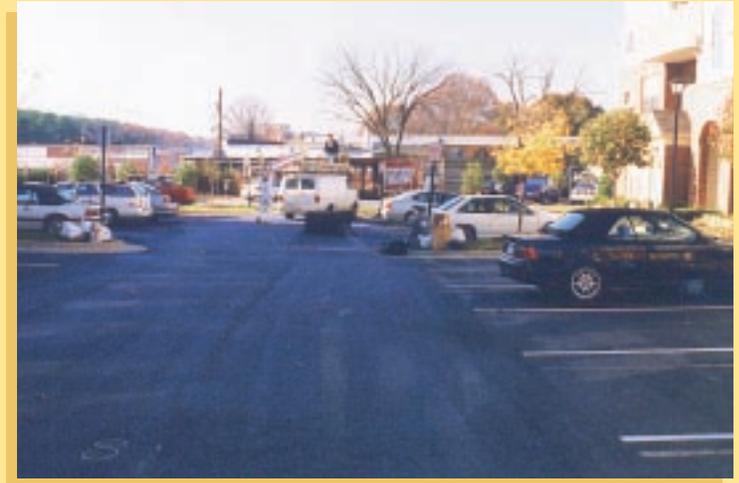
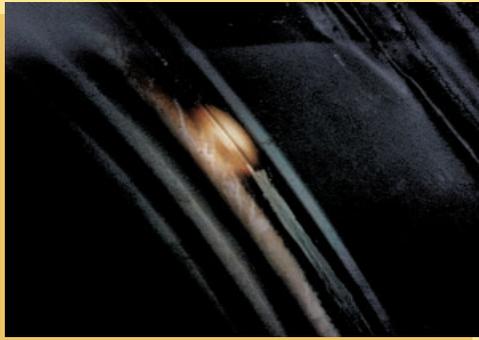
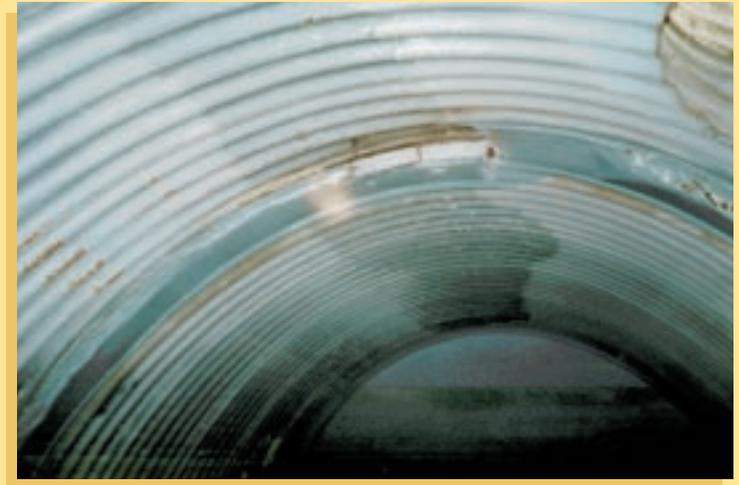
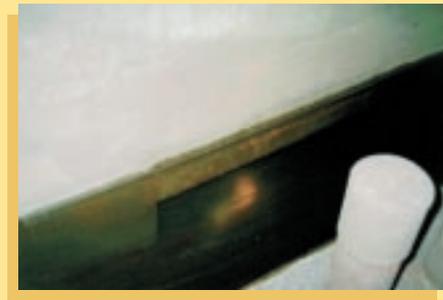
Top95/100
 Sides95/100
 InvertN/A
Avg. Rating.....97.5

Little to no debris;
 no signs of clogging;
 return valve open.
