Sample: Galvanized steel plate coated  
with Trenchcoat polymer

Report No.: 09-020-04-014

**SUBJECT: Corrosion and abrasion tests on galvanized steel plate coated with Trenchcoat polymer**

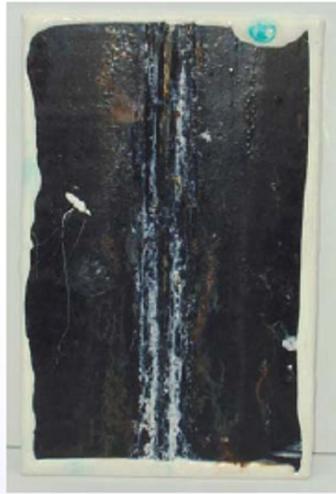
**Plate #2  
Trenchcoat  
Welded Joint**

The repair paint on the welded joint didn't produce the expected results. The paint deteriorated after 1700 hours of exposure, leaving the door open to corrosion under the surface of the adjacent coating.

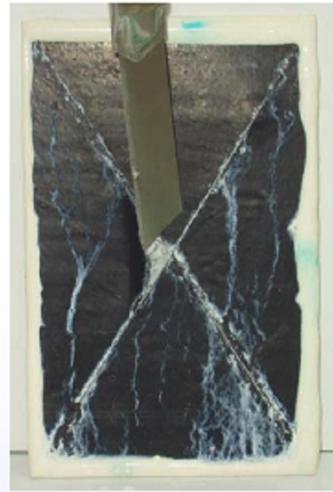
**Plate #3**  
**Trenchcoat**  
**X Groove**

After 2200 hours, the salt started to filter under the polymer surface, causing its gradual delaminating until about 60% of the plate surface at 4000 hours of exposure.

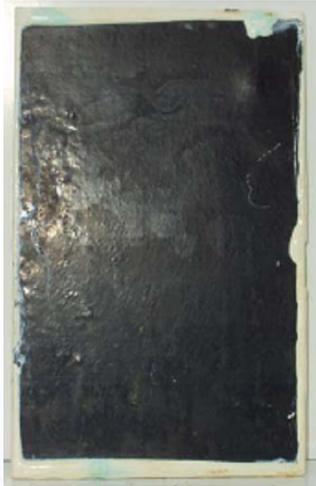
**Plate #1  
Trenchcoat**

Loss of thickness almost null and no polymer coat delaminating after 4000 hours of exposure.

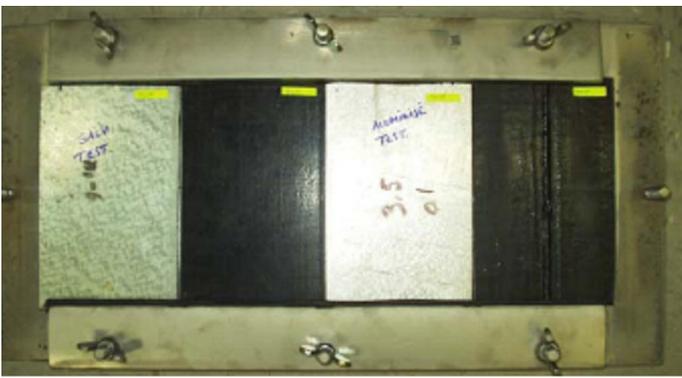
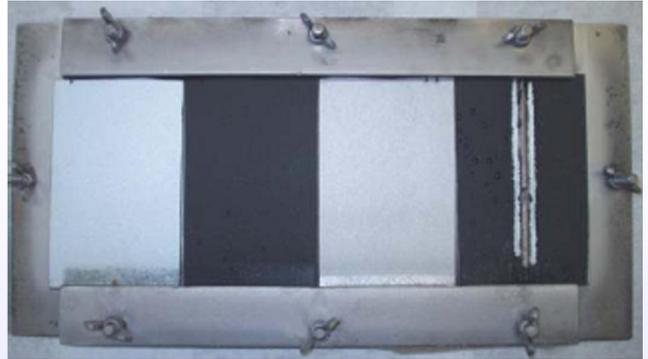
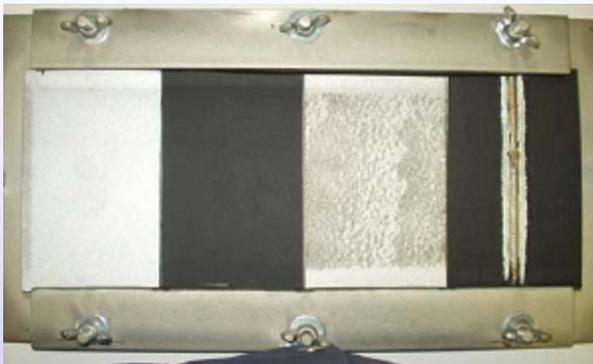
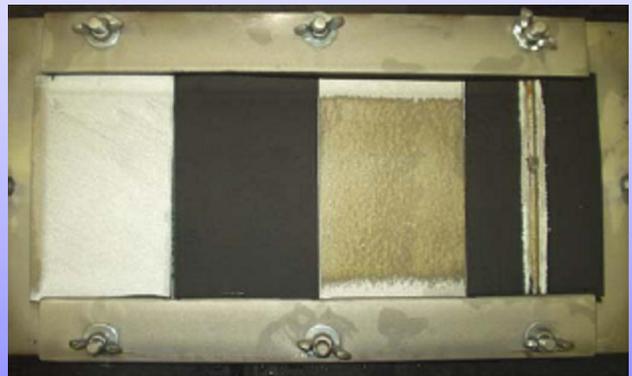
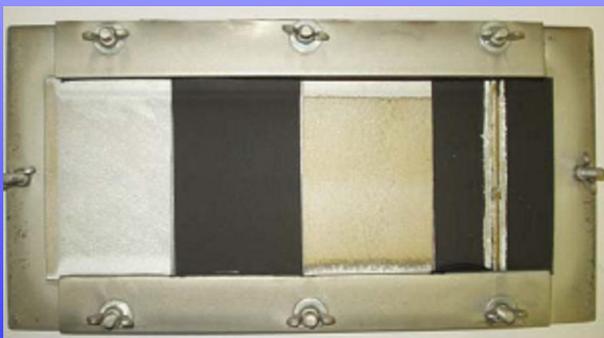
Slight loss of thickness and no polymer coat delaminating at the surface after four abrasion cycles.

The welded joint's repair didn't produce the expected results . The paint used for the repair disappeared at the first abrasion cycle . However, the Trenchcoat product didn't deteriorate during the other cycles. In case of deterioration of the polymer during fabrication, handling or transportation, the repair method must be as sustain able as the polymer itself.
