USDA United States
Department
of Agriculture

General Technical
Report RMRS-GTR-63

Evaluating the Effectiveness of Postfire Rehabilitation Treatments

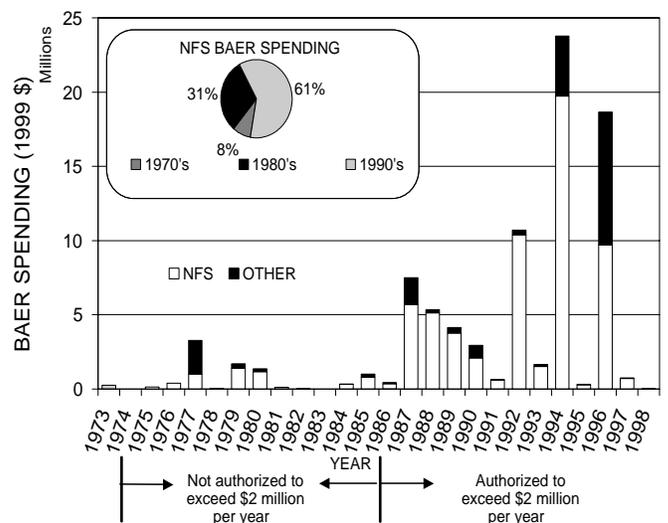
Figure 1—BAER spending by National Forests and other state and private entities that include National Forests by year in 1999 dollars. The insert shows spending by decade as a percent of the total spending. Spending authority changes are shown.

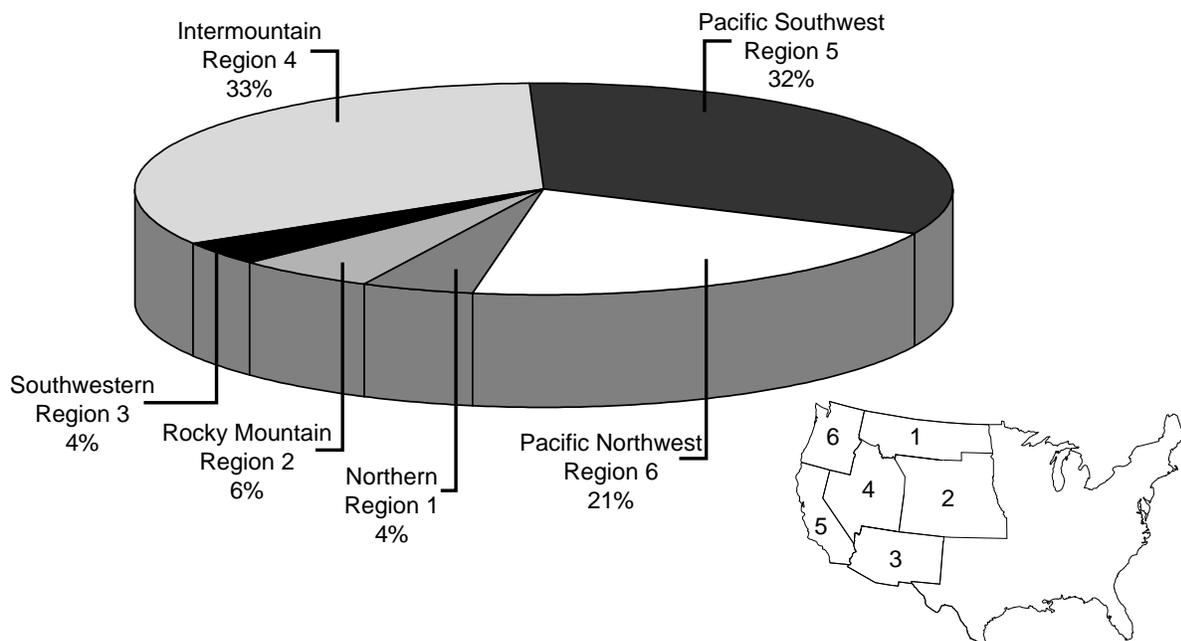
Figure 2—National Forest BAER spending by Region in 1999 dollars, 1973-1998 from Burned Area Reports. The insert shows the Western Forest Service Regions used in this study.

BAER project costs per unit area treated followed the trend of total treatment costs (fig. 2, 8). Costs per acre (ha) were higher for Regions 4, 6, and 5 than Regions 1, 2, and 3. The most expensive cost per acre, \$39 (\$96 ha⁻¹), was for Region 4 and the least expensive, \$9 (\$22 ha⁻¹), was from Region 3. The higher costs per acre in Region 4, 6, and 5 fires reflected investments in BAER projects to protect life and property. This was particularly true for high severity fires in Region 4 (fig. 9).

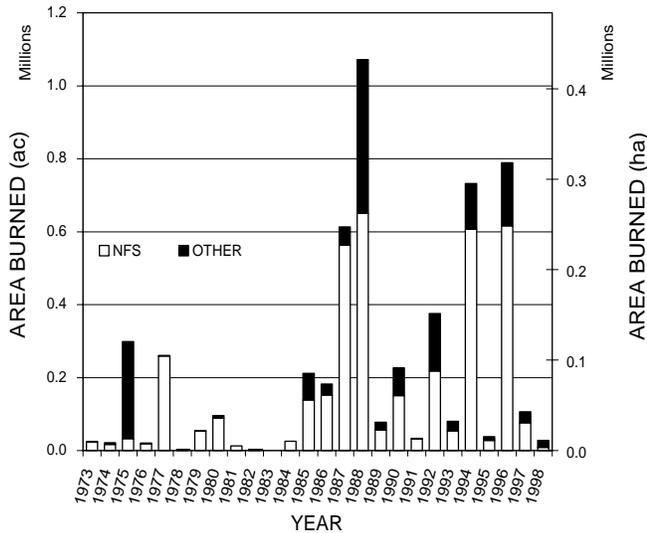
Figure 3—Total area burned in National Forests and other lands that had some portion of National Forest lands by year from the Burned Area Reports.

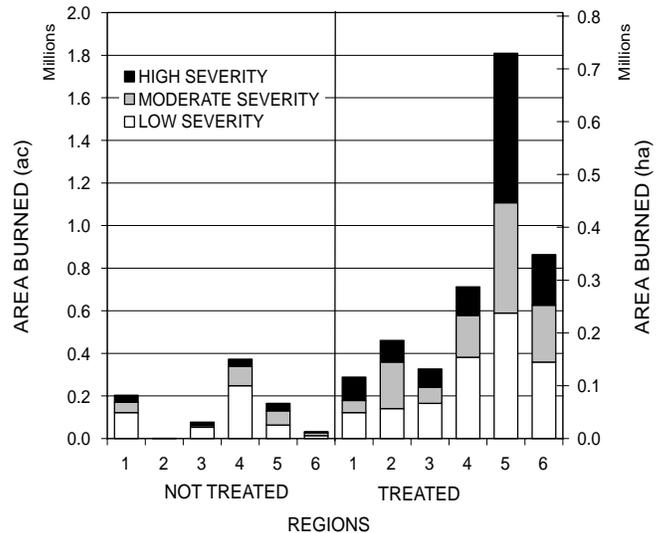
Figure 5—Total areas burned by severity class listed by Region, 1973-1998 from Burned Area Reports. Treated and untreated burned areas by severity are totaled separately.

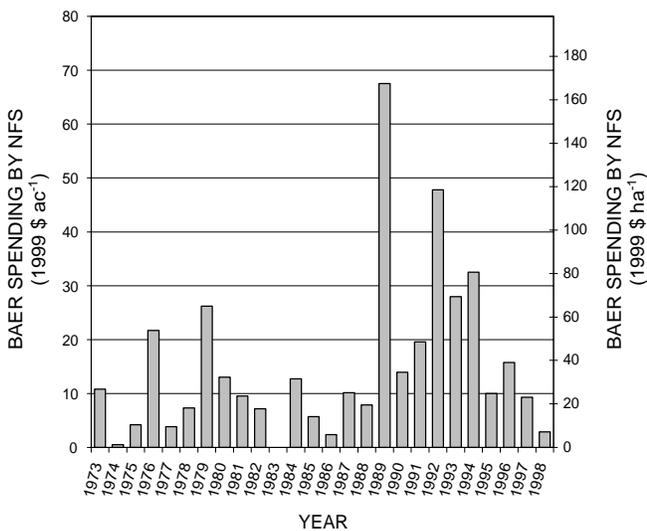
Figure 4—BAER spending by National Forests per unit area burned by year from Burned Area Reports.

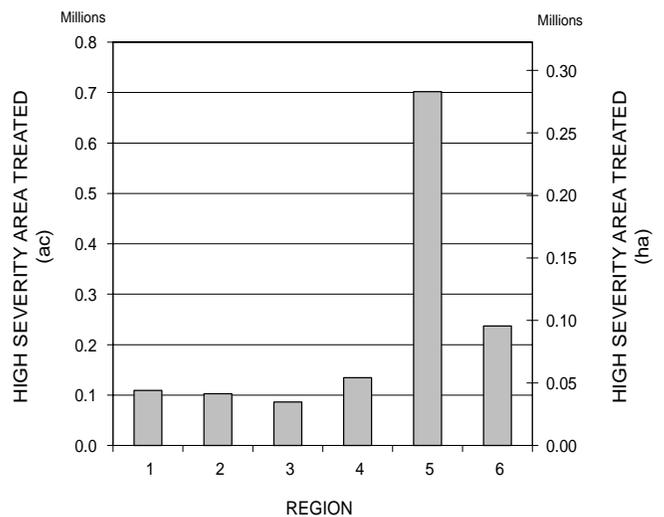
Figure 6—High severity areas burned and treated with BAER funding by region, 1973-1998 from Burned Area Reports.

other Regions combined (670,000 ac, 271,300 ha) (fig. 6). For Region 5, the high severity areas (39 percent of the total reported wildfire-burned area) exceeded the moderate (29 percent) and low severity categories (33 percent); this is due to the large amount chaparral vegetation in Region 5 which generally burn at high severity conditions. In all the other Regions, the acreage of burned land in the low severity class exceeded the high severity class.

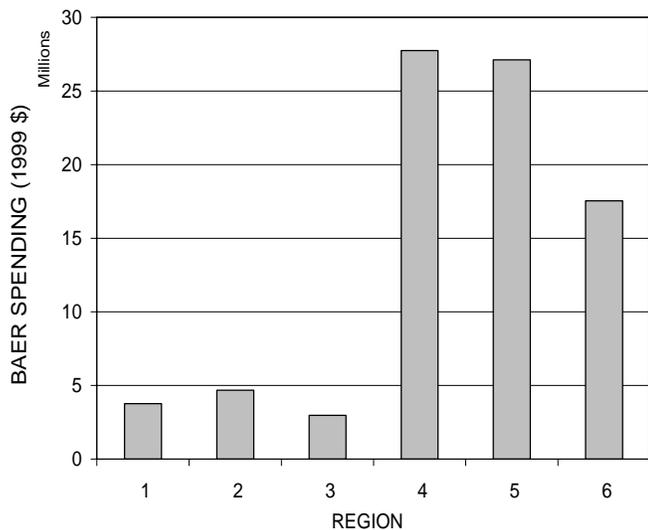
Figure 7—BAER spending by Region for high severity burn areas in 1999 dollars, 1973-1998 from Burned Area Reports.

In terms of expenditures for BAER treatments on high fire severity areas, the Regions segregated into two groups (fig. 7). Both Regions 4 and 5 incurred BAER treatment expenses of over \$27 million, and Region 6 exceeded \$17 million. However, the expenditures for

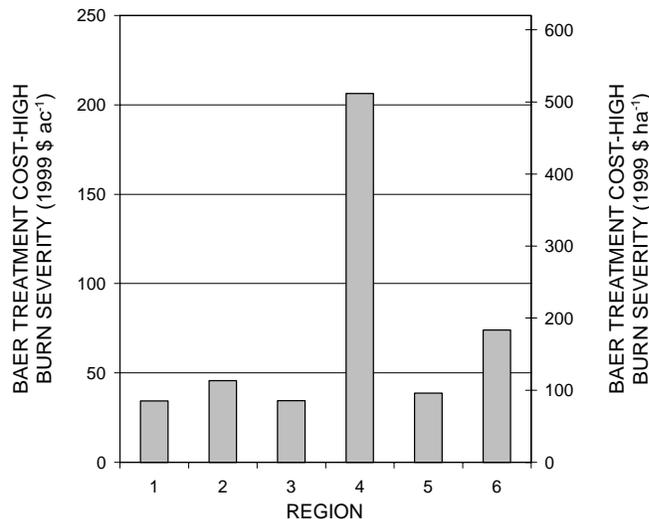
Figure 9—Cost per area for BAER treatment on high severity burned sites in 1999 dollars, 1973-1998 from Burned Area Reports.

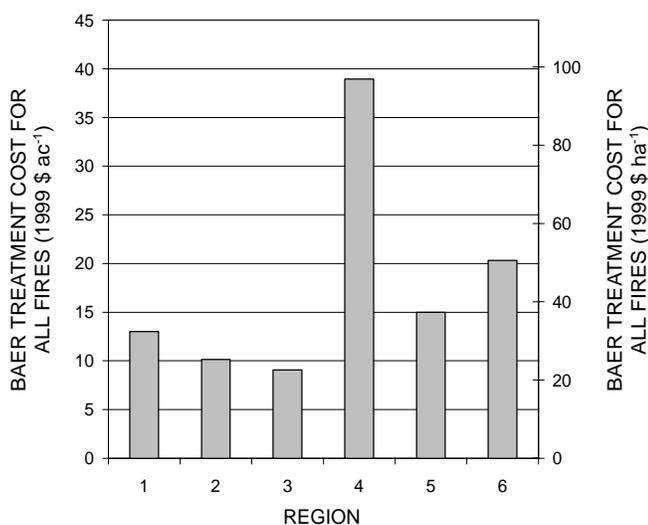
Figure 8—Cost per area for BAER treatment for Forest Service Systems lands by Region in 1999 dollars, 1973-1998 from Burned Area Reports.

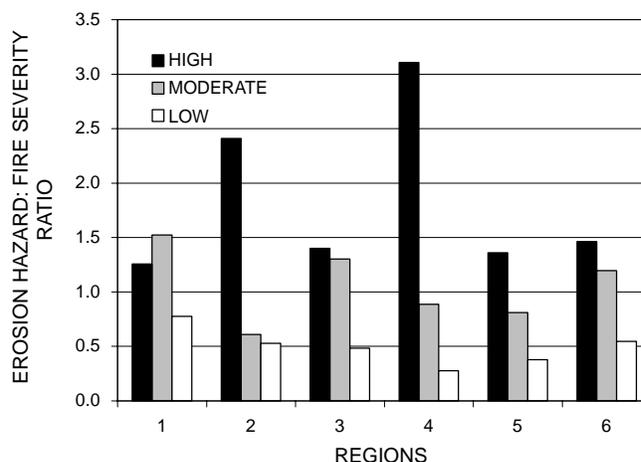
Figure 10—Average ratio of areas described as low, moderate, and high erosion hazard to areas of low, moderate, and high burn severity by Region from Burned Area Reports.

due to conditions such as granitic soils and steep slopes, which create naturally high erosion hazards. On the other hand, in all regions the ratio of low erosion hazard areas to low burn severity areas was low, indicating that erosion potential was small.

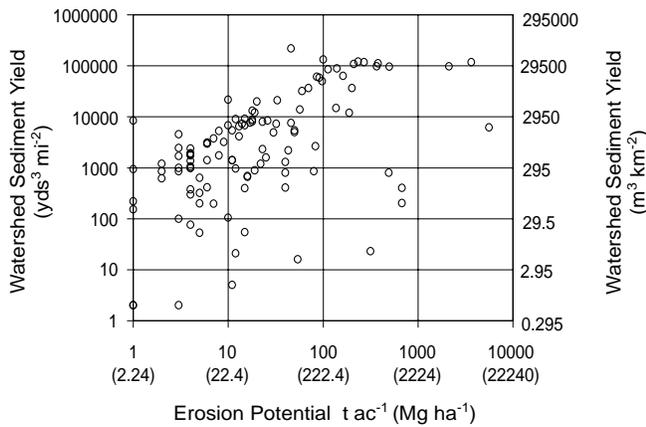
Figure 11—Estimated hillslope erosion potential and watershed sediment yield potential (log scale) for all fires requesting BAER funding.

A wide range of erosion potential estimates and watershed sediment yield (delivered to the channel) potential estimates was found in the Burned Area Report forms, some with very high values that could be considered unrealistic (fig. 11). Erosion potential varied from 1 to 7,000 ton ac⁻¹ (2 to 15,500 Mg ha⁻¹), and sediment yield varied over six orders of magnitude. Erosion potential and sediment yield potential did not correlate well ($r = 0.18$, $n = 117$). Different methods

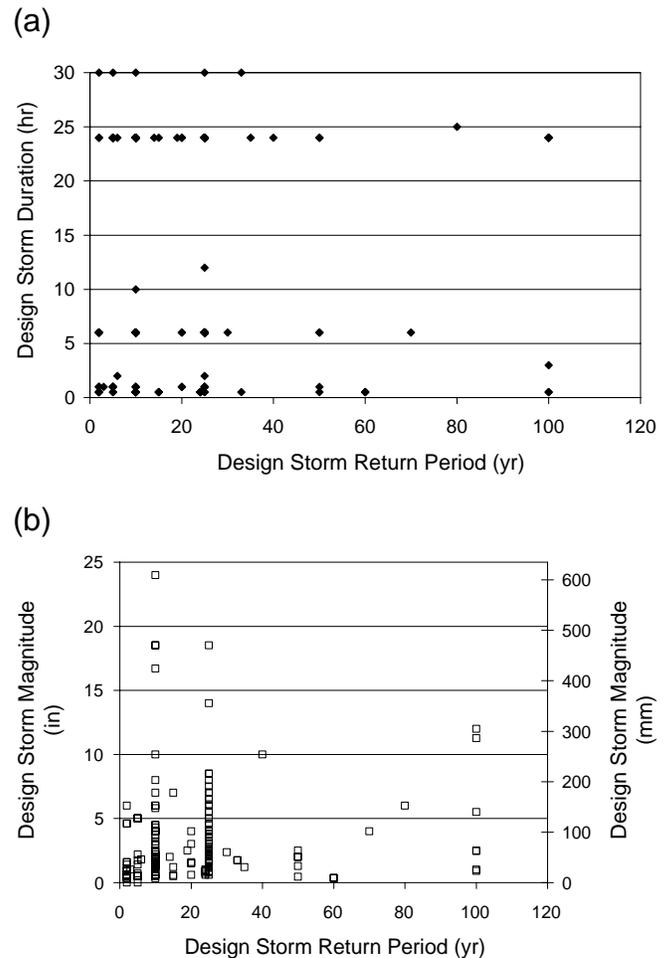
Figure 12—(a) Design storm duration and (b) design storm duration by return period for all fires requesting BAER funding.

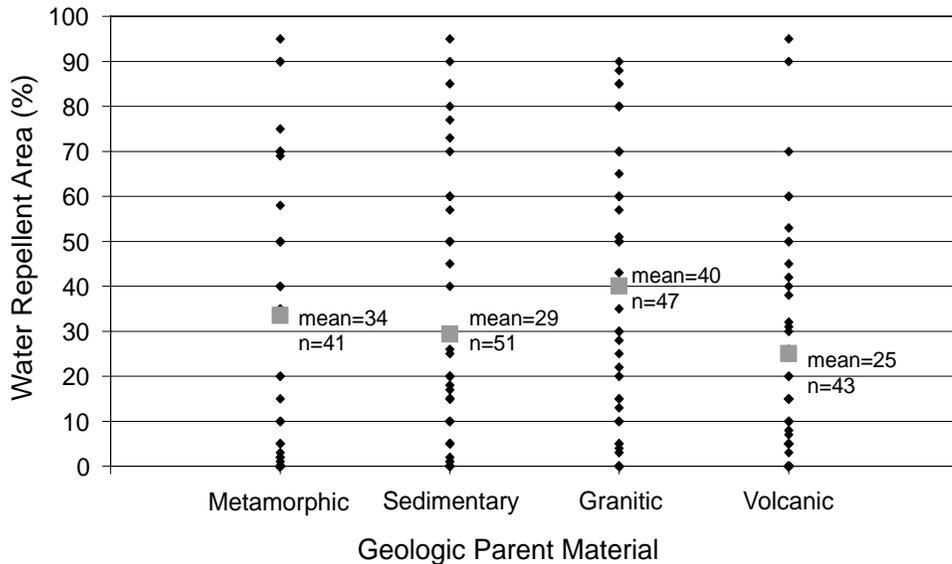
Figure 13—Fire-induced water repellent soil areas and their geologic parent material for all fires requesting BAER funding. Fire-induced water repellency was not significantly different by parent material (t-test, $\alpha = 0.05$).

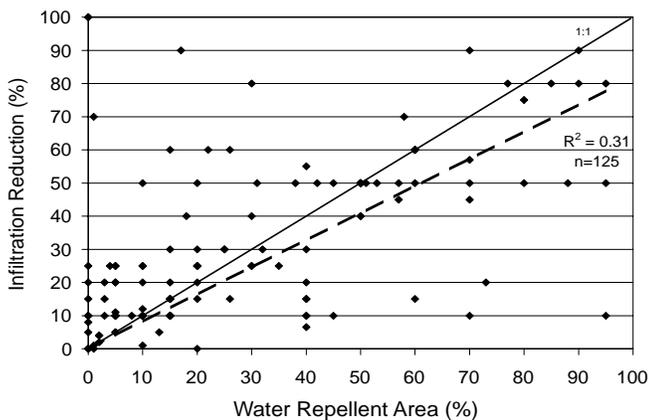
Figure 14—Fire-induced water repellent soil areas compared to the estimated reduction in infiltration for all fires requesting BAER funding. Regression line shows a poor correlation between increased water repellent soil areas and the reduction in infiltration ($R^2 = 0.31$).

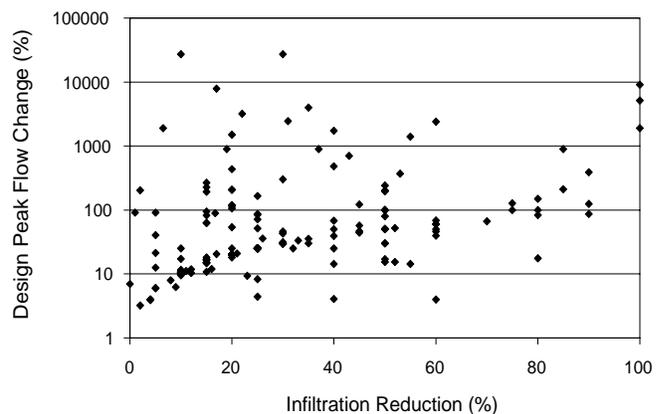
Figure 15—Estimated design peakflow change (log scale) due to burned areas related to the estimated reduction in infiltration for all fires requesting BAER funding.

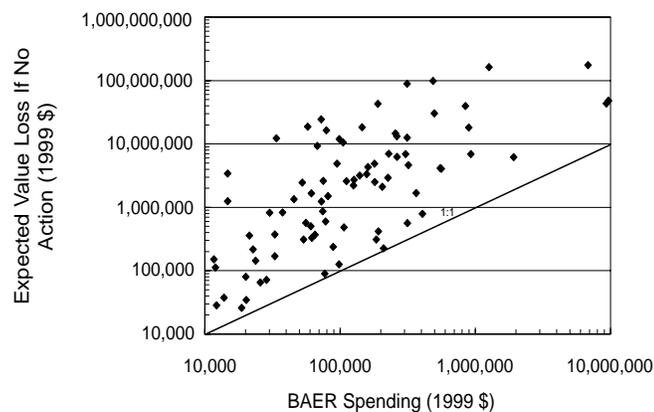
Figure 16—BAER spending compared to projected value loss if no action was taken (log scale). BAER spending did not exceed estimated values.

Costs of BAER treatments were compared to estimated losses (without treatment) from the Burned Area Report forms (fig. 16). BAER treatments appear to be very cost effective, generally costing one-tenth as much as the expected losses if no treatment were to be implemented. Expected losses are just estimates; we

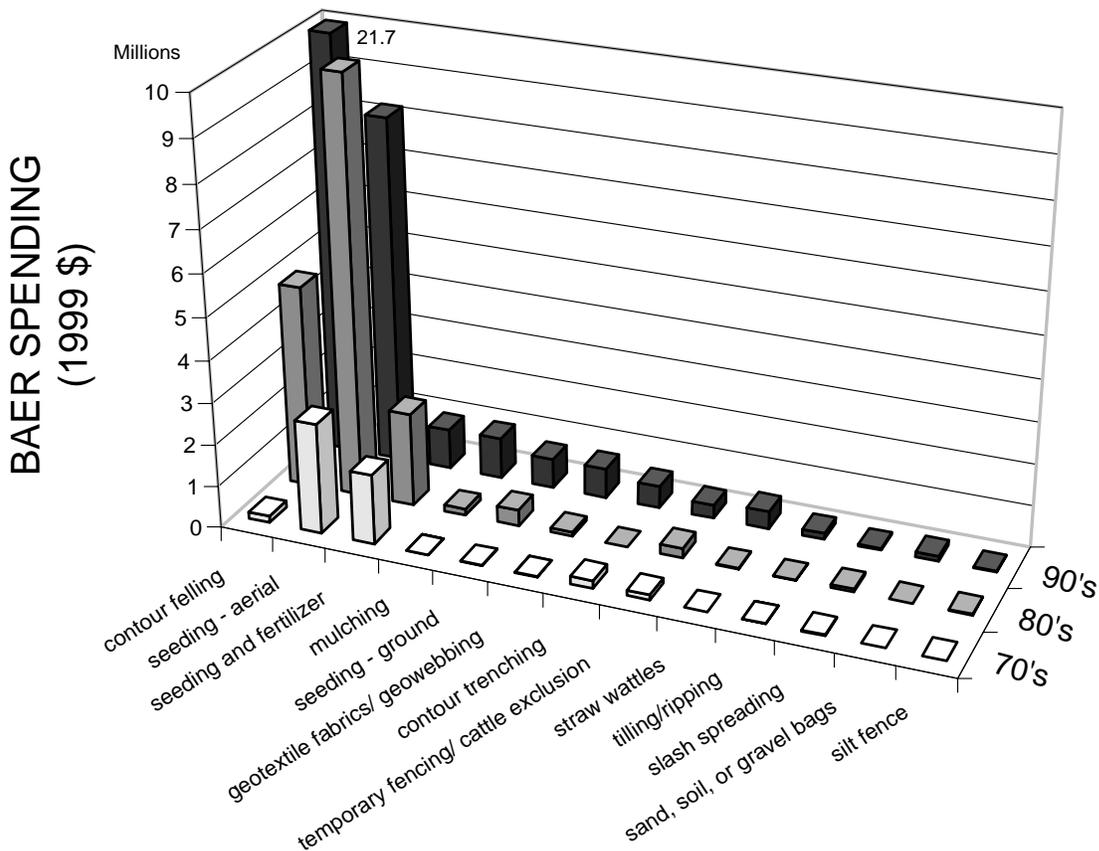
HILLSLOPE TREATMENT

Figure 17—BAER spending on hillslope treatments by decade in 1999 dollars. Treatments are ordered by decreased spending.

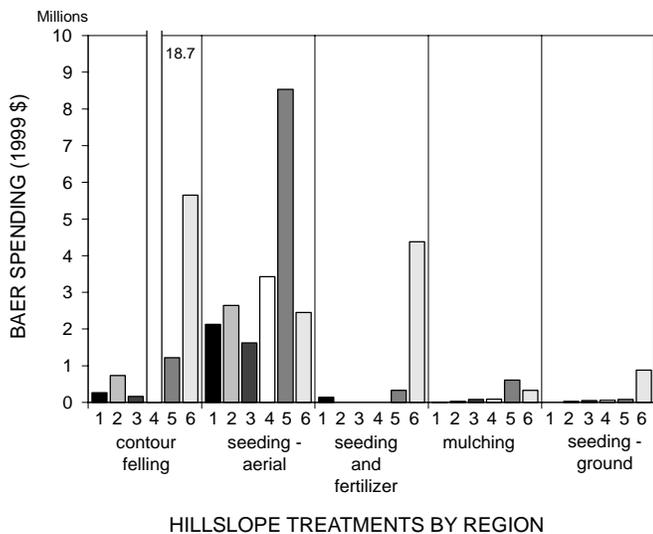
Figure 18—BAER spending on the five most expensive hillslope treatments by Region in 1999 dollars.

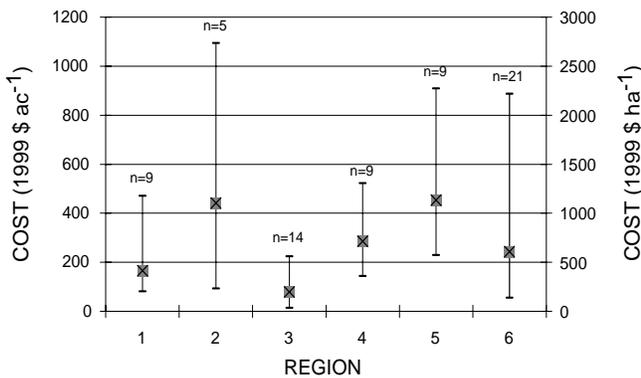
Figure 19—Cost per area for BAER spending on contour-felled logs by Region in 1999 dollars. Mean unit cost with range for each region is shown.

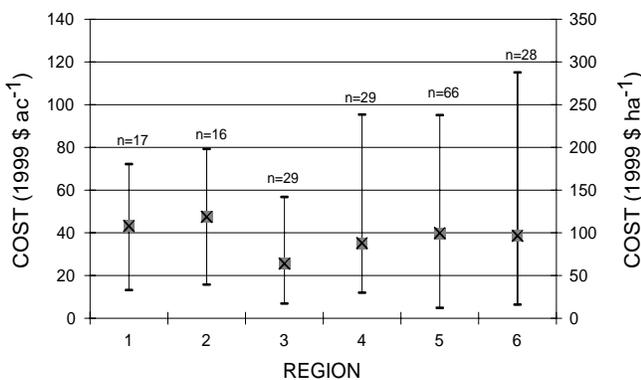
Figure 20—Cost per area for BAER spending on aerial seeding by Region in 1999 dollars. Mean unit cost with range for each region is shown.

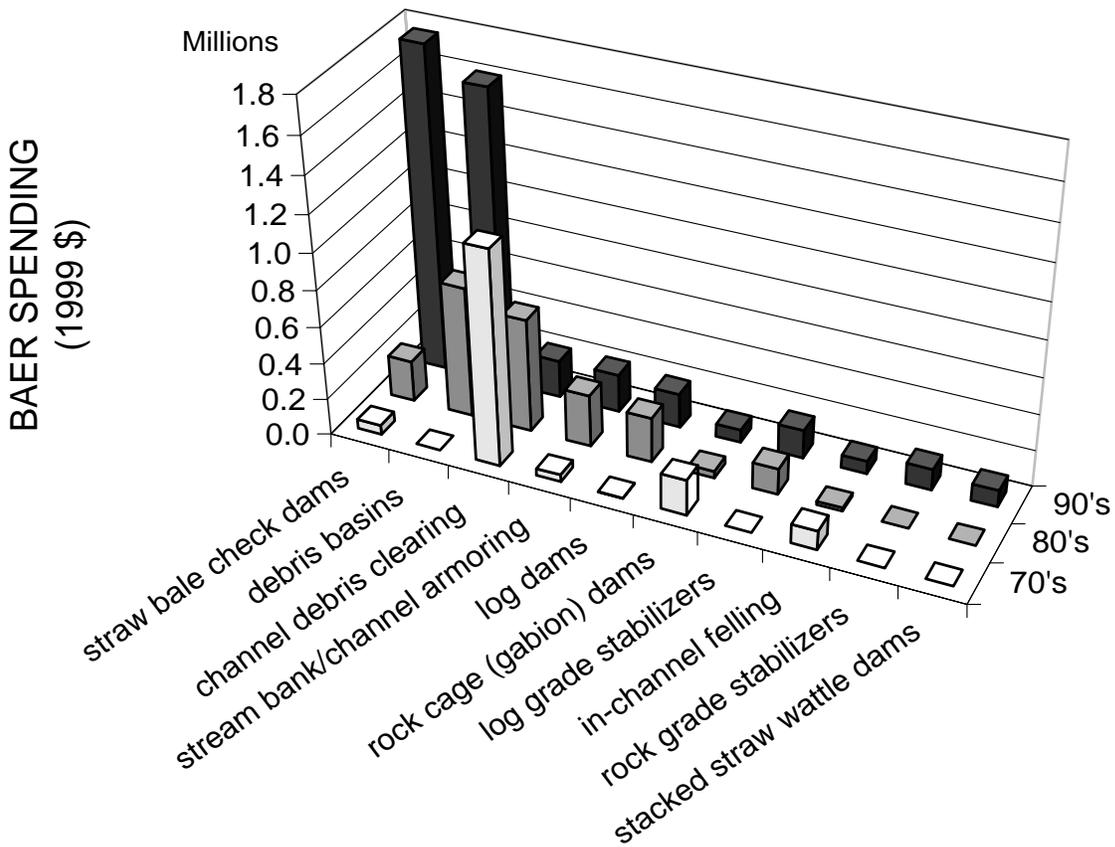
CHANNEL TREATMENTS

Figure 21—BAER spending on channel treatment by decade in 1999 dollars. Treatments are ordered by decreased spending.

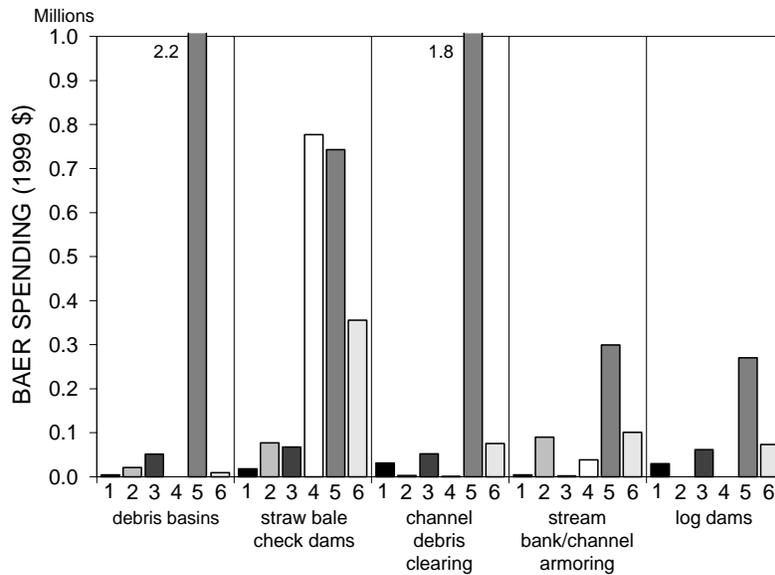
CHANNEL TREATMENTS BY REGION

Figure 22—BAER spending on the five most expensive channel treatments by Region in 1999 dollars.

Region 5 spent the most on debris basins (1990's) and channel debris clearing (1970's) (fig. 22). Straw bale check dams were used mostly by Regions 4, 5 and 6. There were far fewer interviewee comments recorded in our database for channel treatments (38) than for hillslope treatments (168), indicating a lower frequency of use in BAER projects.

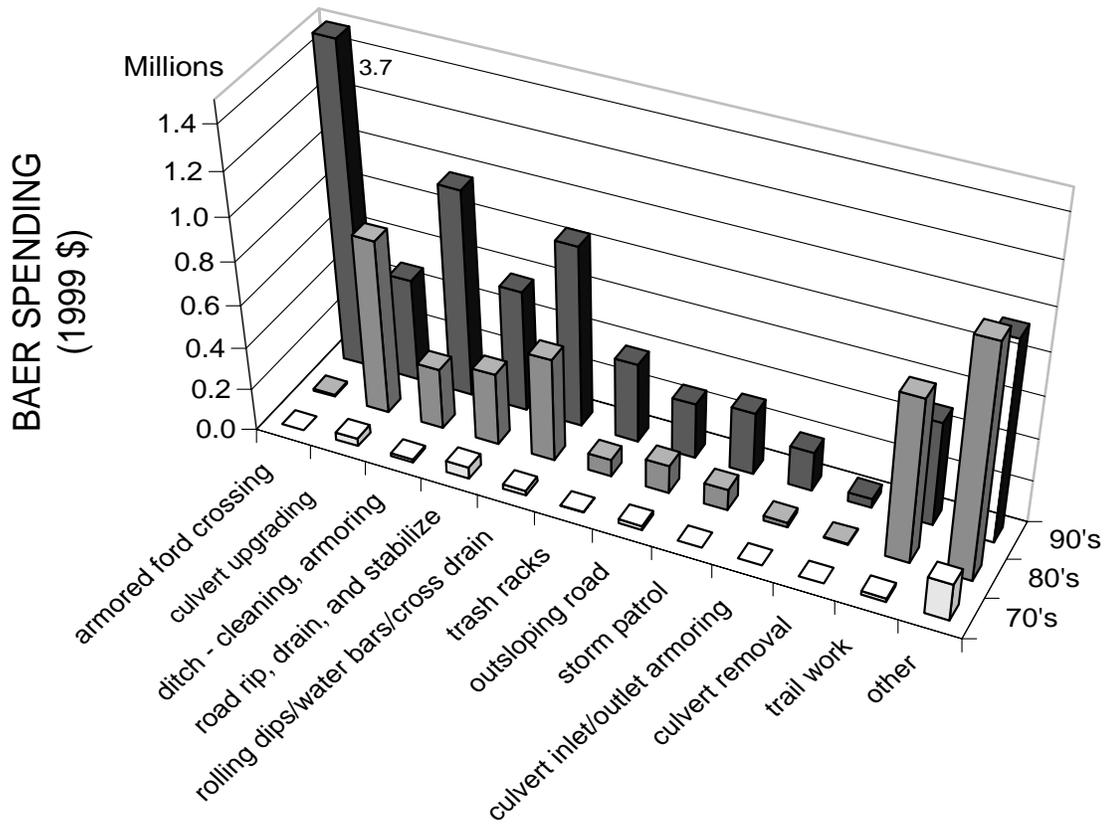
ROAD TREATMENTS

Figure 23—BAER spending on road and trail treatments by decade in 1999 dollars. Treatments are ordered by decreased spending except for trail work and other treatment that were not categorized.

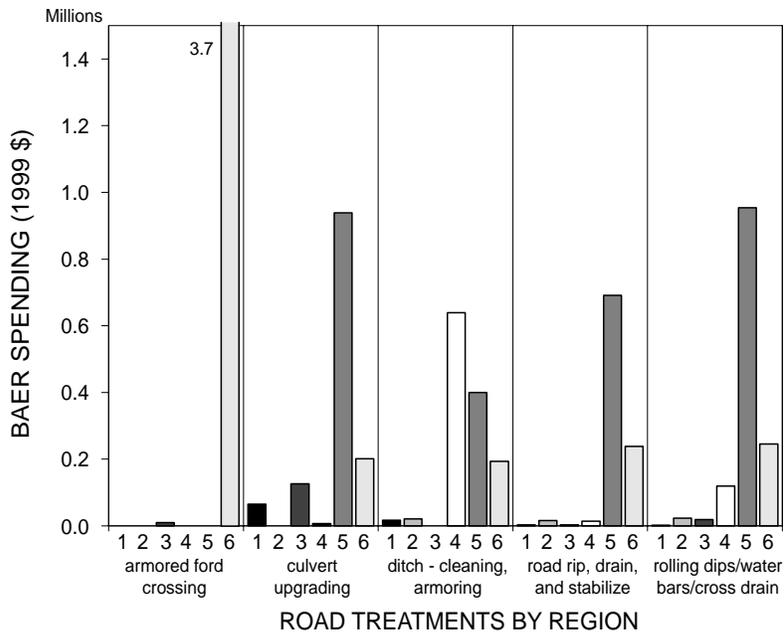
Figure 24—BAER spending on the five most expensive road and trail treatments by Region in 1999 dollars.

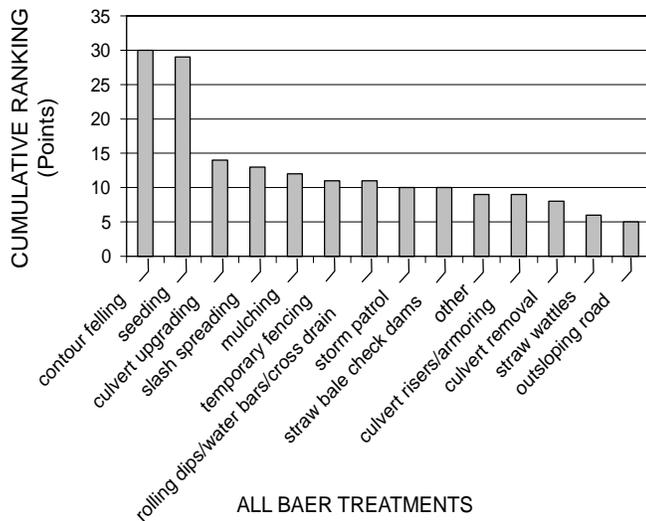
Figure 25—Cumulative ranking of treatment effectiveness for all treatments combined. Cumulative rankings are taken from interviewees ranking of their top three treatment preferences. The top 14 treatment preferences are shown out of a total of 26 treatments.

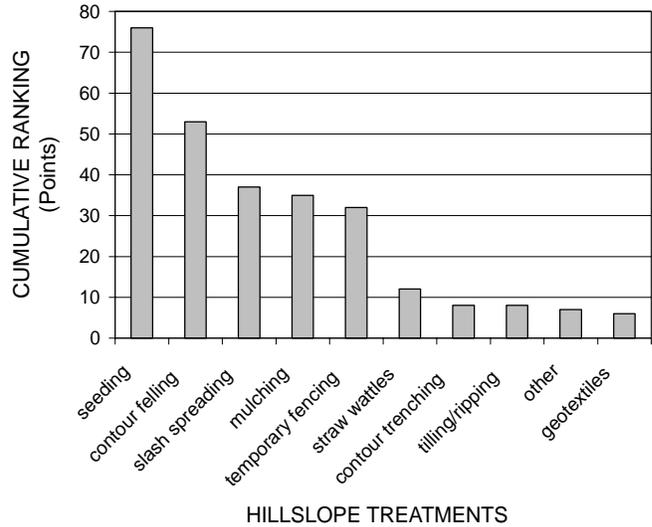
Figure 26—Cumulative ranking of treatment effectiveness for hillslope treatments. Cumulative rankings are taken from interviewees ranking of their top three treatment preferences. The top 10 treatment preferences are shown out of a total of 16 treatments.

Aerial seeding had the highest ranking among hillslope treatments, followed by contour-felled logs, slash spreading, mulch, and temporary fencing. Other treatments received relatively low scores. The high rank for seeding is not surprising considering its high level of use (fig. 26). On the other hand, aerial seeding was listed as the most overused treatment by far, with ground seeding second (table 18). Seeding also garnered a few votes as underused, and it was most often mentioned (three times) as a treatment that should have been used on no-action fires. These seemingly contradictory results reflect the wide differences in opinion about seeding's effectiveness (table 17) and the on-going controversies surrounding the use of grass seeding as a rehabilitation treatment.

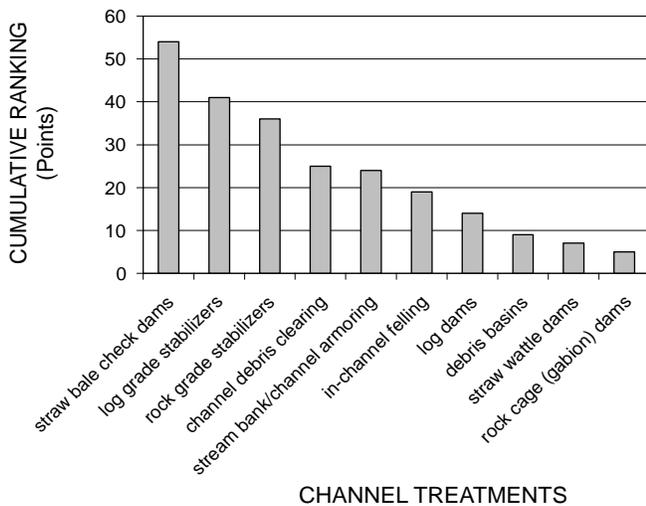
Figure 27—Cumulative ranking of treatment effectiveness for channel treatments. Cumulative rankings are taken from interviewees ranking of their top three treatment preferences. Rankings of all preferences are shown.

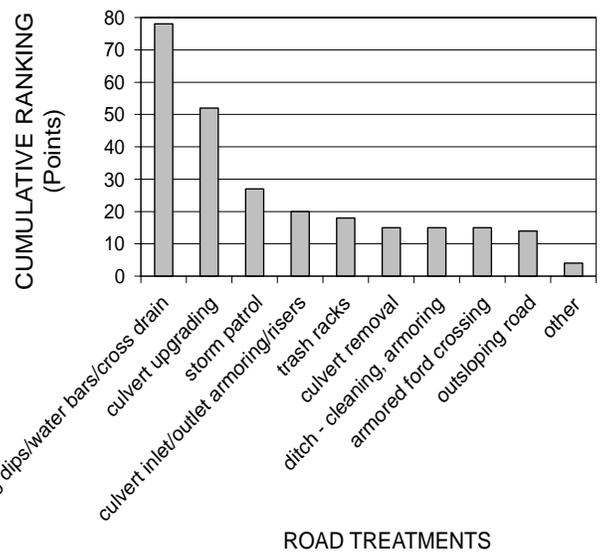
Figure 28—Cumulative ranking of treatment effectiveness for road treatments. Cumulative rankings are taken from interviewees ranking of their top three treatment preferences. The top 10 preferences are shown out of a total of 15 treatments.
