FIELD ASSESSMENT OF TWO COATINGS FOR CORRUGATED STEEL PIPES: GALVANIZED AND ALUMINIZED TYPE 2

January, 2020

301013357: BI-METAL CULVERT ASSESSMENT
TECHNICAL REPORT NO. 2 (2020)

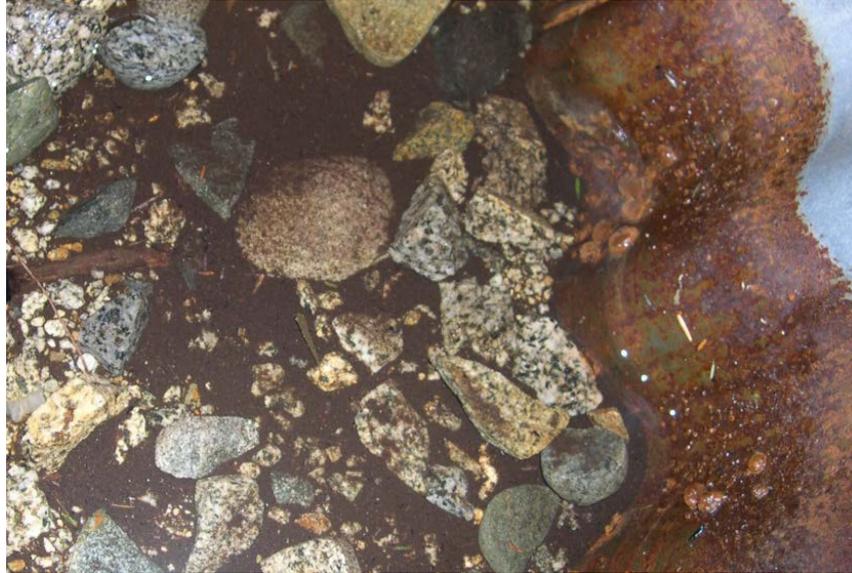
Figure 2. Possible MIC on the metal of a culvert, showing a film, or anaerobic bubbles, forming (This picture was not taken at any of the sites discussed in this report).

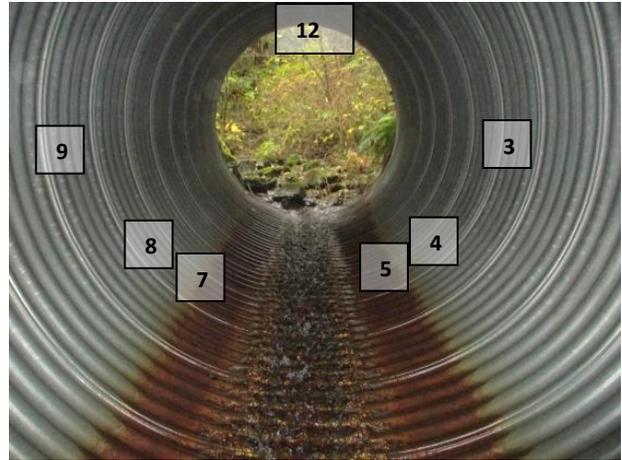
Figure 4. Locations where coating thickness measurements were taken (indicated by numbers). (Note that this is a galvanized section of culvert).

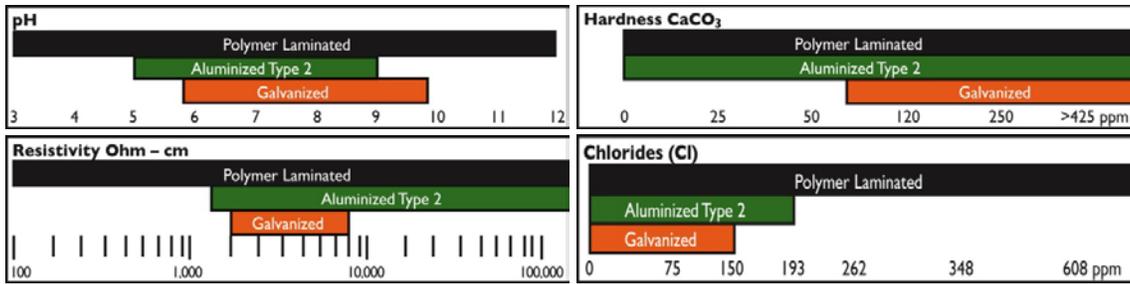
Figure 17. Bar charts showing the ranges in water chemistry measurements and their associated appropriate culvert coatings. (Courtesy of CSPI.)

At sites 1 (A-Branch) and 2 (Rainbow Main), the measured pH (4–5) and hardness (25) were outside the suggested range for galvanized coatings and were within the suggested range for aluminized type 2. The chlorides (none) were within the suggested range for both coatings. At site 3 (Loon Lake), the measured pH (7) and chlorides (none) were within the suggested range for both coatings. The hardness was within the suggested range for the aluminized type 2 coating and at the border of the suggested range for galvanized. Based on a resistivity calculator (CSPI.ca/resources/calculators) using inputs for hardness and chlorides, sites 1 and 2 are approximately 16 000 ohm-cm (outside the suggested range for galvanized), and site 3 is approximately 5 500 ohm-cm (within the range of both coatings). The field measurements showed the aluminized type 2 coating as having a greater amount of coating remaining at all three sites. The suggested ranges for water chemistry provide good guidance, but the abrasion level must also be considered when planning expected service life.
