Sample: Galvanized steel plate coated  
with Trenchcoat polymer

Report No.: 09-020-04-014

**SUBJECT: Corrosion and abrasion tests on galvanized steel plate coated with Trenchcoat polymer**

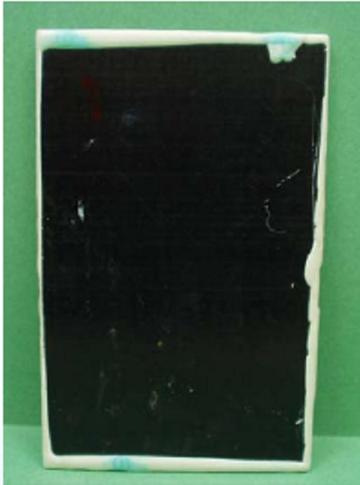
**Plate #1**  
**Trenchcoat**

Loss of thickness almost null and no polymer coat delaminating after 4000 hours of exposure.

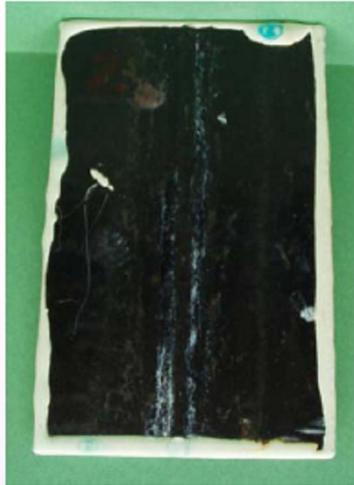
**Plate #2**  
**Trenchcoat**  
**Welded Joint**

The repair paint on the welded joint didn't produce the expected results. The paint deteriorated after 1700 hours of exposure, leaving the door open to corrosion under the surface of the adjacent coating.

In case of deterioration of the polymer during fabrication, handling or transportation, the repair method must be as sustainable as the polymer itself.
