February 3, 2009

Subject: Aluminized Type 2, The First 50 Years
RI No. 090017, Report No. 1 - Final

During 1952-3 Armco collaborated with state departments of transportation which installed of Type 2 Aluminized corrugated steel pipes (T2 CSP) in various locations. Two reports were published documenting T2 CSP durability in 1983 and 1996 summarizing the 30 and 43 year status. This Research Investigation represents the third report summarizing the status of the remaining 22 sites following more than 50 years in service. Ten of the sites assessed in 1996 were removed from service due to changes in land use. The site in Sangamon Co. Illinois was completely submerged due to locally heavy rains prior to the time of the assessment, while a site in Marshall Co. IA had to be relined and grouted due to damage on the galvanized half of this tandem site.

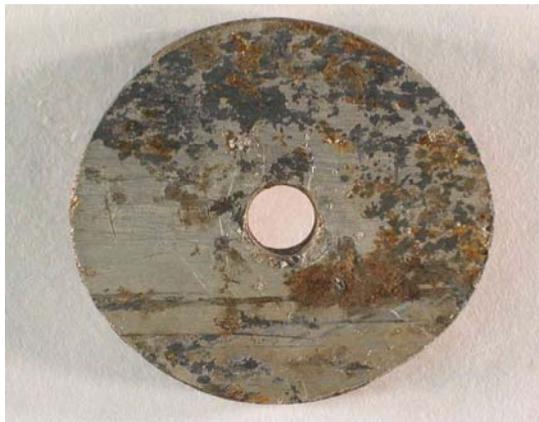
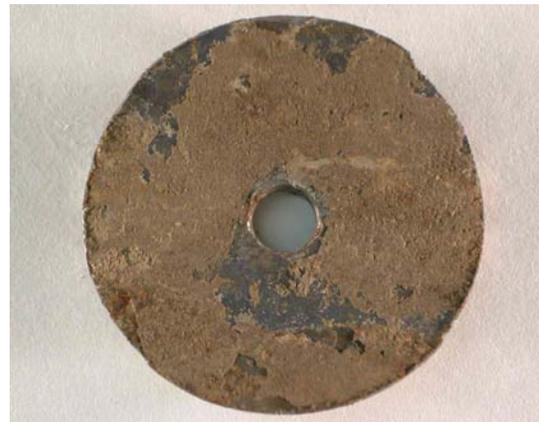
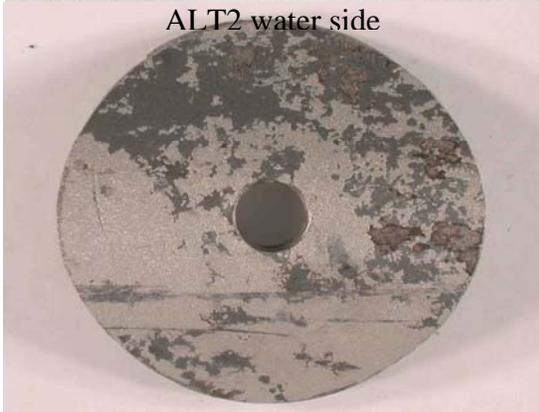
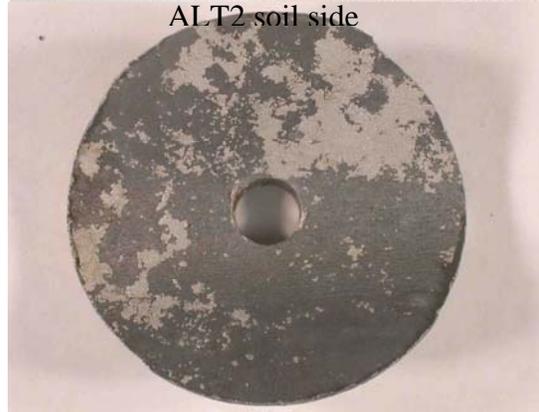
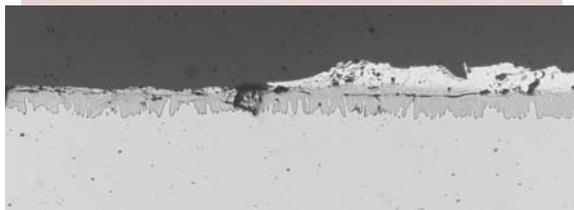
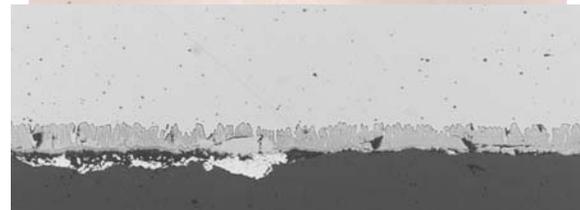
Images of trepan from Site 4: all 6 o'clock pipe positions

Site 4 Trepan Evaluation ALT2: The top images are of the coupon as removed after rinsing off loose dirt and debris. The coupon was then bead blasted to remove loose oxides and the lower images were recorded. Some shallow small pits were visible on the water side.

Based on conservative pit penetration extrapolations, the service life of 16 gage T2 CSP will exceed 100 years.

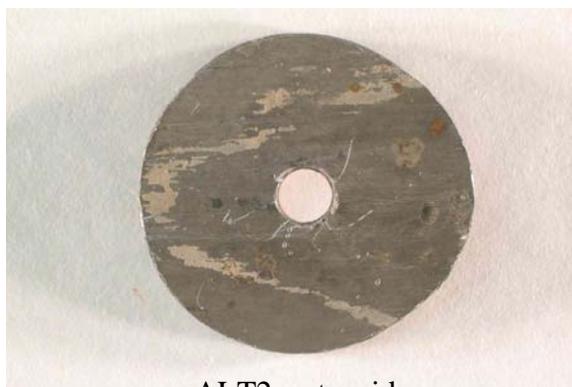
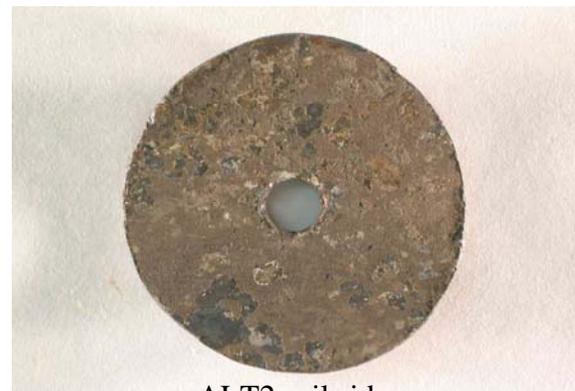
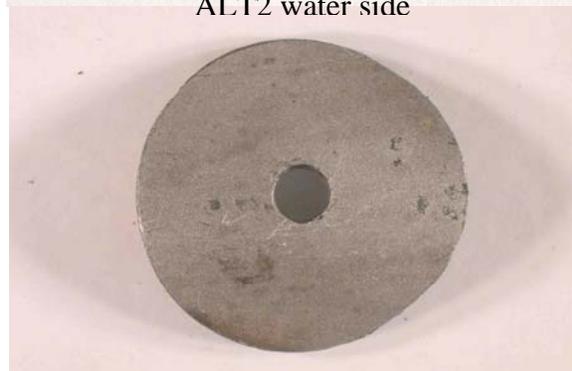
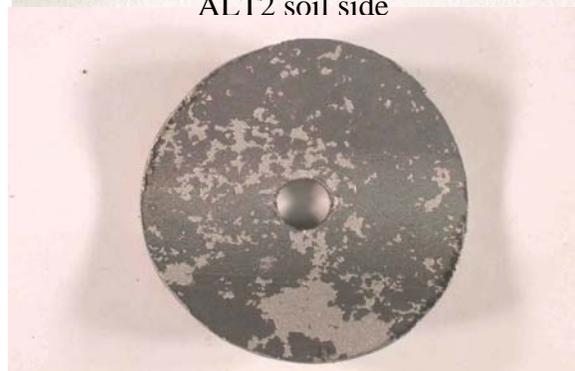
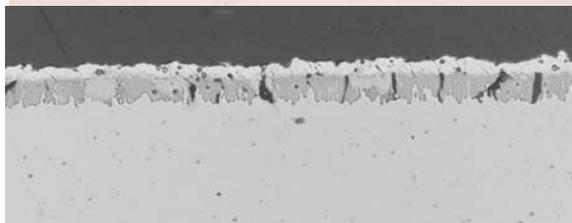
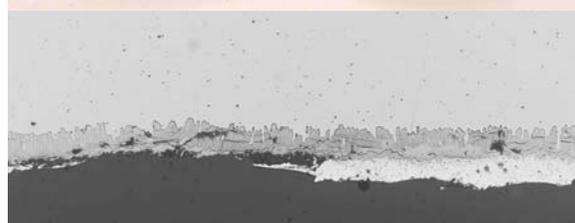
Images of ALT2 trepans from Site 5: all 6 o'clock pipe positions

Site 5 Trepan Evaluation ALT2: The top images are of the coupon as removed after rinsing off loose dirt and debris. The coupon was then bead blasted to remove loose oxides and the lower images were recorded. Few very lite, shallow pits mostly on the soil side.

Based on conservative pit penetration extrapolations, the projected service life of 16 gage T2 CSP will exceed 100 years.

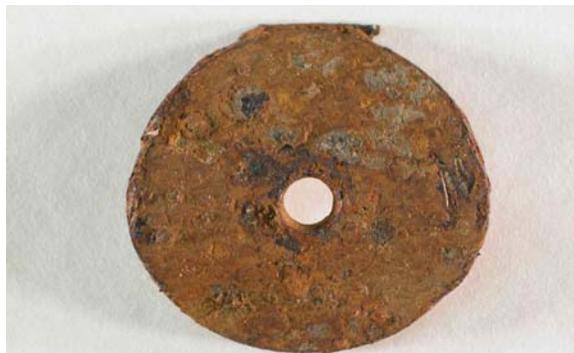
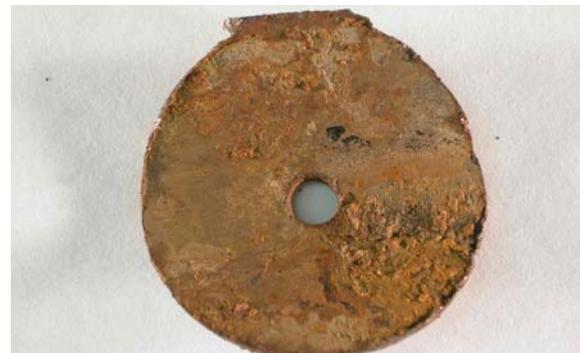
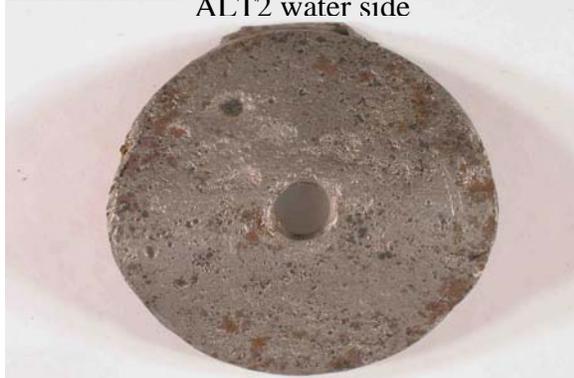
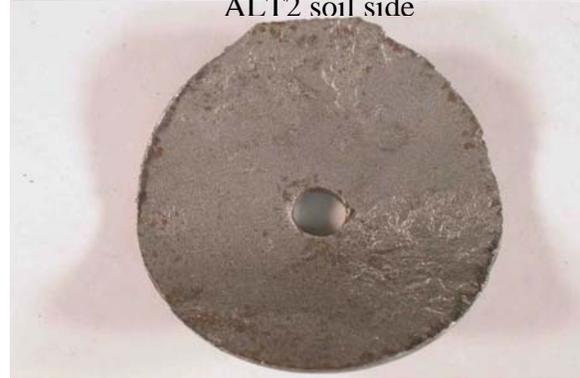
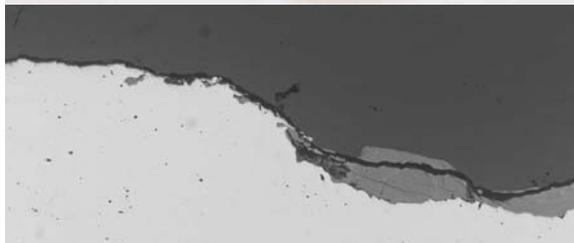
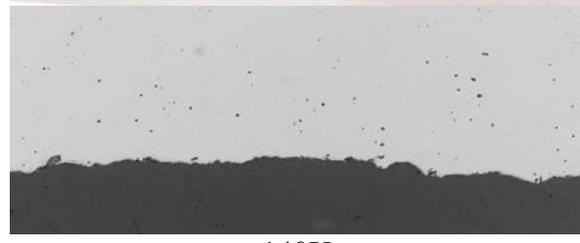
Images of ALT2 trepans from Site 7 at six o'clock pipe position

Site 7 Trepan Evaluation ALT2: The top images are of the coupon as removed after rinsing off loose dirt and debris. The coupon was then bead blasted to remove loose oxides and the lower images were recorded. Moderate to heavy pitting on the water side, and lite pitting on the soil side.

Based on conservative pit penetration extrapolations, the 16 gage service life would remain 75 years, low resistivity water and soil likely contributed to the poorer performance.

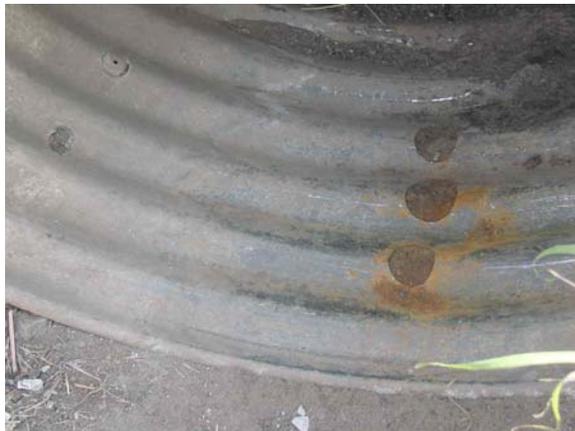
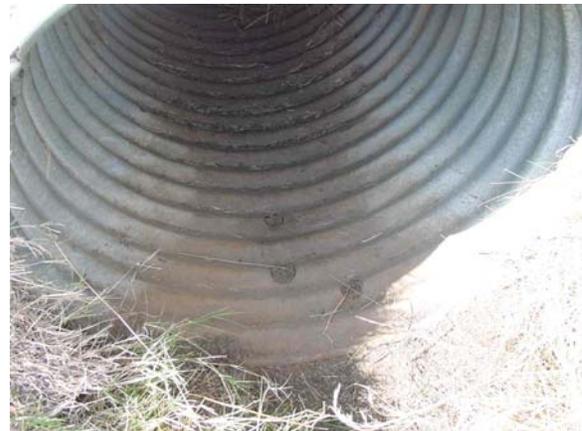
Observations: Both ends looked good. Previous trepan holes not corroded further on either end. Sample taken at 6:30 position. Galvanized end has some red rust from the 5 to 7 o'clock position.

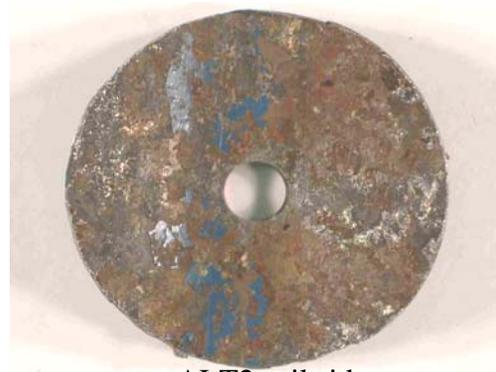
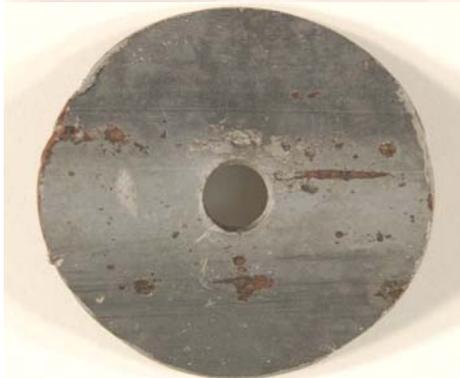
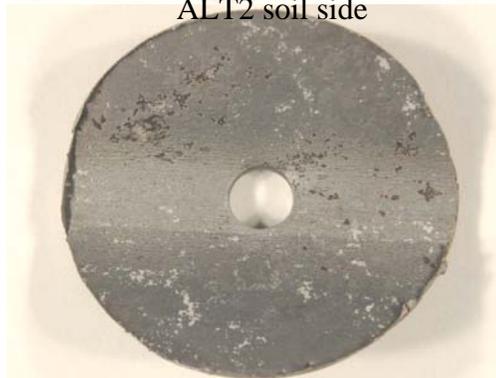
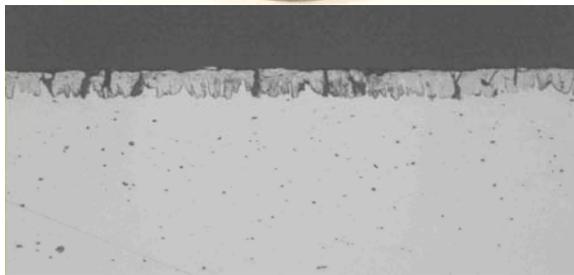
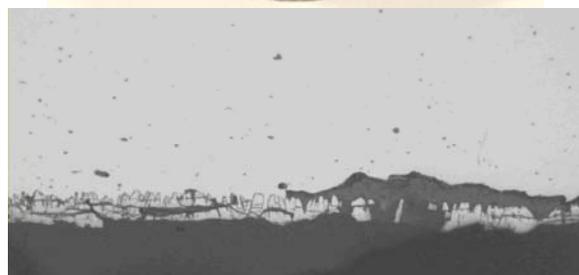
ALT2 water side

Site 13 ALT2 Trepan Evaluation: The top images are the coupon as removed after rinsing off loose dirt and debris. The coupon was then bead blasted to remove loose oxides and the lower images were recorded. Lite to moderate pitting is present on the top surface near the peak. Micrometer readings were taken after bead blasting using a ball micrometer (general thickness) and a point micrometer (deepest pit depth). Starting thickness: 0.082”
Results Ball: 0.081”, 0.081”, 0.082” Point: 0.066” (0.016”deep)
Based on conservative pit penetration extrapolations, the service life of 16 gage T2 CSP will exceed 100 years.

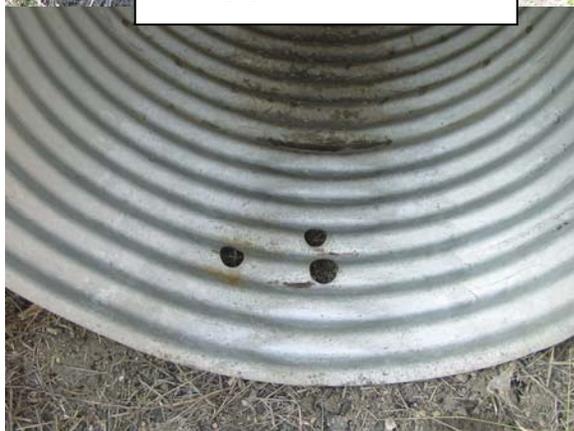
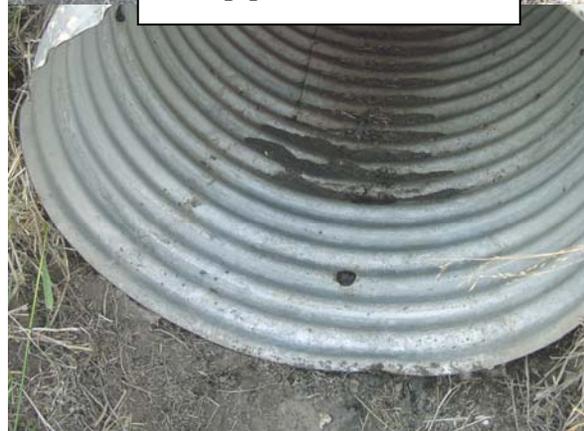
west pipe aluminized end

Observations: Both ends looked pretty good. Aluminized end still has good free aluminum coating intact. Previous trepan holes had not corroded further on either end. Samples were taken at 6:00 position. Galvanized end has red rust from the 4 to 8 o'clock position. Not perforated.

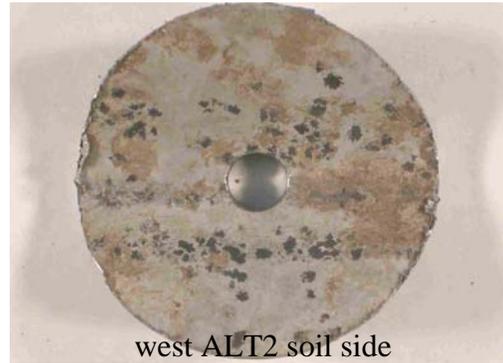
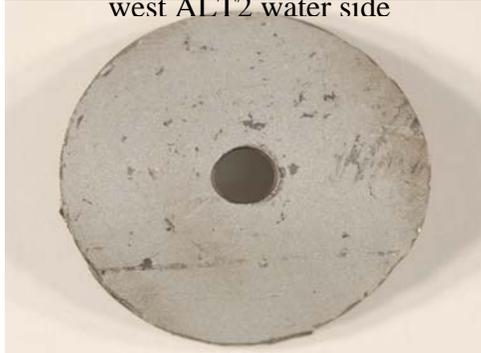
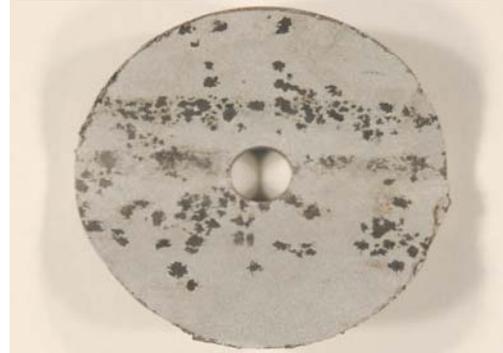
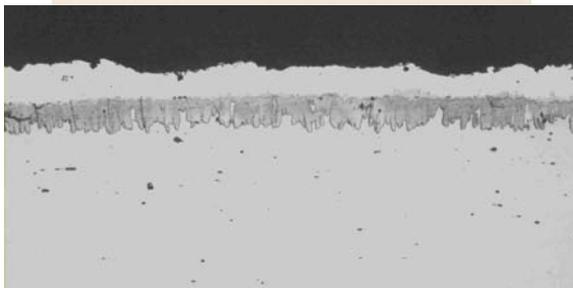
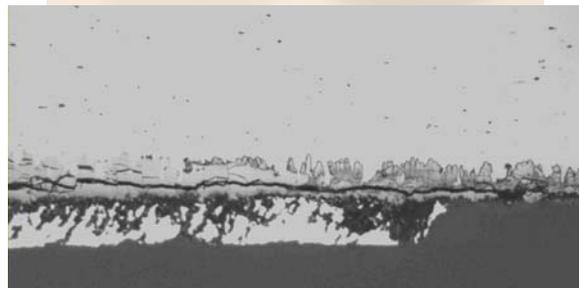
west ALT2 water side

Site 14 West ALT2 Trepan Evaluation: The top images are the coupon as removed after rinsing off loose dirt and debris. The coupon was then bead blasted to remove loose oxides and the lower images were recorded. Lite pitting is present scattered on the top and bottom surfaces. Micrometer readings were taken after bead blasting using a ball micrometer (general thickness) and a point micrometer (deepest pit depth). Starting thickness: 0.110".
Micrometer results: Ball: 0.107", 0.108", 0.108", 0.109" Point: 0.105" (0.005")
Based on conservative pit penetration extrapolations, the service life of 16 gage T2 CSP will exceed 100 years.

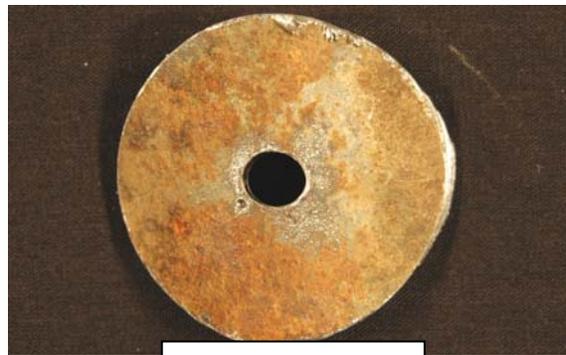
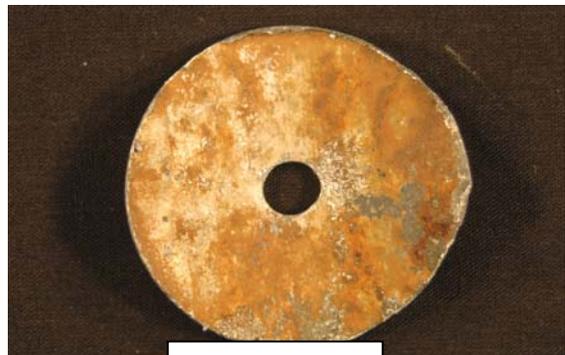
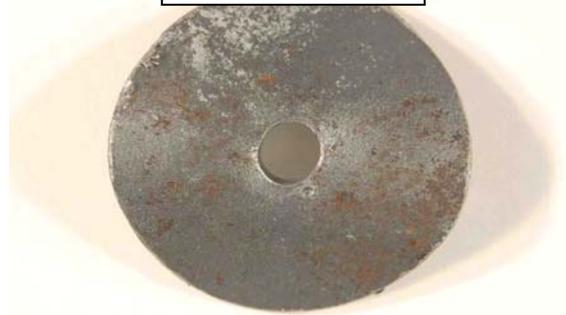
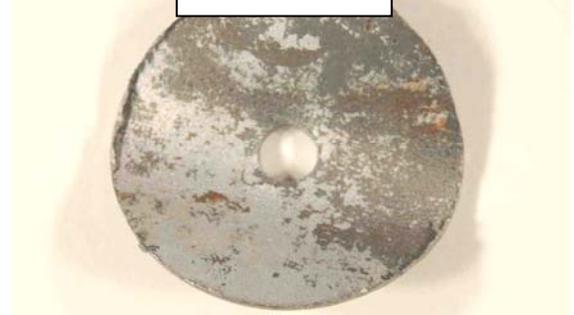
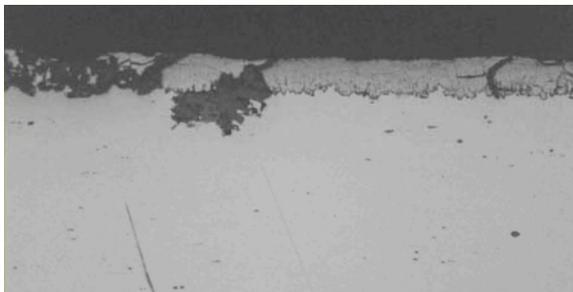
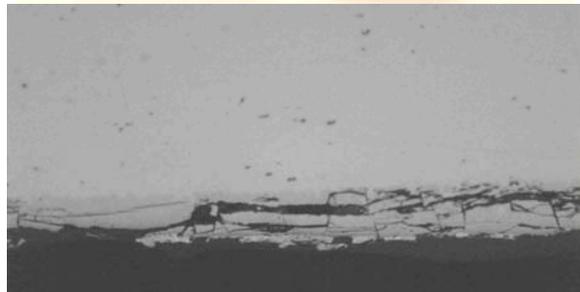
Images of ALT2 trepan from San Juan Co. Site 15:

Site 15 ALT2 Trepan Evaluation: The top images are the coupon as removed after rinsing off loose dirt, debris and moss. The coupon was then bead blasted to remove loose oxides and the lower images were recorded. Light to moderate pitting is present on the upstream corrugation of the water side.

Based on conservative pit-penetration extrapolations, the service life of 16 gage material would be in excess of 100 years.

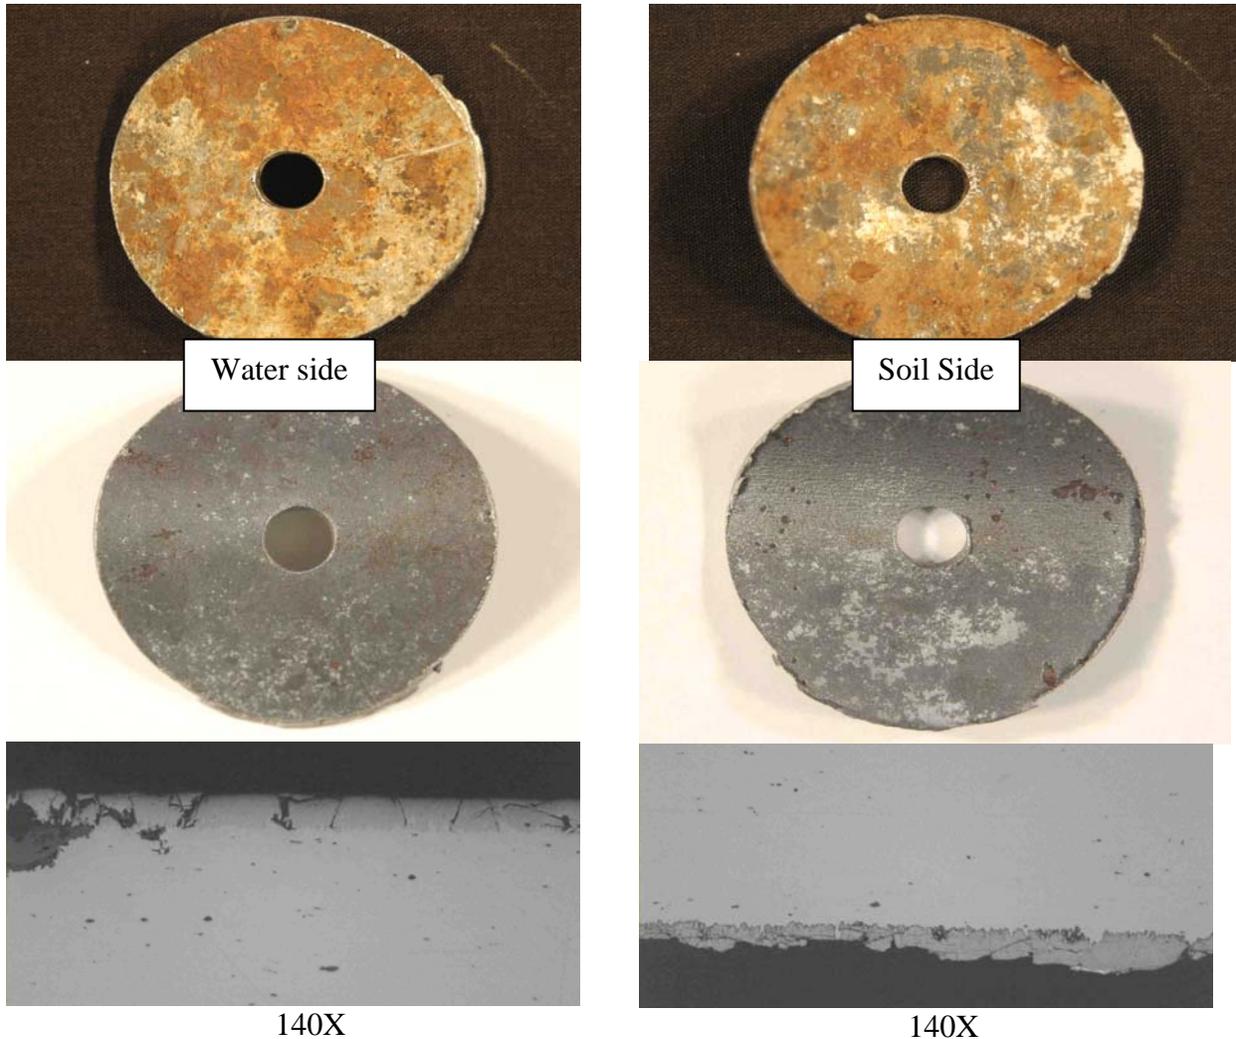
Images of ALT2 trepan from 16:

Site 16 ALT2 Trepan Evaluation: The top images are of the coupon removed from the 6 o'clock position in the pipe after rinsing off loose dirt, debris and moss. The coupon was then bead blasted to remove loose oxides and the lower images were recorded. Light pitting is present on the soil side, but the water side is smooth. Removal of the red rust revealed that the smooth iron-aluminide alloy layer was intact.

Based on conservative pit penetration extrapolations, the service life of 16 gage ALT2 material would be in excess of 100 years.

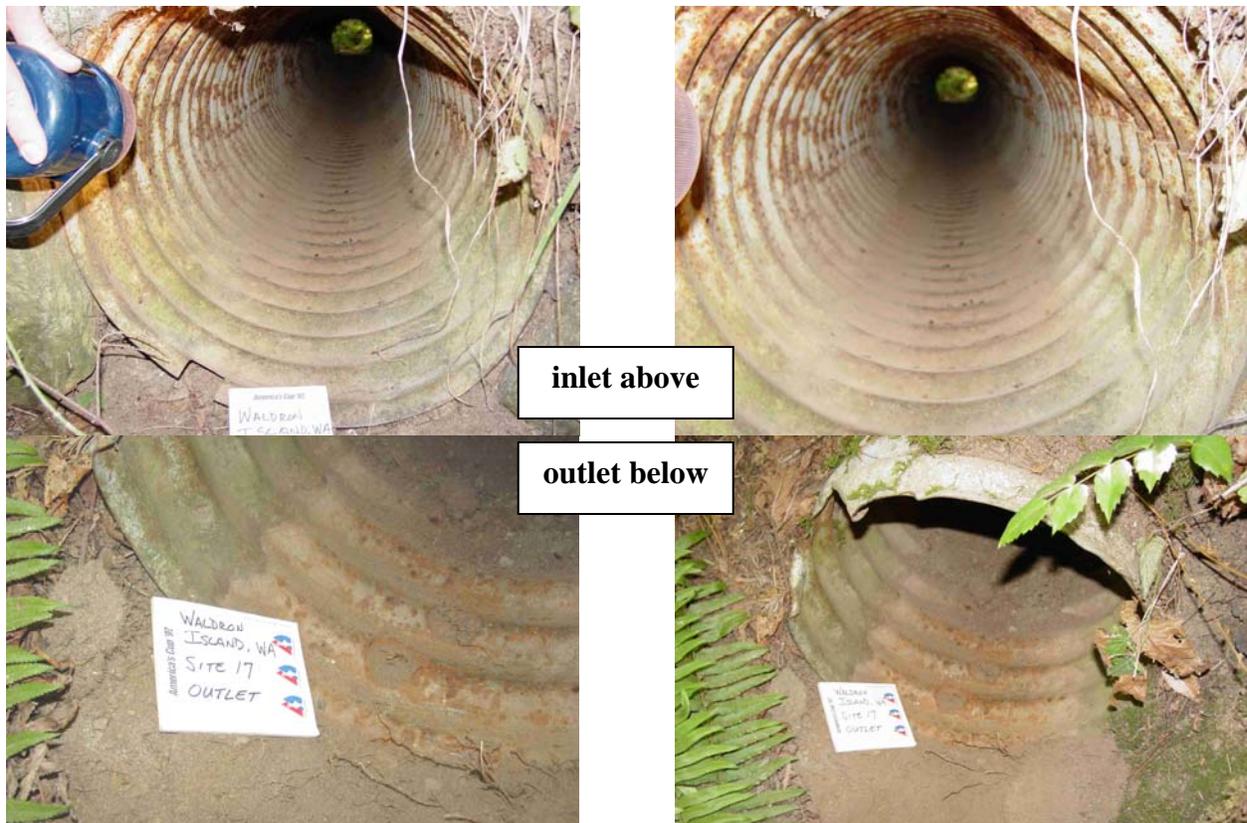
Images from San Juan County Site 17:

Observations: The remnant of aluminized coating was obscured by moss and oxide similar to other Waldron Island sites. No ovality was noted.

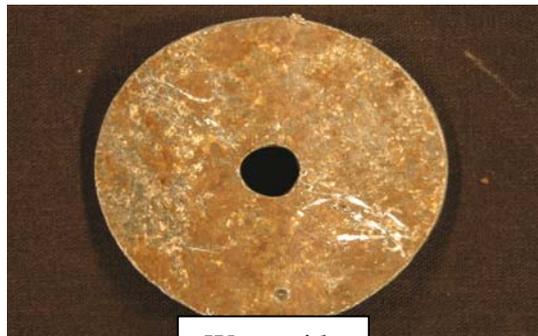
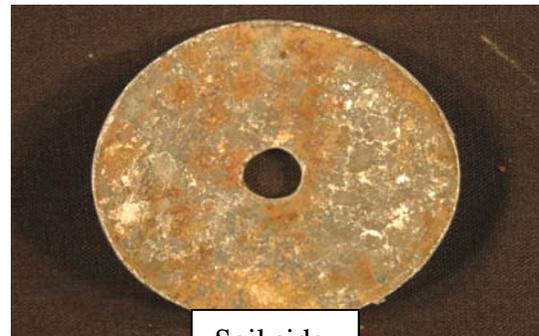
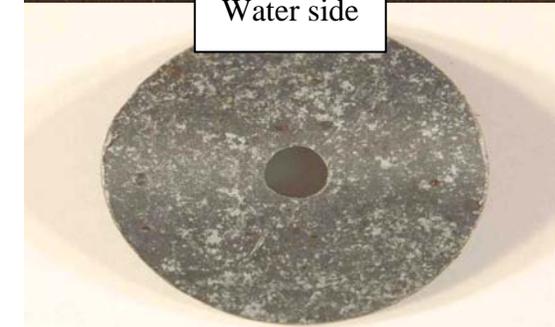
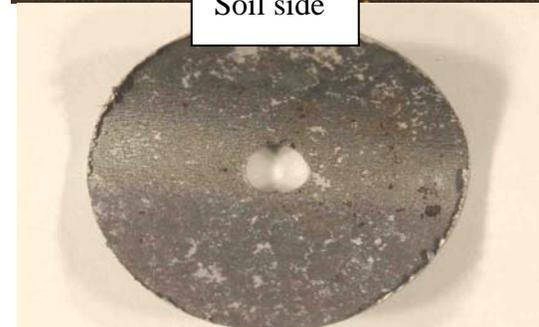
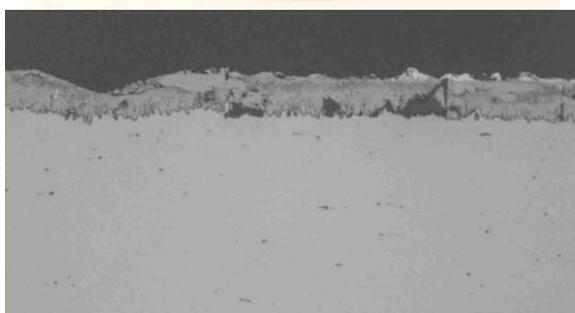
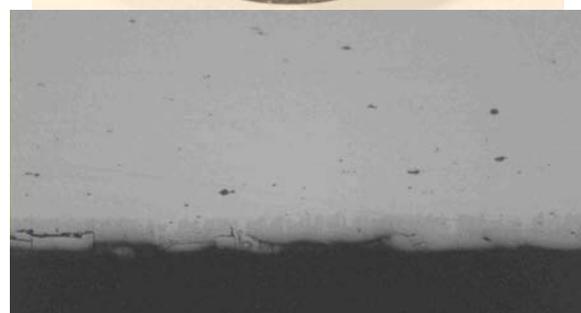
Images of ALT2 trepan from site 17 inlet:

Site 17 Inlet ALT2 Trepan Evaluation: The top images are of the coupon removed from 6 o'clock position on the pipe after rinsing off loose dirt, debris and moss. The coupon was then bead blasted to remove loose oxides and the lower images were recorded. Almost no pitting is present on the top or bottom surfaces. Removal of the red rust revealed that some of the free aluminum component of the Type 2 coating was intact.

Based on conservative pit penetration extrapolations, the service life of 16 gage ALT2 material would be in excess of 100 years.

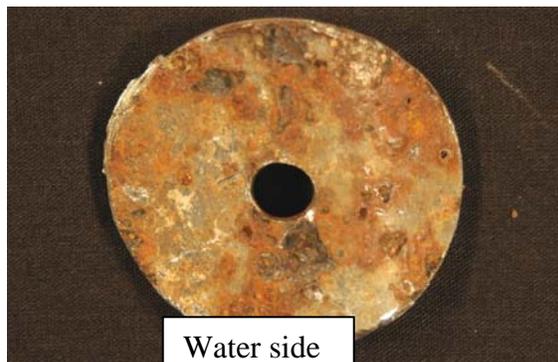
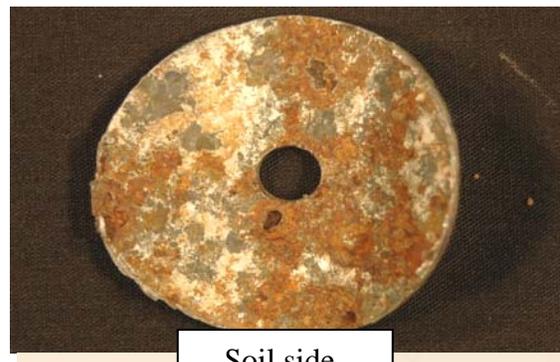
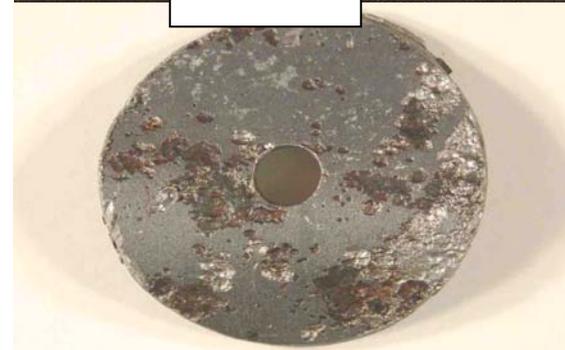
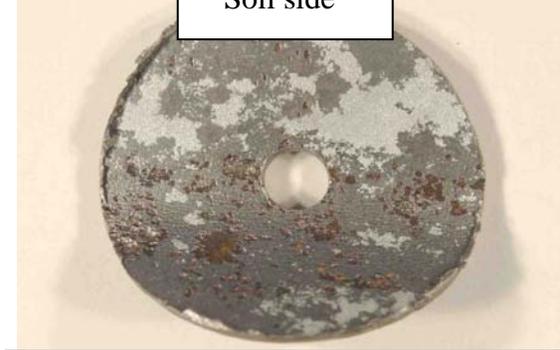
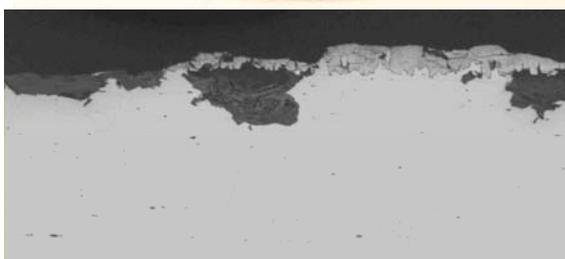
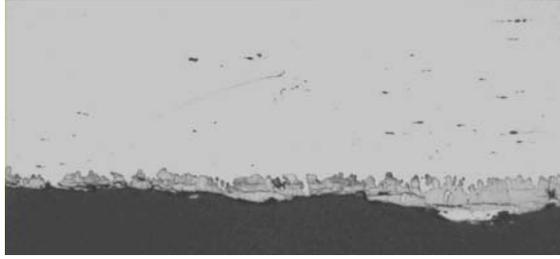
Images of ALT2 trepan from site 17 outlet:

Site 17 Outlet ALT2 Trepan Evaluation: The top images are of the coupon removed from 6 o'clock position on the pipe after rinsing off loose dirt, debris and moss. The coupon was then bead blasted to remove loose oxides and the lower images were recorded. Moderate pitting is present on the water and soil sides. Removal of the red rust revealed that portions of the alloyed iron-aluminide component of the Type 2 coating remained. The soil side still had patches of free aluminum coating remaining.

Based on conservative pit penetration extrapolations, the service life of 16 gage ALT2 material would be in excess of 100 years.

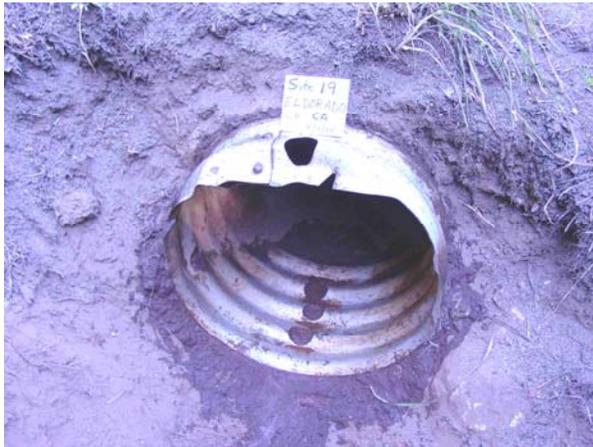
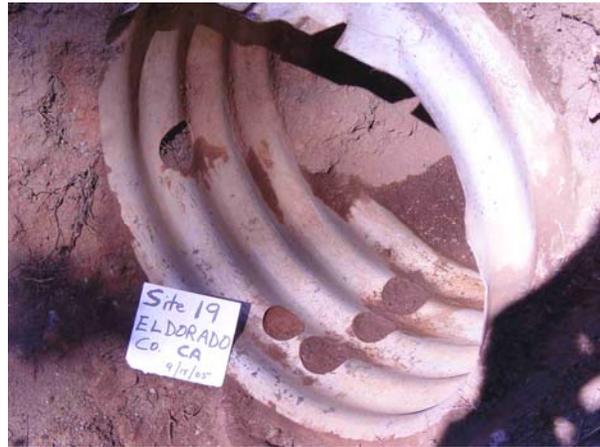
Images from El Dorado County Site 19:

Description: 18” dia. ALT2 on the inlet end. The galvanized outlet was not accessible. Currently dry, no recent rainfall. Pipe is silted to approximately 1/2 full. It has a low overburden and some ovality is evident in the middle of the road. The aluminized end is in good condition. The pipe end is only 2 feet from the edge of the pavement. Not much nearby vegetation.

Observations: ALT2 is in very good condition. Previous hole saw cuts are intact with no appreciable ‘creep’.

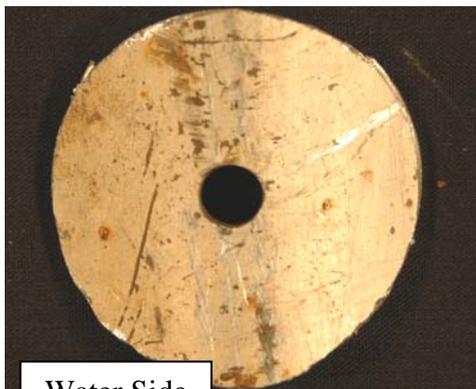
Images of ALT2 trepan from El Dorado Co. Site 19:

Based on conservative pit-penetration extrapolations, the service life of 16 gage material would be in excess of 100 years.

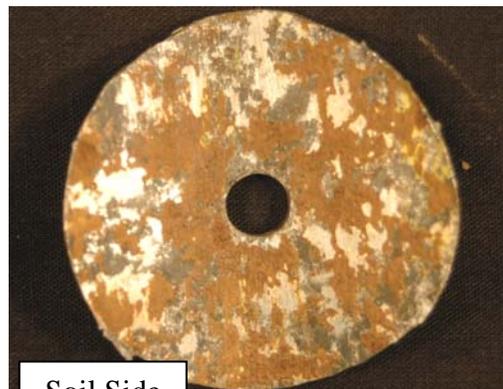
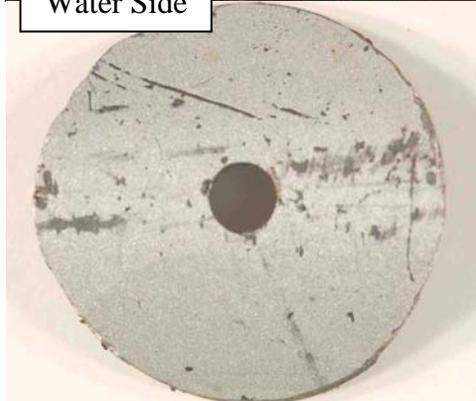
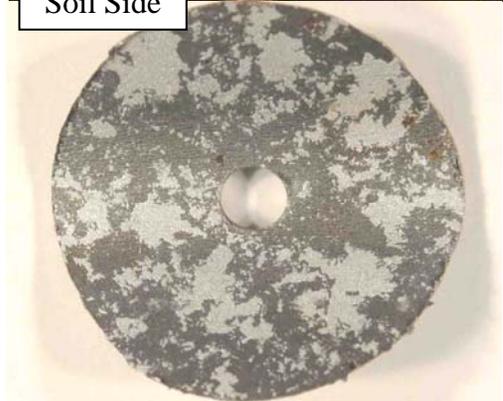
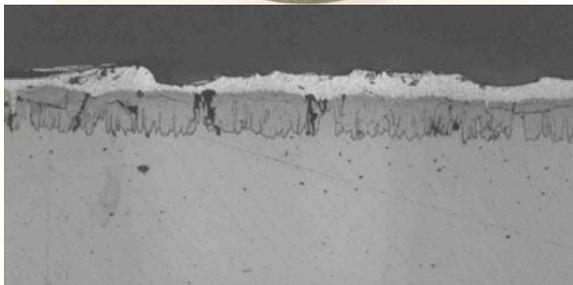
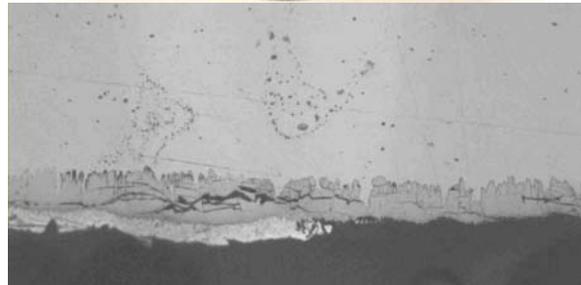
Site 19 ALT2 Trepan Evaluation: The top images are the coupon as removed after rinsing off loose dirt, debris. The coupon was then bead blasted to remove loose oxides and the lower images were recorded. Water side is smooth. Some minimal pitting is present on the soil side. The iron-aluminide alloy layer still remains on most of the soil side.

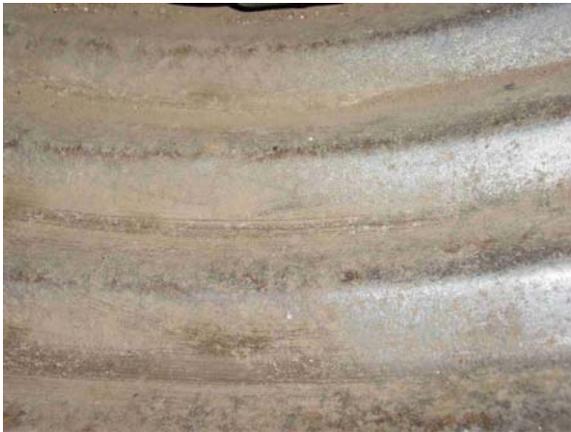
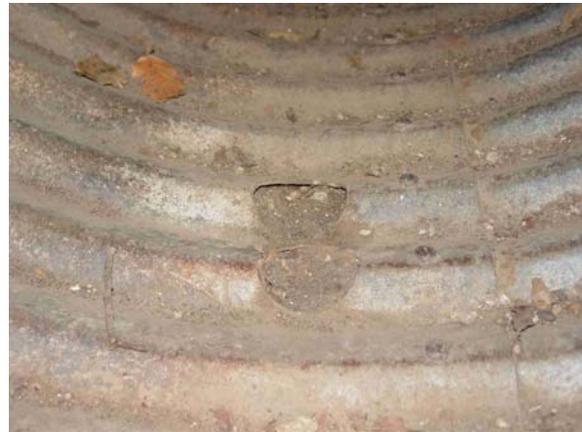
Images from San Benito County Site 20:

Description: 30” dia. 14 gage ALT2 pipe with a 20 foot galvanized extension added in 1968. The galvanized extension had no remaining zinc from the 5 to 7 o’clock positions. The pipe is currently dry. A lot of leaf decay is present in the pipe. Overall good condition – no ovality. The original galvanized end was cantilevered out the west side and perforated. It not sampled due to the steep landscape.

Observations: The aluminized coating was still present on the water side with patches of oxide on the crests. No ovality was noted.

previous holes

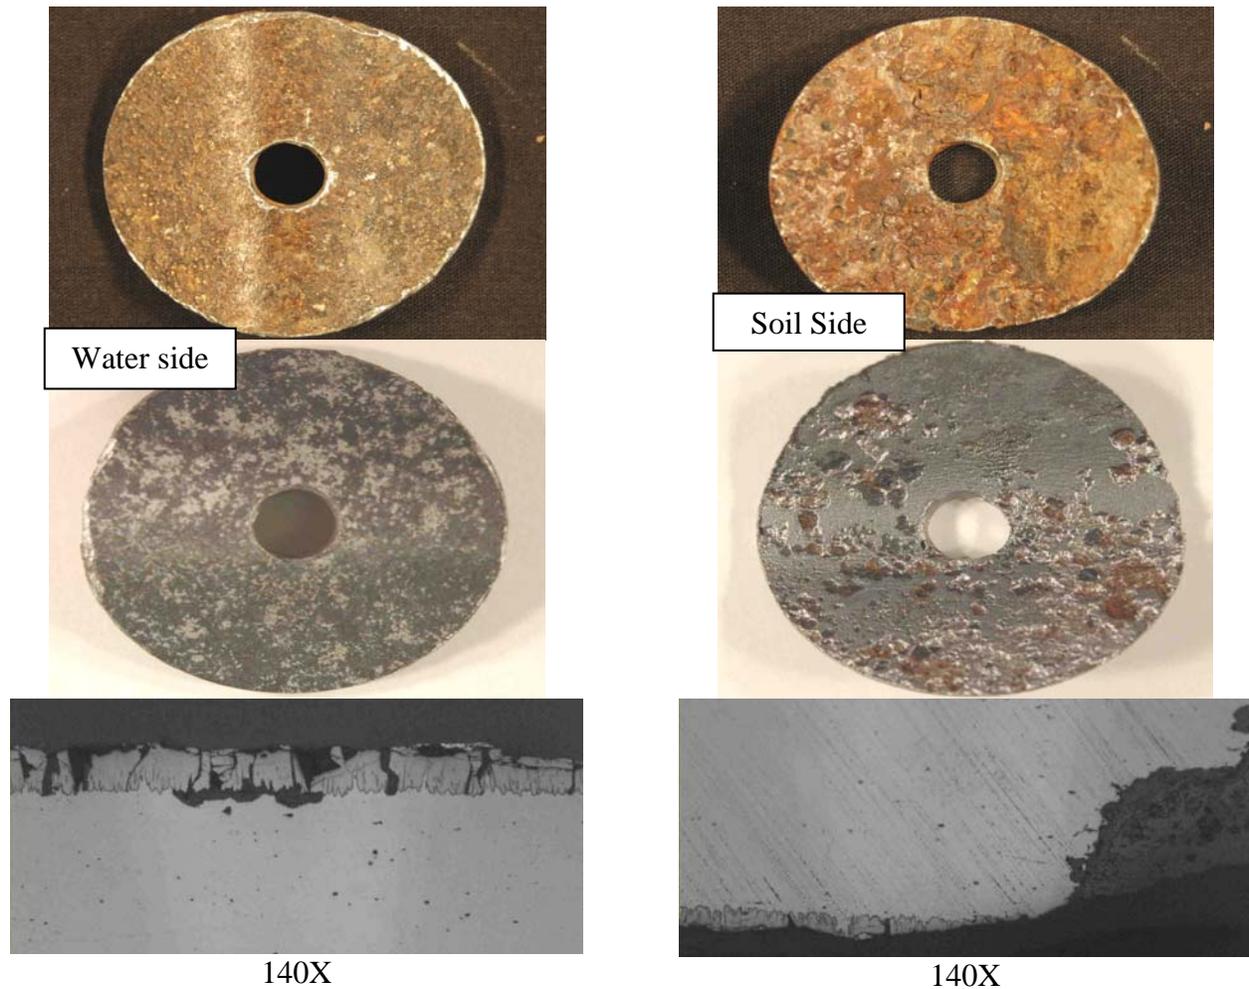
Images of ALT2 trepan from 20 San Benito Co.:

Site 20 San Benito Co. ALT2 Trepan Evaluation: The top images are of the coupon removed from the 6 o'clock position in the pipe after rinsing off loose dirt, debris and moss. The coupon was then bead blasted to remove loose oxides and the lower images were recorded. Moderate to heavy pitting is present on the soil side, but the water side is smooth. Removal of the red rust revealed very little coating was intact on the soil side.

Based on conservative pit penetration extrapolations, the service life of 16 gage ALT2 material would remain 75 years. The low resistivity and high chloride content of the soil collected near the pipe entrance was much more reactive than the soil measurements taken at the 42 year time frame. This may be an indicator of some change in the upstream landscape.

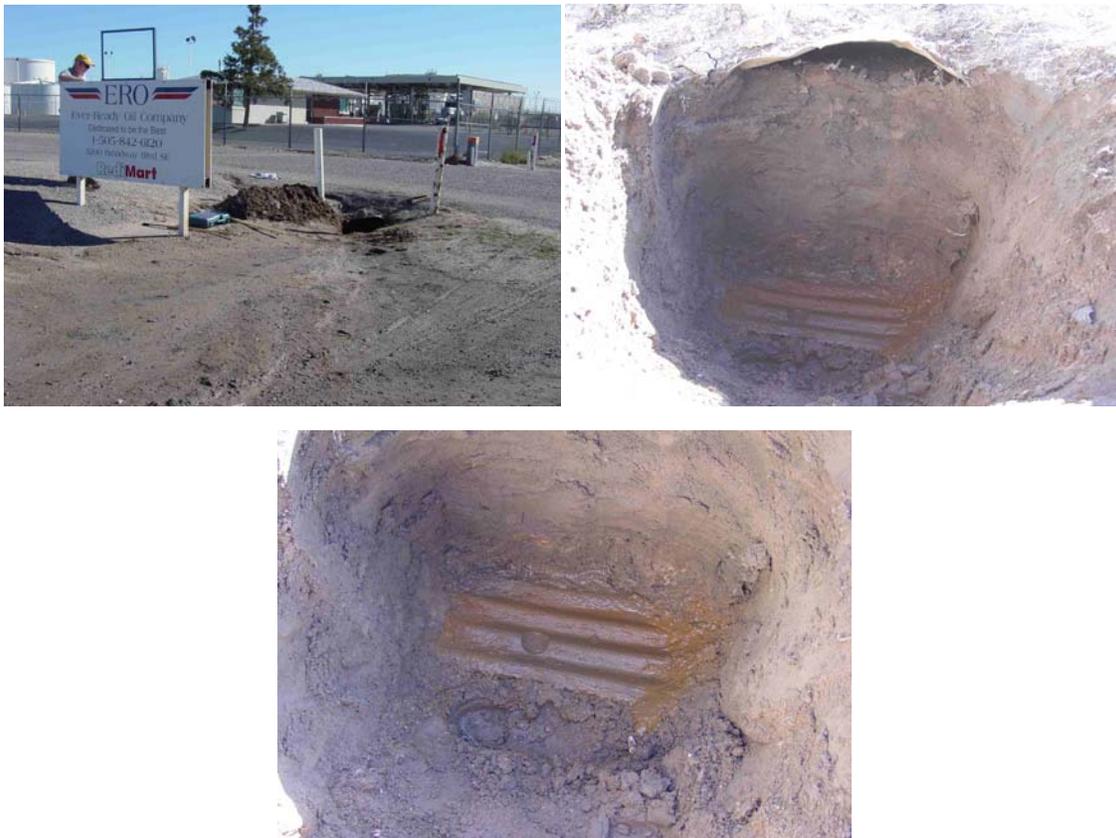
Images from Bernalillo County Site:

Description: 30” dia. 14gage ALT2 that is silted to within 4” of the top of the pipe. Excavation revealed pipe in good condition. Estimate 7 days since previous rainfall per K. Fetter.

Observations: Pipe appeared in fair condition; however no coating was visible at the 6 o’clock position. In case of a significant rain event, this pipe is too full of silt to be effective.

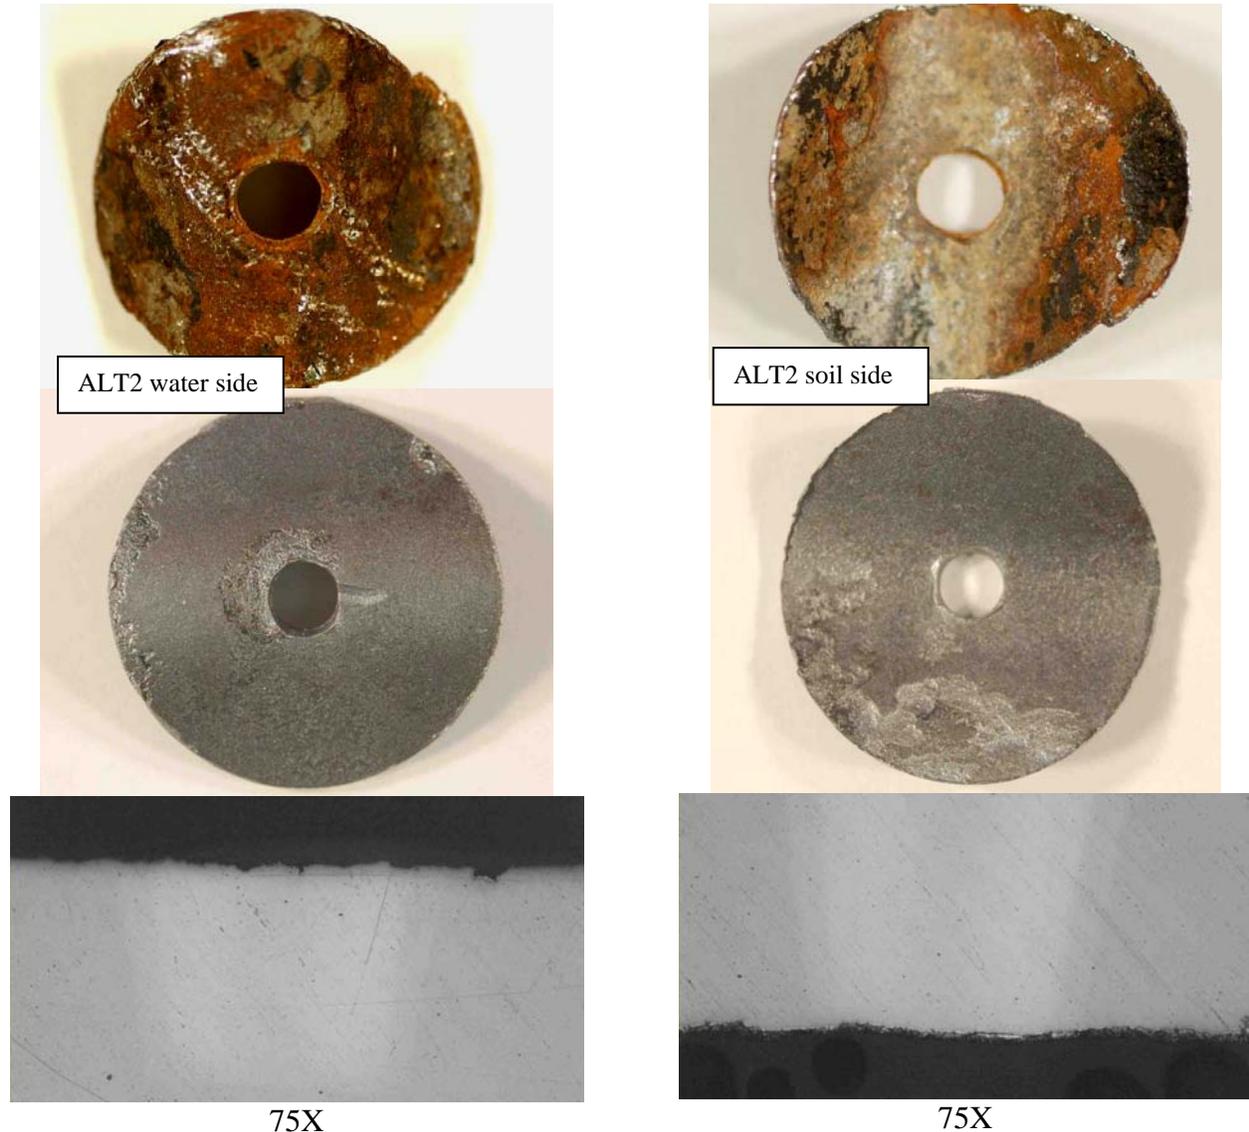
Images of trepan from Site 21:

Trepan Evaluation: The coupon was washed and photographed as received (top 2 images) then bead blasted to remove loose oxides and the bottom images were recorded.

Based on conservative pit penetration extrapolations, the service life of this pipe may be in excess of 75 years, however this CSP is too full of silt and sand to be an effective culvert.

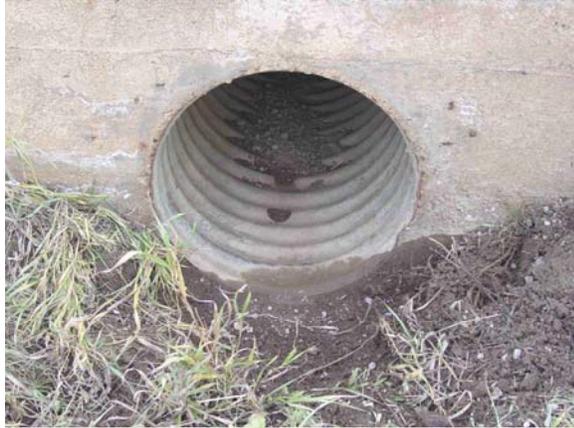
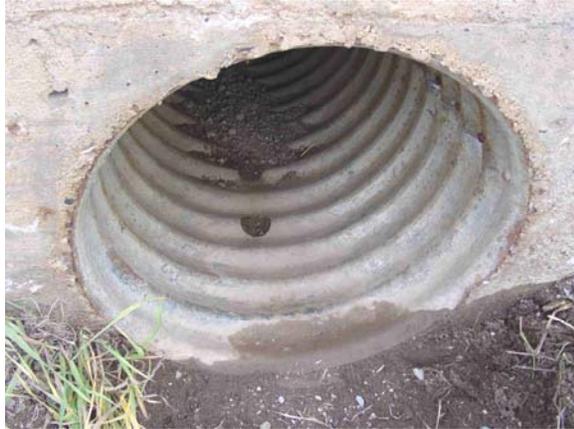
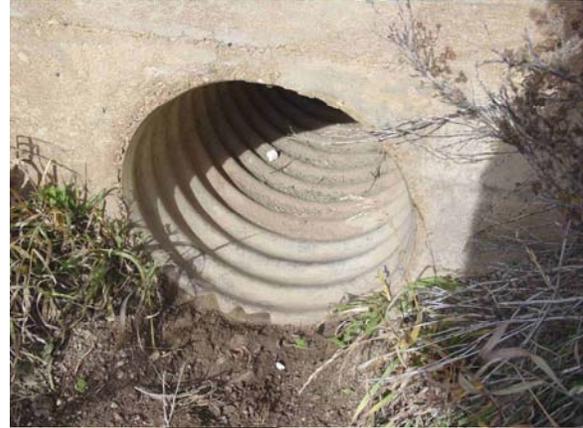
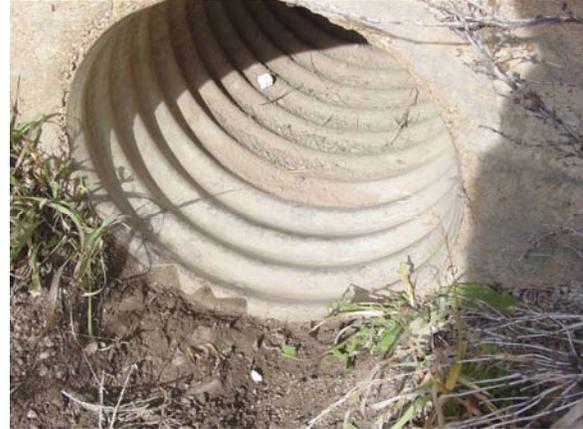
Images from Fairplay Colorado Site:

Description: 24” dia. ALT2 in very good condition on both ends with concrete headwalls.

Observations: Free aluminum coating is visible around the complete circumference. Previous trepan holes were not corroded further. Sample taken at 6:00 position.

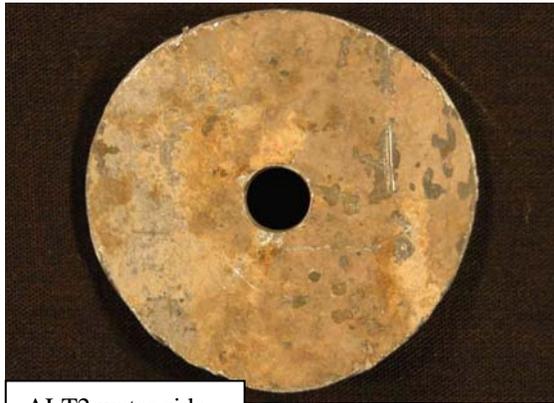
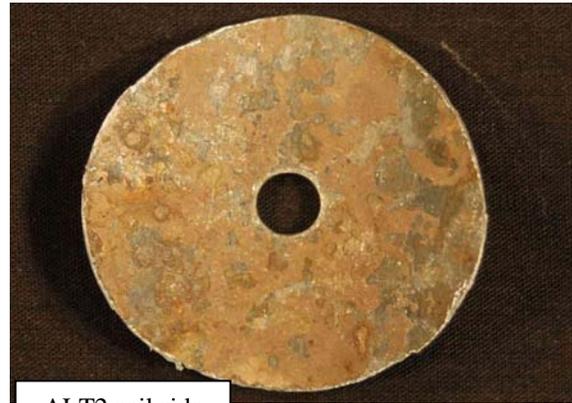
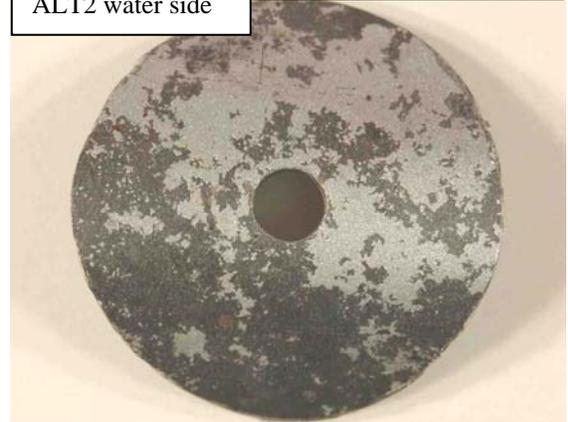
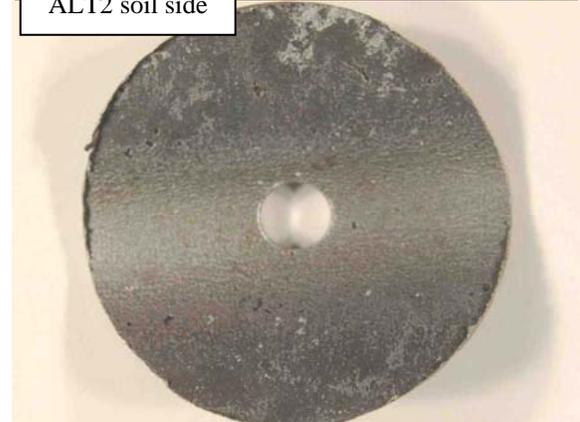
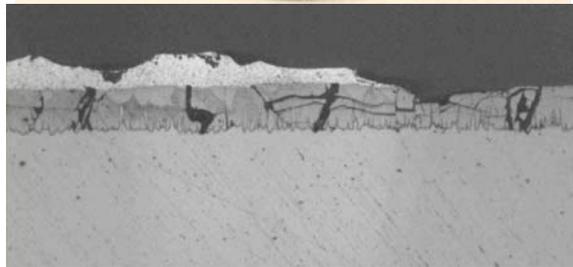
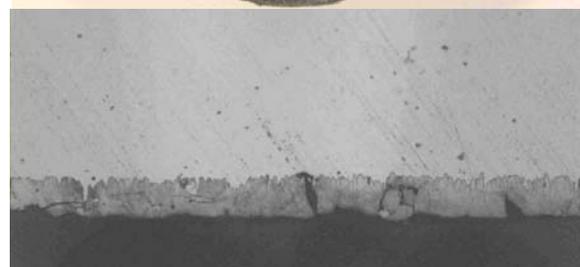
Images of trepan from Site 22:

Trepan Evaluation: The coupon was washed and photographed as received (top 2 images) then bead blasted to remove loose oxides and the bottom images were recorded.

Micrometer Results Ball: 0.065”, 0.065”, 0.064” Point: 0.059” (0.007” deep – few small pits)
Based on conservative pit penetration extrapolations, the service life of this pipe would be in excess of 100 years.
