National
Corrugated Steel Pipe
Association

Condition Survey of Corrugated Steel Pipe Detention Systems

An Interim Report
March, 1999

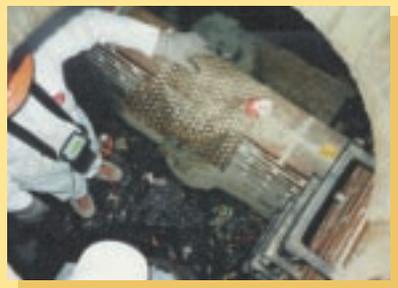
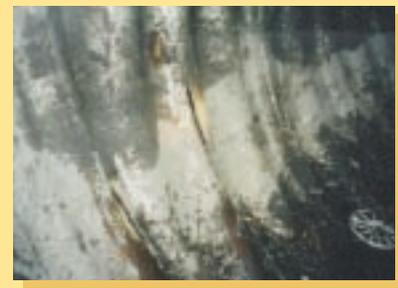
Top90/95
 Sides90/95
 Invert75
Avg. Rating.....86.7

Comments:
 36" saw-cuts in every
 corrugation to promote
 infiltration;
 stone backfill.

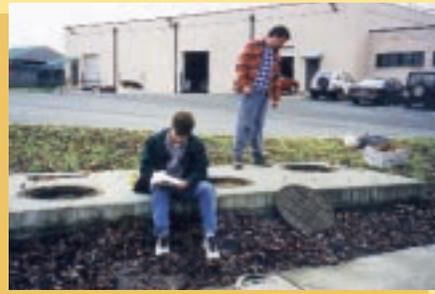
Top100
 Sides100
 Invert90
Avg. Rating.....96.7

Oil grit separator at entrance.

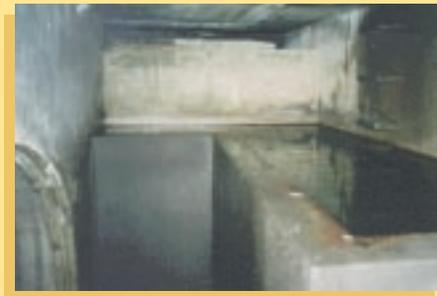
Top	95
Sides	95
Invert	85
Avg. Rating.....	91.2

Oil grit separator at
entrance;
minor soil trough joints;
no sign of gaskets with
joints.

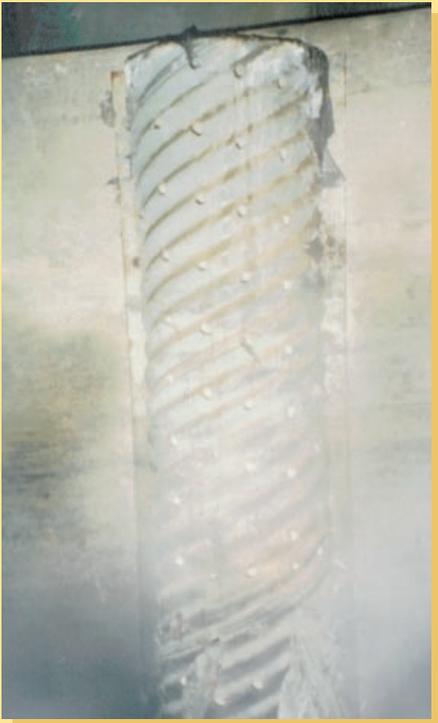
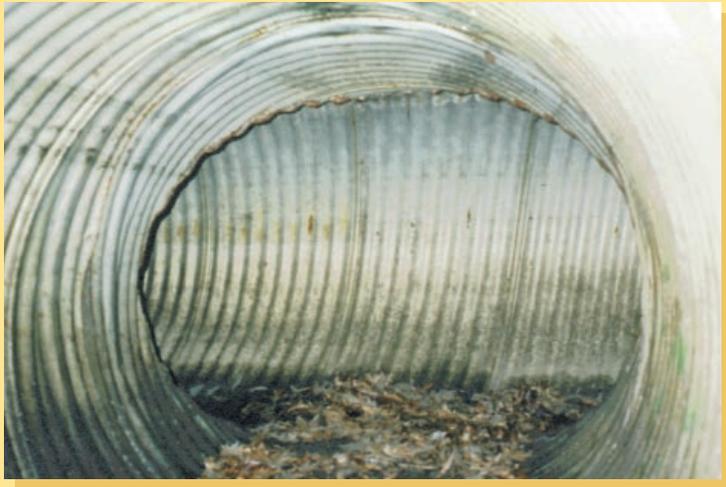
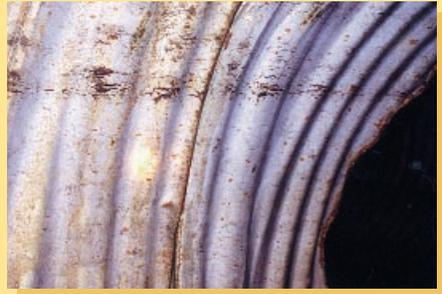
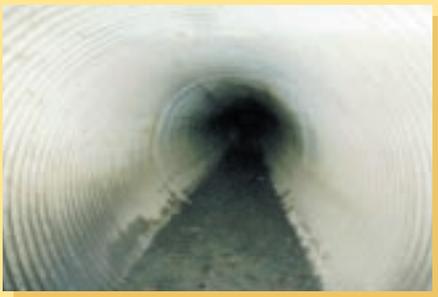
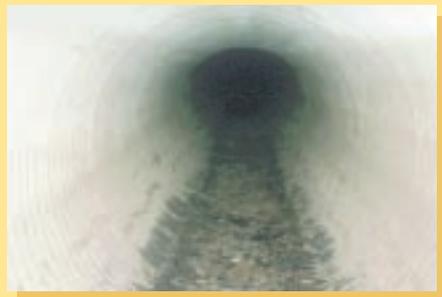
Top90
 Sides90/100
 Invert80/85
Avg. Rating.....88.3

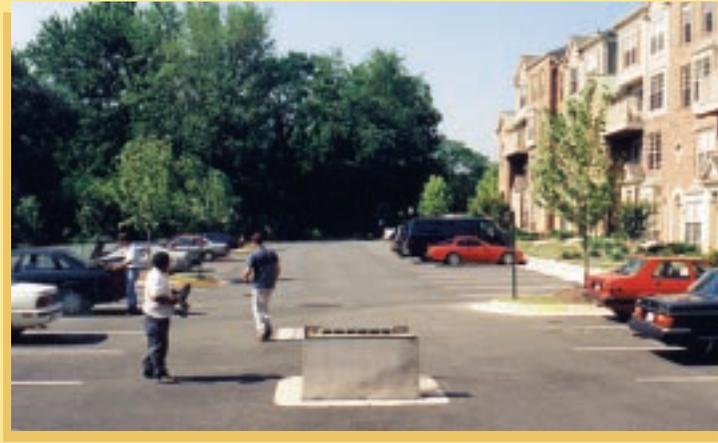
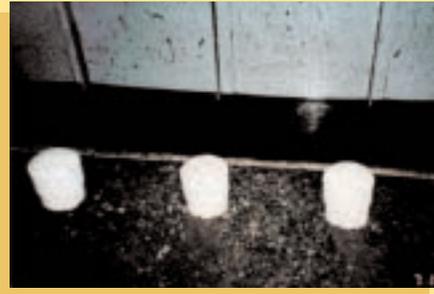
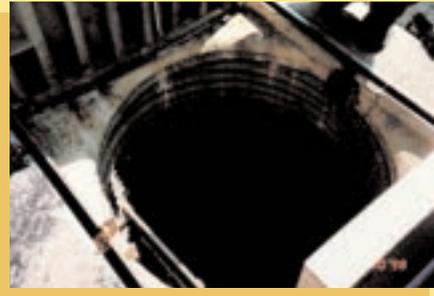
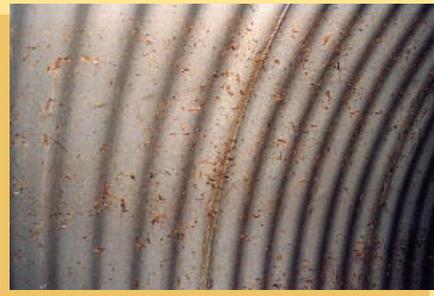
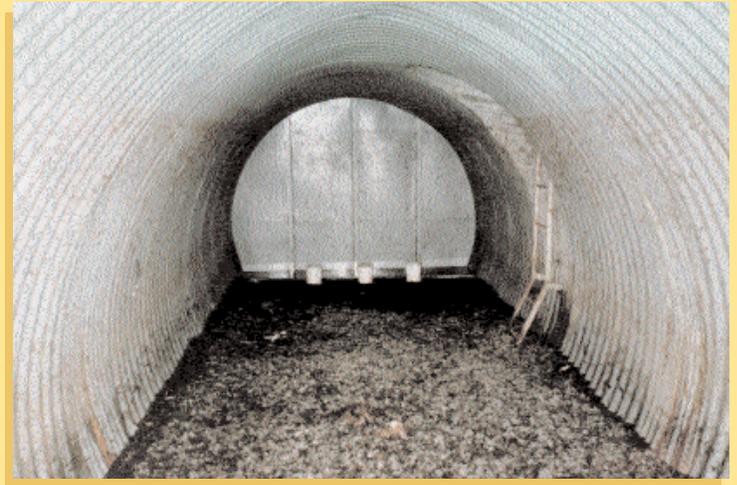
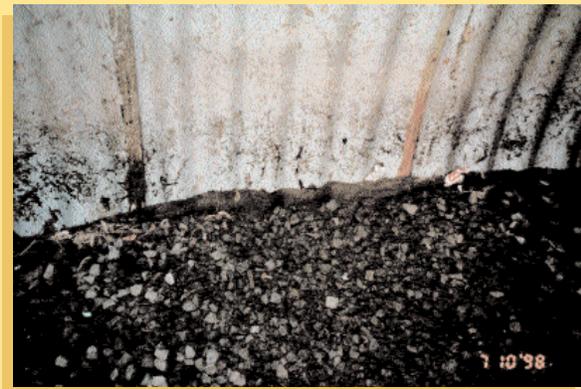
Top	100
Sides	100
Invert	N/A
Avg. Rating.....	100

Well drained;

no signs of sediment
 clogging.

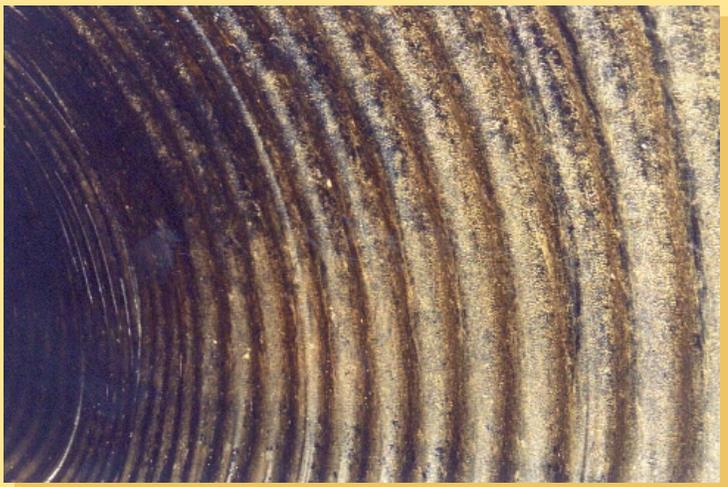
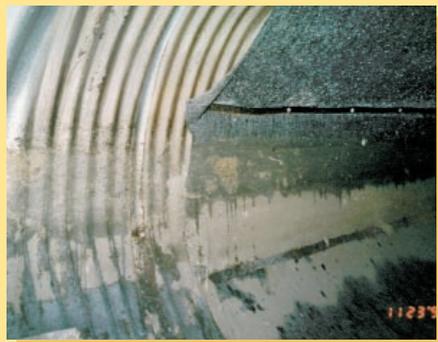
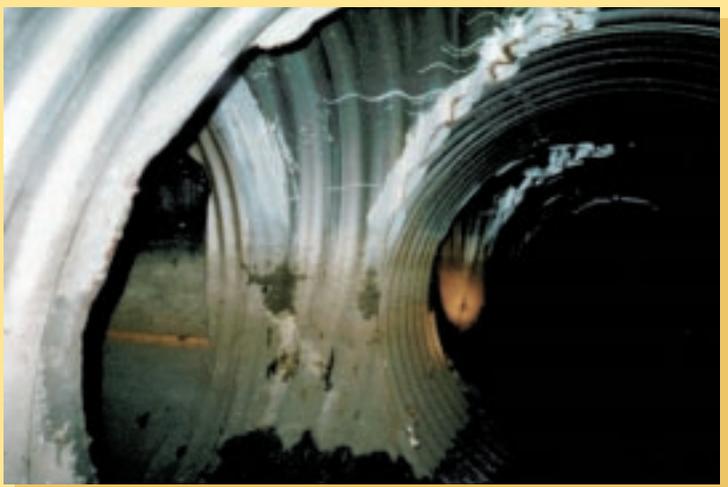
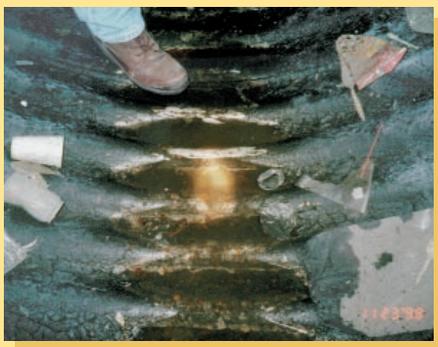
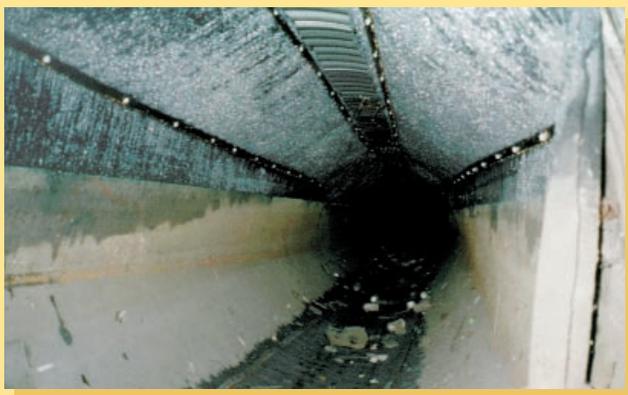
Top95/100
 Sides95/100
 Invert95
Avg. Rating.....96.7

Oil grit separator at entrance.
Non-woven geotextile inside pipe to minimize clogging of backfill stone.

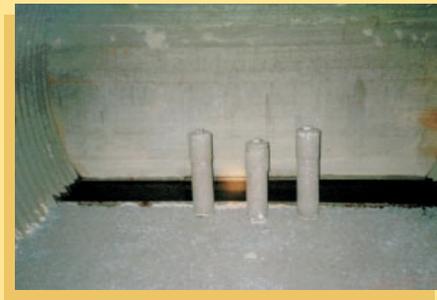
Top95/100
 Sides95/100
 InvertN/A
Avg. Rating.....97.5

Little to no debris;
 no signs of clogging;
 return valve open.

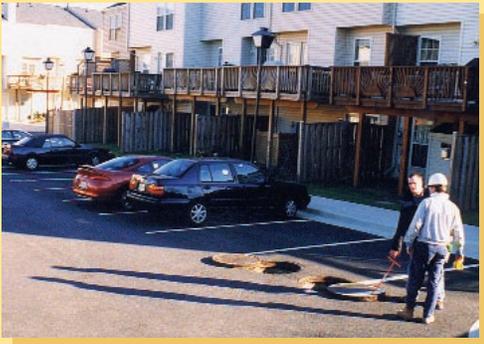
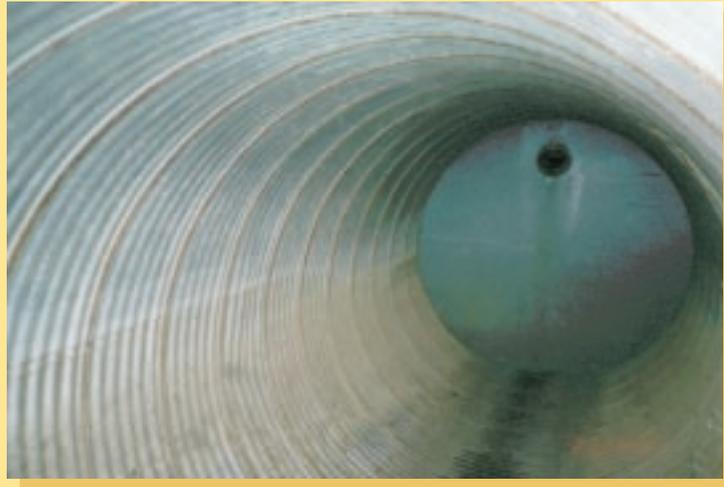
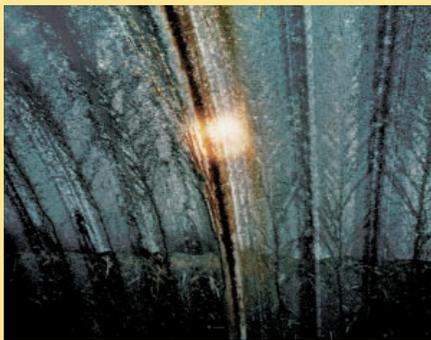
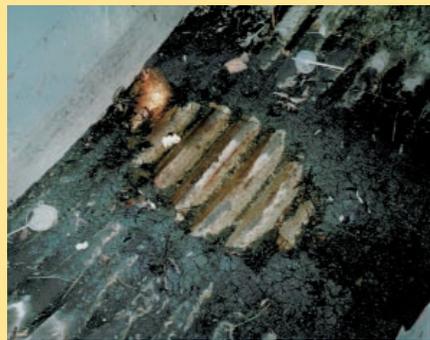
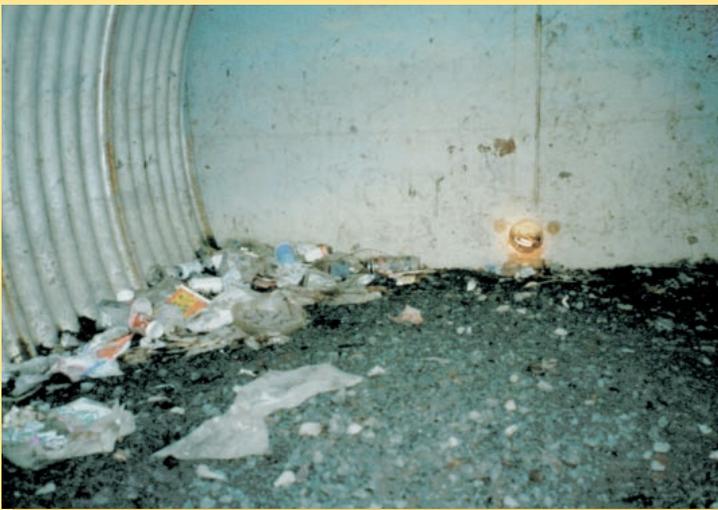
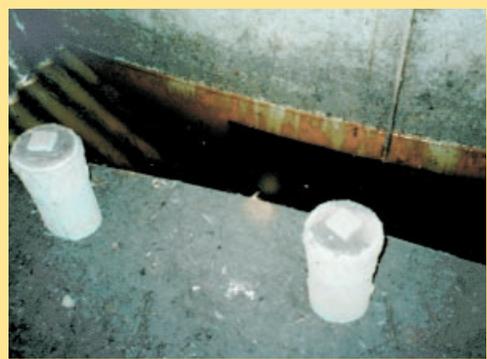
<p>Condition Rating</p>	<p>Age: 5 years Coating Type: Galvanized Diameter: 144" Corrugation: 1x5" Helical Land Use: Residential Location: Alexandria, Virginia</p>	<p>Comments: <u>Detention system with</u> <u>sand filter.</u> <hr/> <hr/> <hr/></p>
<p>Top95 Sides95 Invert95 Avg. Rating95</p>
