1
2 Title:
3 Steel Buried Structures: Condition of Ontario Structures and Review of Deterioration Mechanisms and
4 Rehabilitation Approaches

20 Buried steel structures, commonly referred to as buried bridges, culverts, or soil-steel structures are a
21 valuable bridge crossing solution. Owners manage their bridge assets by evaluating their condition and
22 rehabilitating as required. Ontario's resources for managing and rehabilitating buried steel bridge
23 structures are limited, and an investigation into the maintenance and rehabilitation practice of Ontario's
24 assets demonstrates a lag in their maintenance and rehabilitation. Knowledge regarding rehabilitation of
25 these structures is dispersed and unconcise, leaving owners challenged to understanding how to best
26 manage and rehabilitate their assets. This paper investigates the age, condition, and rehabilitation of steel
27 buried bridges in Ontario and reviews the commonly encountered deterioration and distress mechanisms
28 along with the state-of-the-art rehabilitation practices. With an understanding of structural behavior,

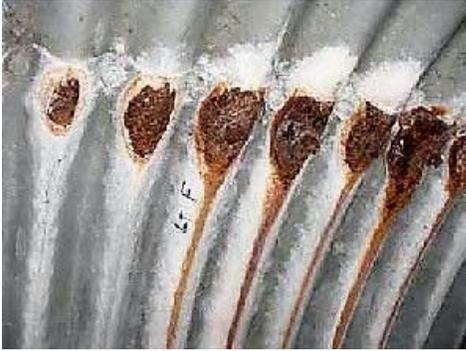
<p data-bbox="256 842 630 877">Concentrated Bolt Corrosion*^{2.1}</p>	<p data-bbox="711 380 1414 751">Concentrated Bolt Corrosion - rust and salt deposits are forming around the bolts and seeping down the crests. As these deposits are above the waterline, a highly corrosive soil environment is likely driving the loss of conduit wall thickness from the soil-side. Salts are likely present from de-icing salt being distributed on the road surface above. Salts feature aggressive ions which also increase the rate of corrosion. As the joint leaks, rust and salt stains run down the crests and rust deposits concentrate on the outside surface of the bolts.</p>

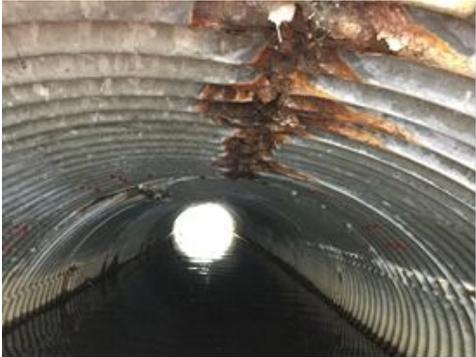
<p data-bbox="272 1367 613 1402">Joint and Seam Corrosion*^{2.2}</p>	<p data-bbox="711 1066 1398 1451">Joint and Seam Corrosion - corrosion occurs due to external factors above the waterline as salt and rust deposits form at joints and seams. The affected section of pipe is located under a soft shoulder and the side slopes of the embankment. The parts under the pavement were not exposed to the salts.</p>

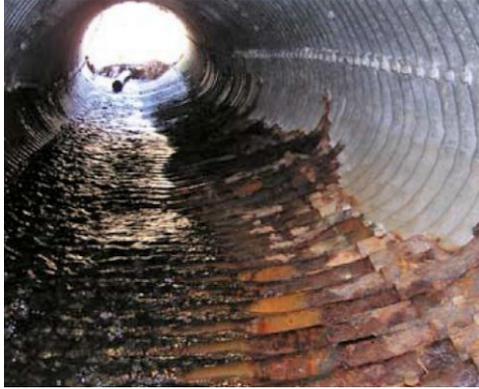
Invert Corrosion*2.3

Invert Corrosion - non-uniform deposits of rust are present within and around the water environment, below the springline, and concentrated between the haunches and invert. Moderate perforations on the crests around the waterline level are also visible. The development of perforations near and at the waterline suggest a corrosive water environment. At the waterline, the oxygen differential from water to air further promotes the site of the reduction reaction.

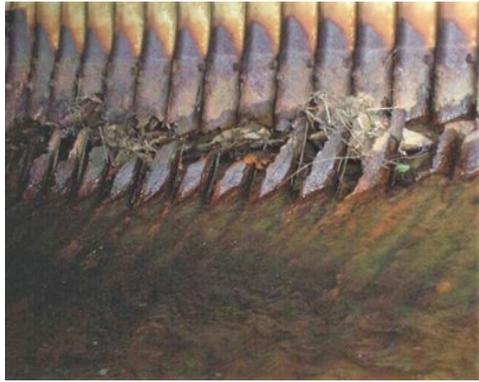
Corrosion Section Loss*2.4

Section Loss - advanced stages of loss of wall thickness resulting in complete section loss around the haunches of the structure. The development of perforations at the tops and upstream side of the crests suggest some erosive water action. Dark, stained, wear zones suggest the galvanizing has worn away and steel is being exposed.

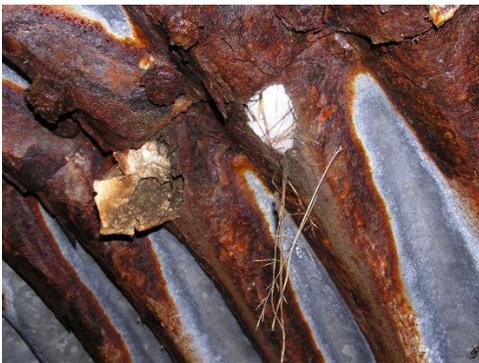
Corrosion Perforation*2.2

Corrosion Perforation - corrosive water damage is present and seems to be the leading cause of barrel wall deterioration. Evidence of the corrosive water environment include: 1) irregular patchy patterns of rust 2) rust primarily located in bolt holes 3) lack of signs and possibility of abrasion.

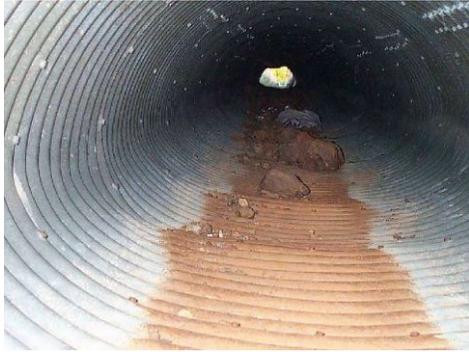
Abrasion & Corrosion^{*2.1}

Abrasion & Corrosion - abrasive bedload deposits from peak flow events are present in the conduit. As the bed load is concentrated to the invert and lower haunches of the pipe, the relative zinc coating is uniformly worn down by abrasion. Following the event, the exposed steel is readily oxidized when exposed to the atmosphere. As corrosion is uniformly concentrated to the area of the bedload, the loss of wall thickness is mainly driven by abrasion and accelerated by corrosion.

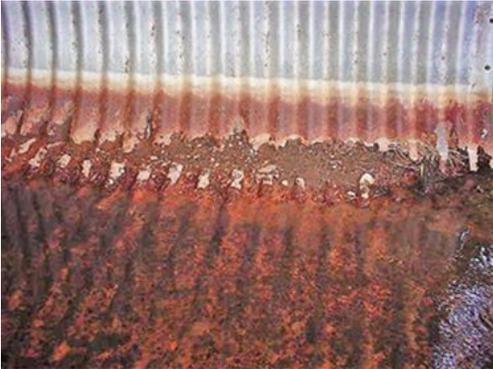
<p data-bbox="313 816 626 848">Loss of Haunch Section^{*3.1}</p>	<p data-bbox="764 394 1406 695">Loss of Haunch Section – the section loss facilitates erosive action by offering sites for infiltration as water can seep from the embankment into the conduit and piping as internal water pressure during peak storm events may force water to seep into the soil.</p>

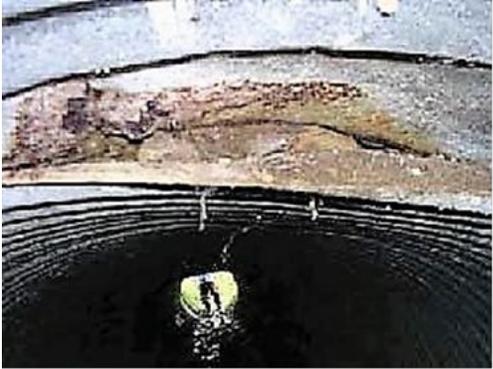
<p data-bbox="313 1257 626 1289">Crown Joint Separation^{*3.2}</p>	<p data-bbox="764 762 1406 1192">Crown Joint Separation – joint separation at the crown has occurred due to differential deformations along the crown. The separation allows for soil infiltration to occur as water can seep in from the embankment carrying soil particles with it. In buried steel bridges, the largest unbolted space is 500 mm which helps minimize joint separations.</p>

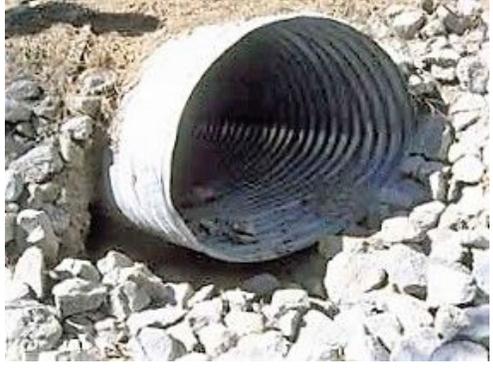
<p data-bbox="313 1707 626 1738">Piping Void at Outlet^{*3.3}</p>	<p data-bbox="764 1266 1406 1759">Piping Void at Outlet - a large void has formed around the haunch and invert of the buried CSP pipe arch. The development of the void may be due to either loose bedding material underneath the pipe or excess scouring at the outlet. Peak flow events can build high water pressures, which seepage flow underneath the pipe, if the capacity of the conduit is insufficient or if the conduit becomes obstructed.</p>

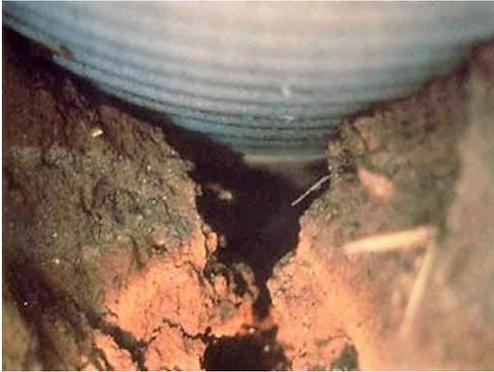
Small Piping Void*^{3.3}

Small Piping Void – a small piping void has developed along the invert of a pipe. Piping may occur along the length of the pipe until the flow exists the end wall of the embankment. Typically, preventative measures include proper compaction practices and seepage collars.

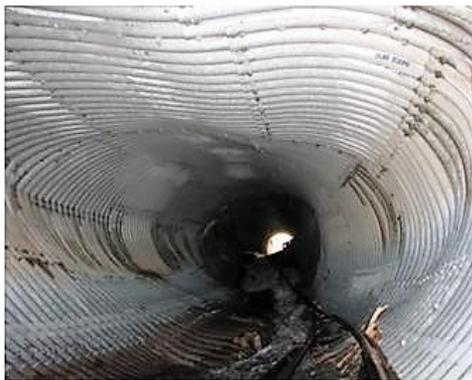
Continuous Barrel Misalignment*^{3.3}

Continuous Barrel Misalignment – large soil movements likely due to soil erosion have resulted in a continuous barrel misalignment. For steel buried bridges, joints are fastened with bolts and no circumferential seams exist to form differential movement between segments.

Consequently, the barrel has absorbed the movement in extreme shape distortions and misalignment.

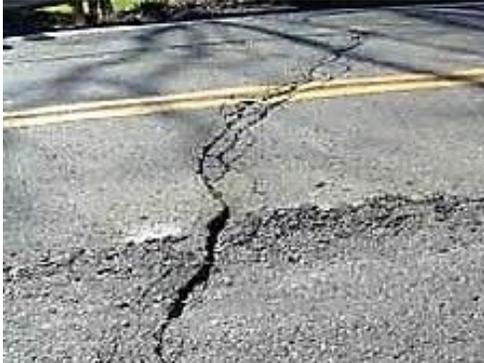
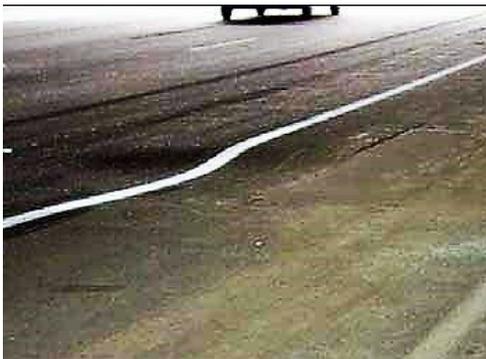
Transverse Surface crack & Surface Settlement - signs of inadequate support from soil due to either soil erosion or soil compaction issues during construction are present on the road surface over the buried soil structure. Soil erosion may extend to the surface through either infiltration or void collapse mechanisms. Signs of structural distress are seen as large surface depressions with flexible asphalt overtop and large transverse cracks with more brittle roadways. In some cases, soil erosion can leave the road surface unsupported with minimal signs of distress. With soil movements causing surface depressions, voids, and barrel settlements, joint separation and other points for infiltration are likely present.

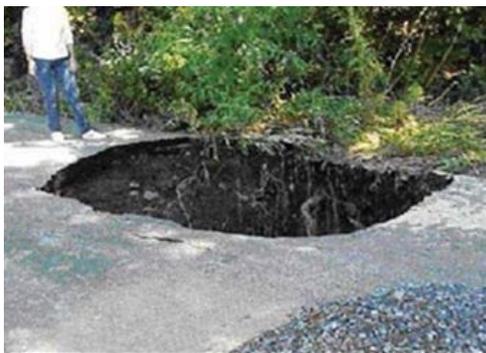
Surface Sink Hole^{*3.2}

Surface Sink Hole - soil erosion has developed to the point of road collapse. Soil infiltration has likely extended to the surface and as the void collapsed a sink hole was formed. The buried conduit beneath has likely collapsed or undergone large joint separations and barrel settlements.

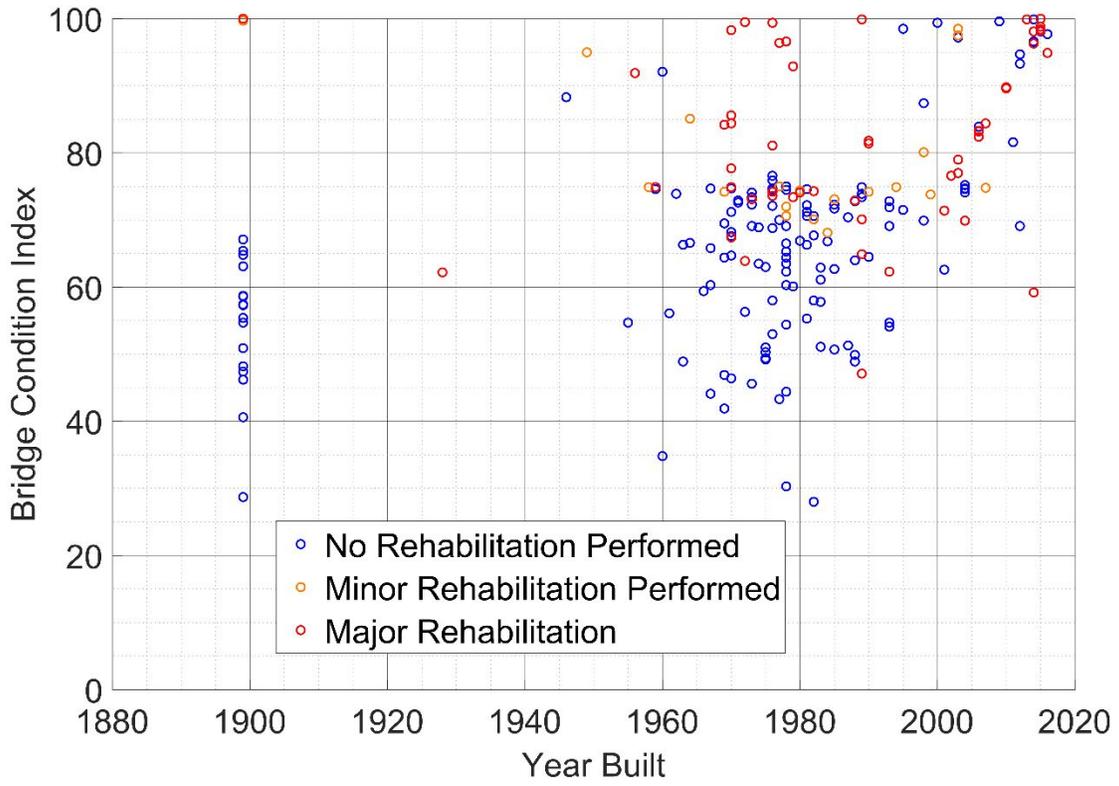
Figure 1. BCI and Age of Buried Steel Bridges in Ontario

93 Using Ontario's 2017 Bridge Condition Inventory (MTO 2018), the state of in-service steel
94 buried bridges in Ontario is examined by investigating the BCI, which is determined bi-annually, and the
95 age of these structures. The MTO services over 4800 bridges of which 280 bridges are steel buried
96 structures referred to as "Corrugated Steel Culverts". The BCI distribution of the 280 bridges in Ontario is
97 plotted against the year built in Figure 1 and out of these 280 structures, 204 have never been
98 rehabilitated, 21 have undergone minor rehabilitation, and 58 have undergone major rehabilitation. If the
99 structure has undergone rehabilitation, the year built is listed as the year of rehabilitation in some cases.
100 Further, if the age of the structure is unknown, the year built is recorded as 1899 (to represent that the age
101 is unknown and not that the structure is over 100 years old). The average BCI of "Corrugated Steel

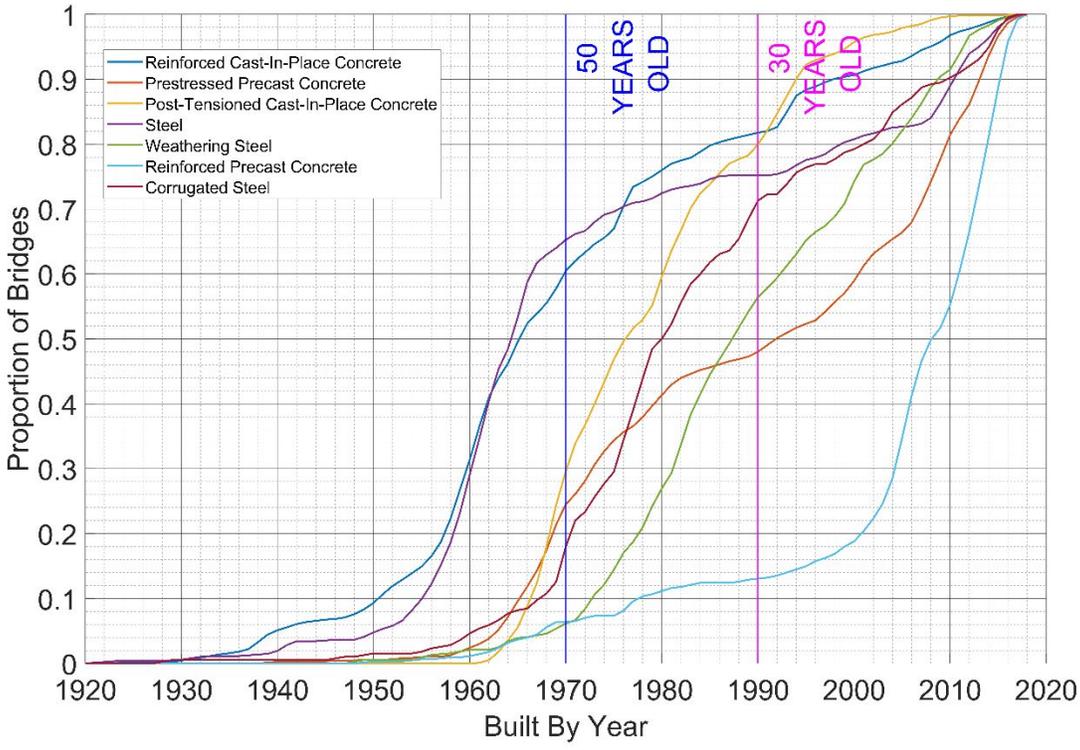
Figure 2. Proportion of In-Service Ontario Bridges Built by Year

107 In order to compare the BCI of the seven most common bridge materials in Ontario, steel buried
108 structures being the 7th most common, cumulative distributions are calculated for each bridge type across
109 their BCI, year built, and year rehabilitated. The population considered in the analysis includes all non-
110 rehabilitated and rehabilitated bridges built after 1920. Investigating the age of the population of these
111 structures, Figure 2 depicts the proportion of the population of different bridge types built by a certain
112 year. For corrugated steel structures, out of the 194 bridges in-service with known construction dates, 18
113 % of the bridges are known to be over 50 years old and 70 % are known to be over 30 years old. With

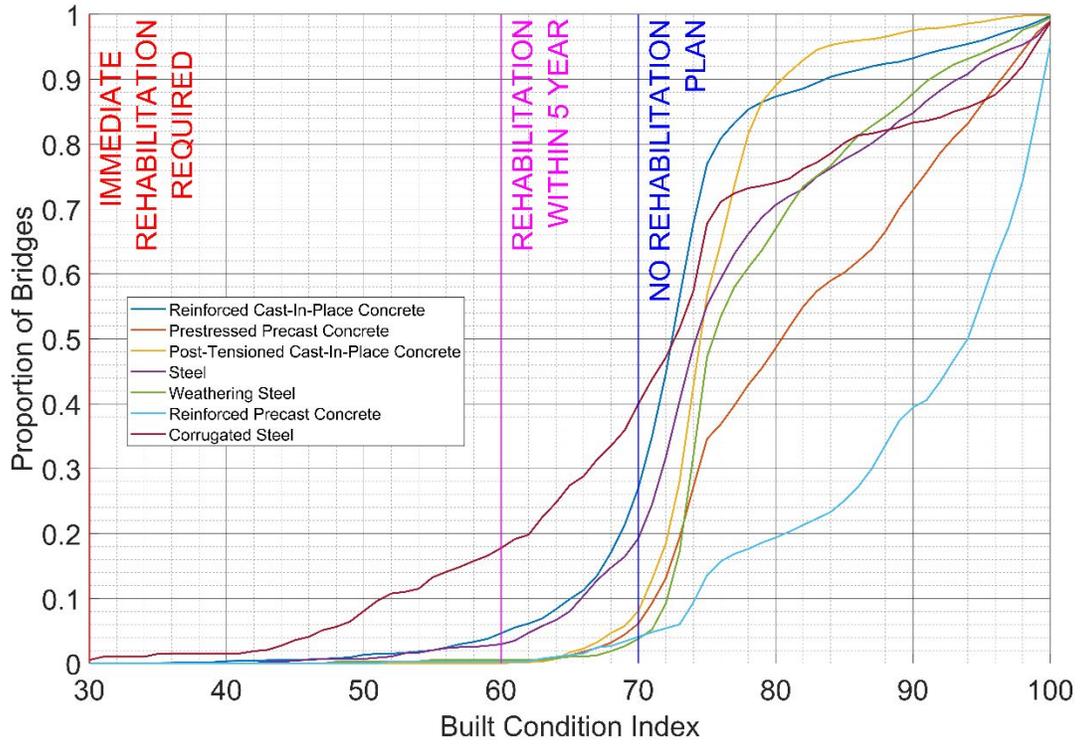
Figure 3. Proportion and Condition of All Common Bridge Materials

114 regards to age, corrugated steel structures lie in the middle of the distribution, while reinforced pre-cast
115 concrete structures are generally newer installations and cast-in-place concrete as well as steel are the
116 oldest structures. In Figure 3, for the different bridge types, the cumulative proportion of the population at
117 a specific BCI and below is depicted. From the analysis, Corrugated Steel Bridges have the highest
118 proportion of bridges with the lowest BCI as 40 % of the population has a BCI of 70 or lower, and 18 %
119 of the population has a BCI of 60 or lower. From the BCI and age distribution data, Table 1 compares the
120 condition of these bridge materials and their age. Corrugated Steel bridges have:

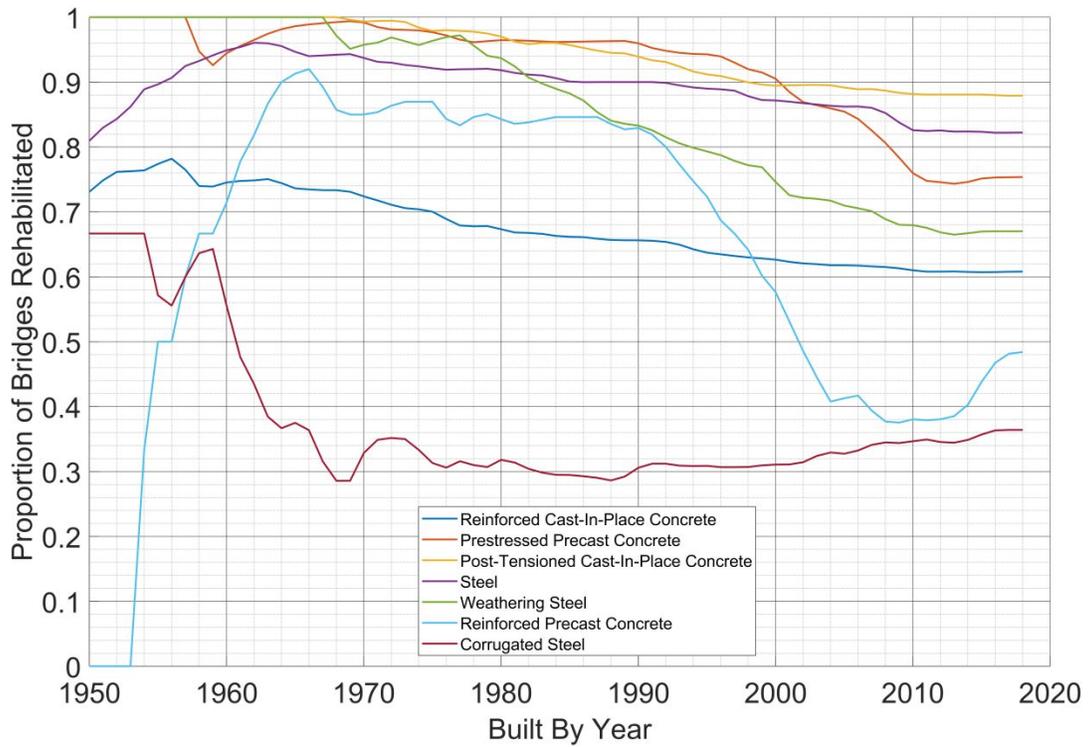
Figure 4. Proportion of Bridges Rehabilitated Built by Year “x” and Earlier

129 The proportions of the different bridge types that have been rehabilitated is depicted in Figure 4.
130 The plot extends from 1950 to 2020 as the bridge populations before 1950 are of meager proportion. For
131 each bridge type, the proportion of structures that have been rehabilitated for a specific age and before is
132 depicted. Corrugated steel bridges have the lowest population of rehabilitated structures across all ages.
133 Out of the structures that are over 50 years old, only 30% of the population has been rehabilitated. In
134 contrast, 72 % to 100 % of other structures have had some sort of rehabilitation performed. A similar
135 situation is also seen for structures that are at least 30 years old and with all present in-service structures.
136 Of the corrugated steel population that is 30 years and older only 30 % has had any rehabilitation. Further,
137 at present only 37 % of the total in-service population has had any rehabilitation, while other structures

- 521 • The high proportion of unmaintained buried steel bridges in Figure 4 and the lack of
522 content on the subject in Ontario's bridge management resources suggest that there are
523 issues associated with maintenance and management of these structures in Ontario.

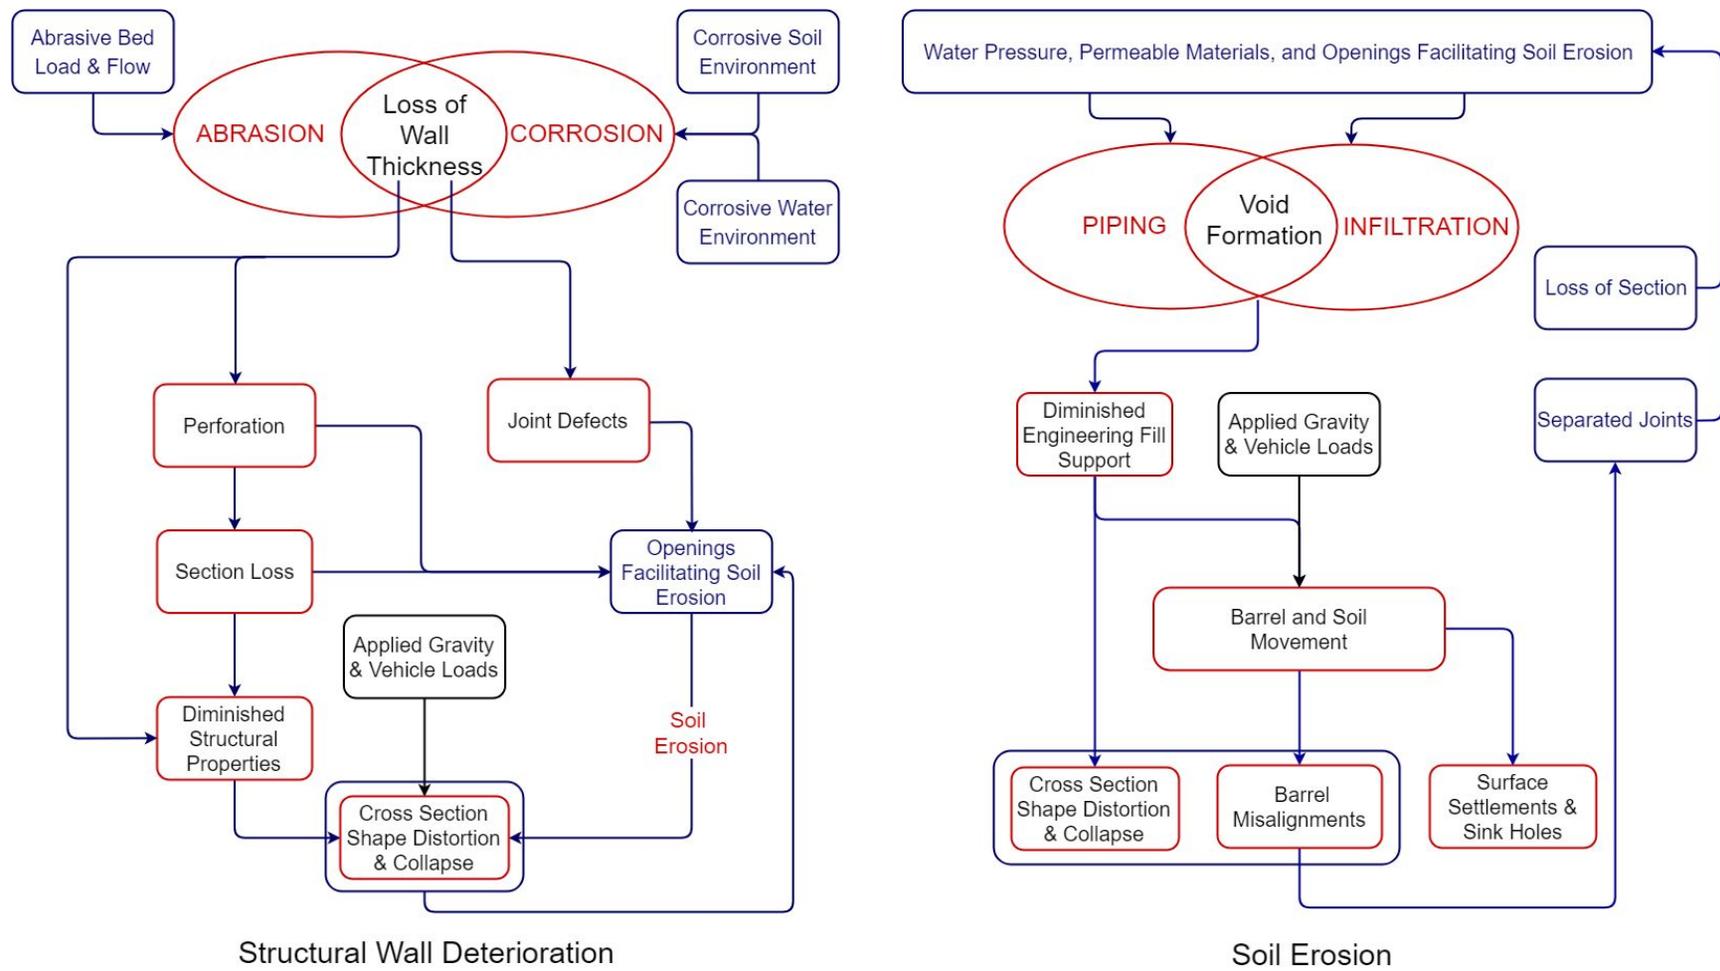
Figure 5. Deterioration of Steel Buried Bridges

185 An outline on how buried steel structural walls may deteriorate due to corrosion and abrasion and
186 how the engineering fill may be affected by soil erosion is presented in Figure 5 (the authors' synthesis of
187 the literature is discussed in more detail through the remainder of this section). Deterioration of the
188 structural plate wall thickness is driven by the structure's surrounding environment. Corrosion may apply
189 to both watercourse and grade separation structures. Abrasion is a concern solely in watercourse
190 structures where the water is flowing against the wall of the structure. Both processes may result in
191 perforations, damaged joints, section loss, diminished structural properties and cross-sectional distortions

- 530 of structural wall and soil deterioration, Figure 5, along with the rehabilitation options
 - 531 related to signs of distress, Figure 6.
 - 532 ● Deterioration is dependent on the local environment of the structure which varies

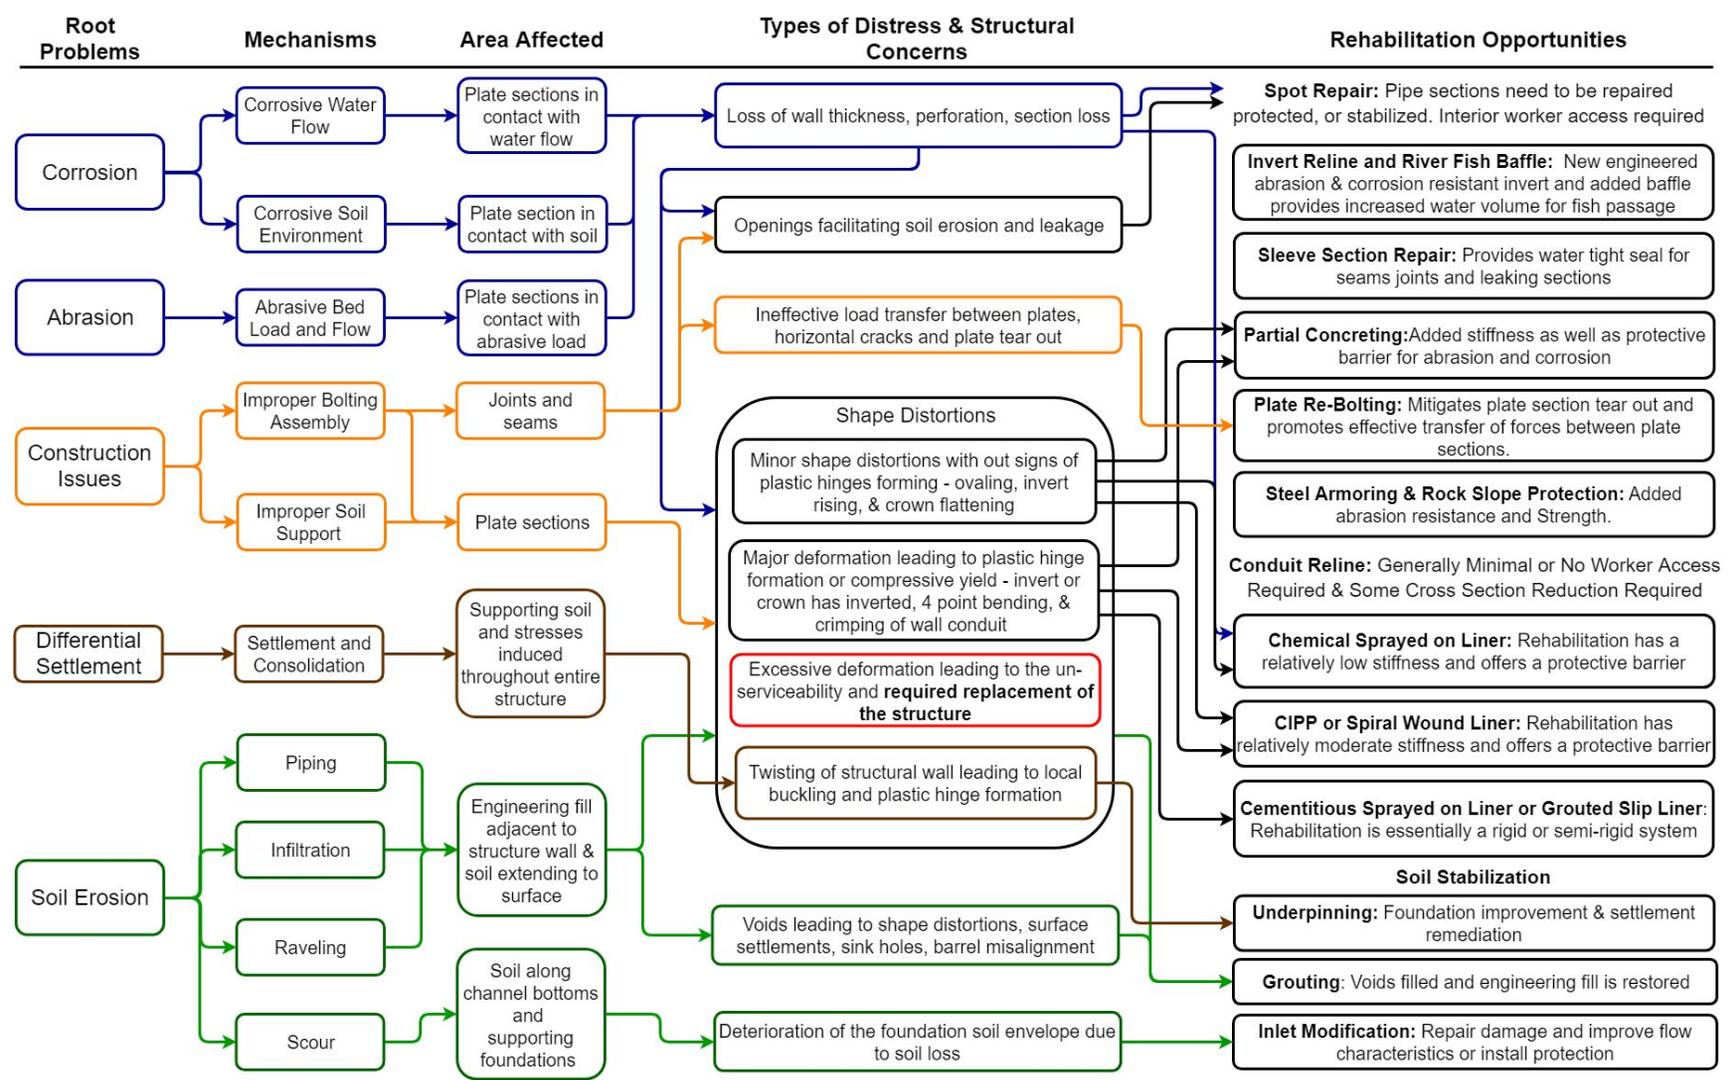
Figure 6. Rehabilitation Options for Distressed Steel Buried Bridges

- 524 • Resources are available for assessing, managing, maintaining and rehabilitating steel
525 buried structures. An overview of the deterioration and rehabilitation possibilities of steel
526 buried structures is presented in this work, and a summary of the results is presented in
527 Figure 6.
