CSP Caissons Extend 100 Year Steel Bridge Prediction

OLD BRIDGE, BRIDGEWATER

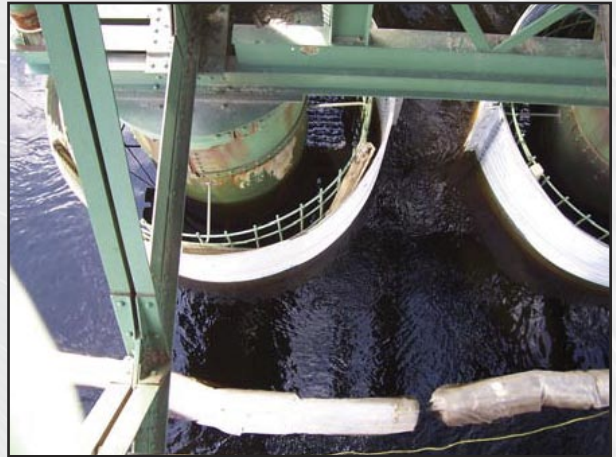
CAISSONS & REINFORCING STEEL IN PLACE

Corrugated Steel Pipe was selected to facilitate construction of the piers. Pipes 2400mm diameter x 3 metre long x 3.5mm thick were used. Each was fitted with four, 4" x 4" x 1/4" steel angles. All angles were match punched for bolting and then hot dip galvanized. The steel angles were welded to each side of the pipe before the pipe was cut lengthwise to form the two matched halves of the CSP caisson. Rolled angles were attached at the bottom of each caisson. These served to support short, vertical timber forms that were field trimmed to match and sealed against the irregular surface of the river bottom.

Caissons were securely bolted to form a strong continuous ring around an epoxy coated steel reinforcing cage. Each was filled with concrete at low tide and allowed to cure within the caisson as the tides continued to rise and fall.
